AERONAUTICAL RESEARCH COUNCIL

Civil Aircraft Airworthiness  
Data Recording Programme.  
Special Events Related  
to Airspeed Control Practices  
(February 1963 to February 1966)

*CAADRP Special Events Working Party*

June 1969

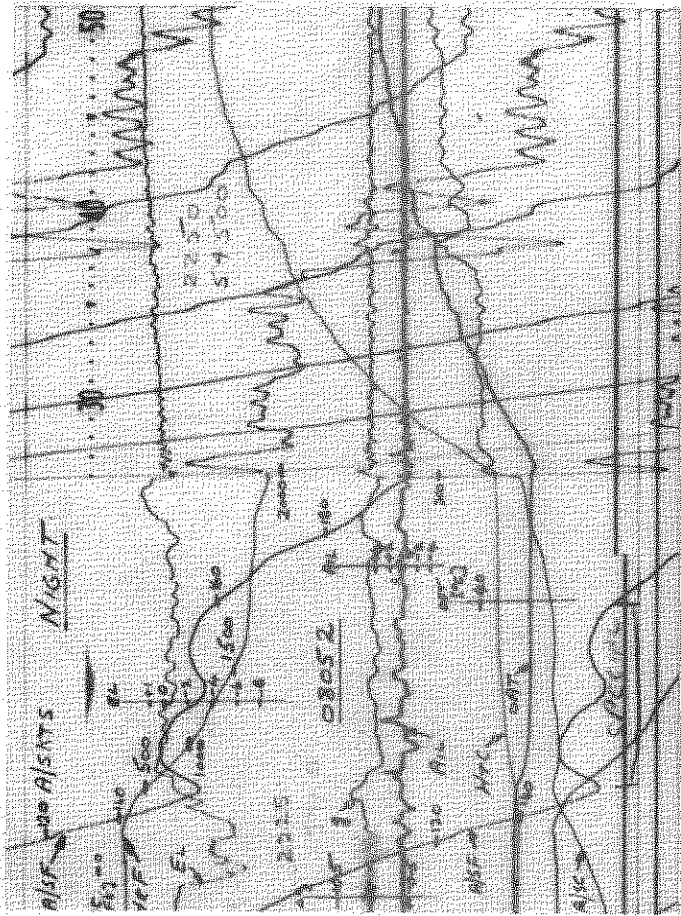
Fig.2. Event in flight 08052

Figs.2 and 3 illustrate airspeed and height fluctuations in the initial climb-out phase. The aircraft were not endangered by these fluctuations because they occurred at a safe height (> 400 feet) above the airfield; at very low height they could be dangerous.

During each take-off, the indicated airspeed was allowed to fall after attaining climb-out speed, and thereafter fluctuated until 2000 feet altitude was reached. (Figs.2 and 3). Note that the time base changes with operation of the flaps.

In both instances the initial rate of climb was lower than normal and the airspeed was permitted to build up to a level well above the normal maximum. Following an increase in rate of climb, airspeed and height oscillations developed, which decayed only after the aircraft levelled out at 1700 feet and 3000 feet respectively. A similar oscillation developed at the top of the climb. In neither instance did the airspeed fall below the recommended minimum.

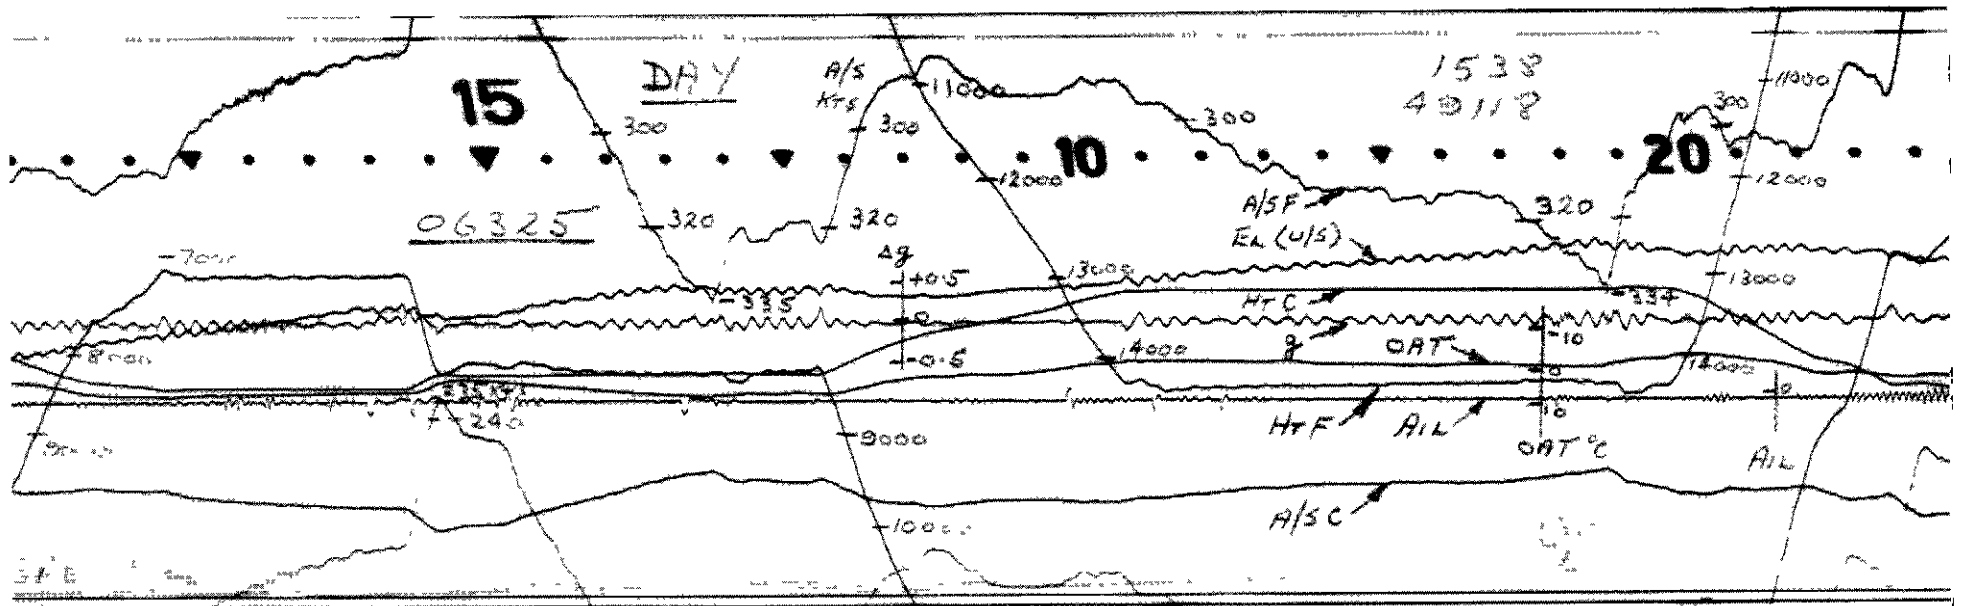
Fig.4. Event in flight 06325

The events depicted in Figs.4 and 7 occurred during periods in which the crew were concerned with diversion procedures.

During climb and re-routing after diversion (at 7000 ft) from London to Manchester, airspeed built up to 335 knots for a very brief period, and then slowly decreased to 280 knots. Sixteen minutes later the airspeed built up to 334 knots but decreased immediately afterwards.

The maximum operating speed,  $V_{MO}$ , for this type of aircraft is 330 knots. An overspeed warning horn operates at approximately 6 knots above this speed.

The exceedences may have been the result of a high workload on the pilot during diversion.

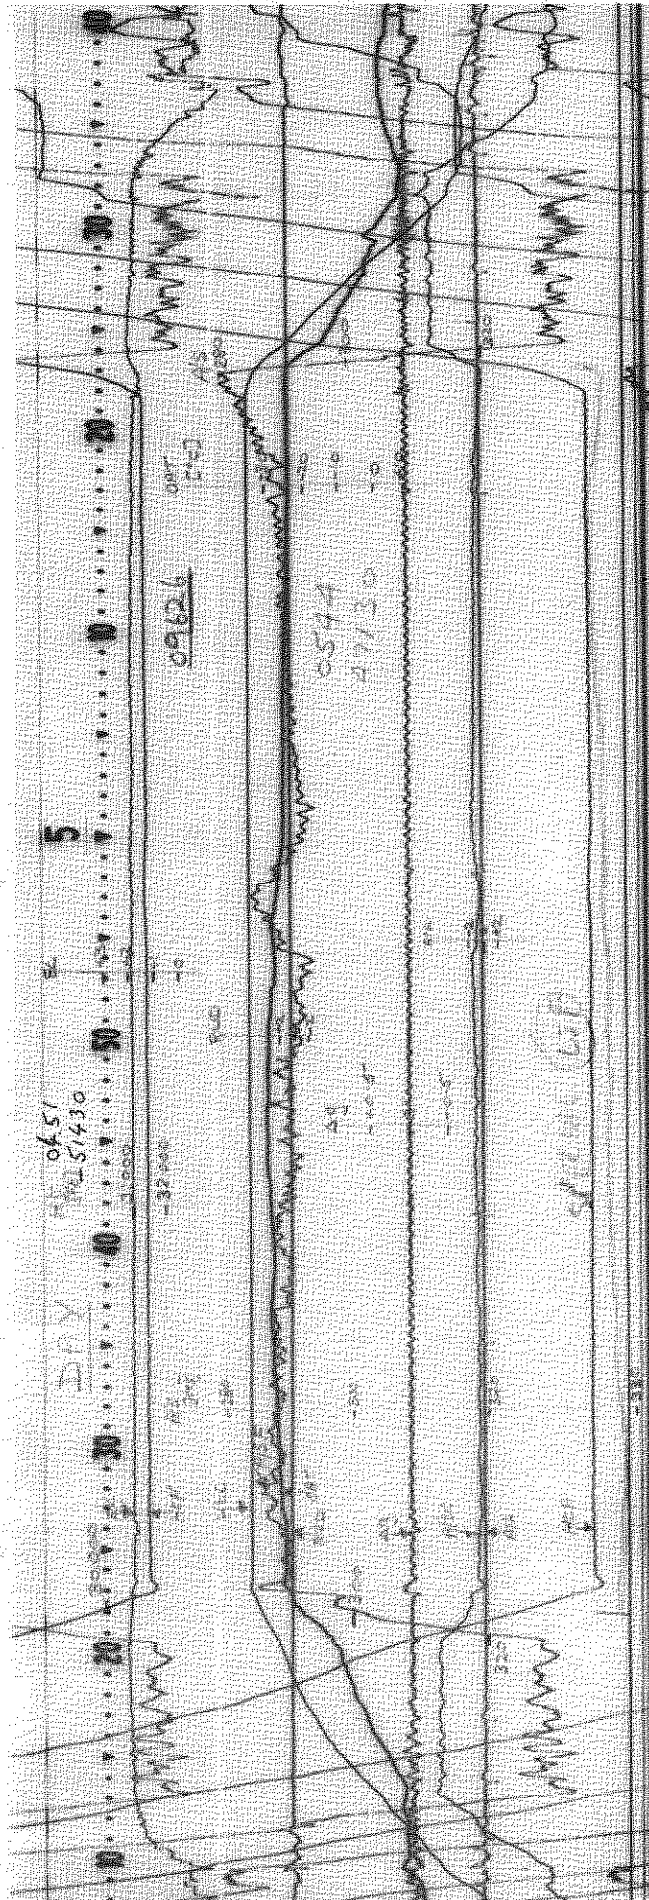
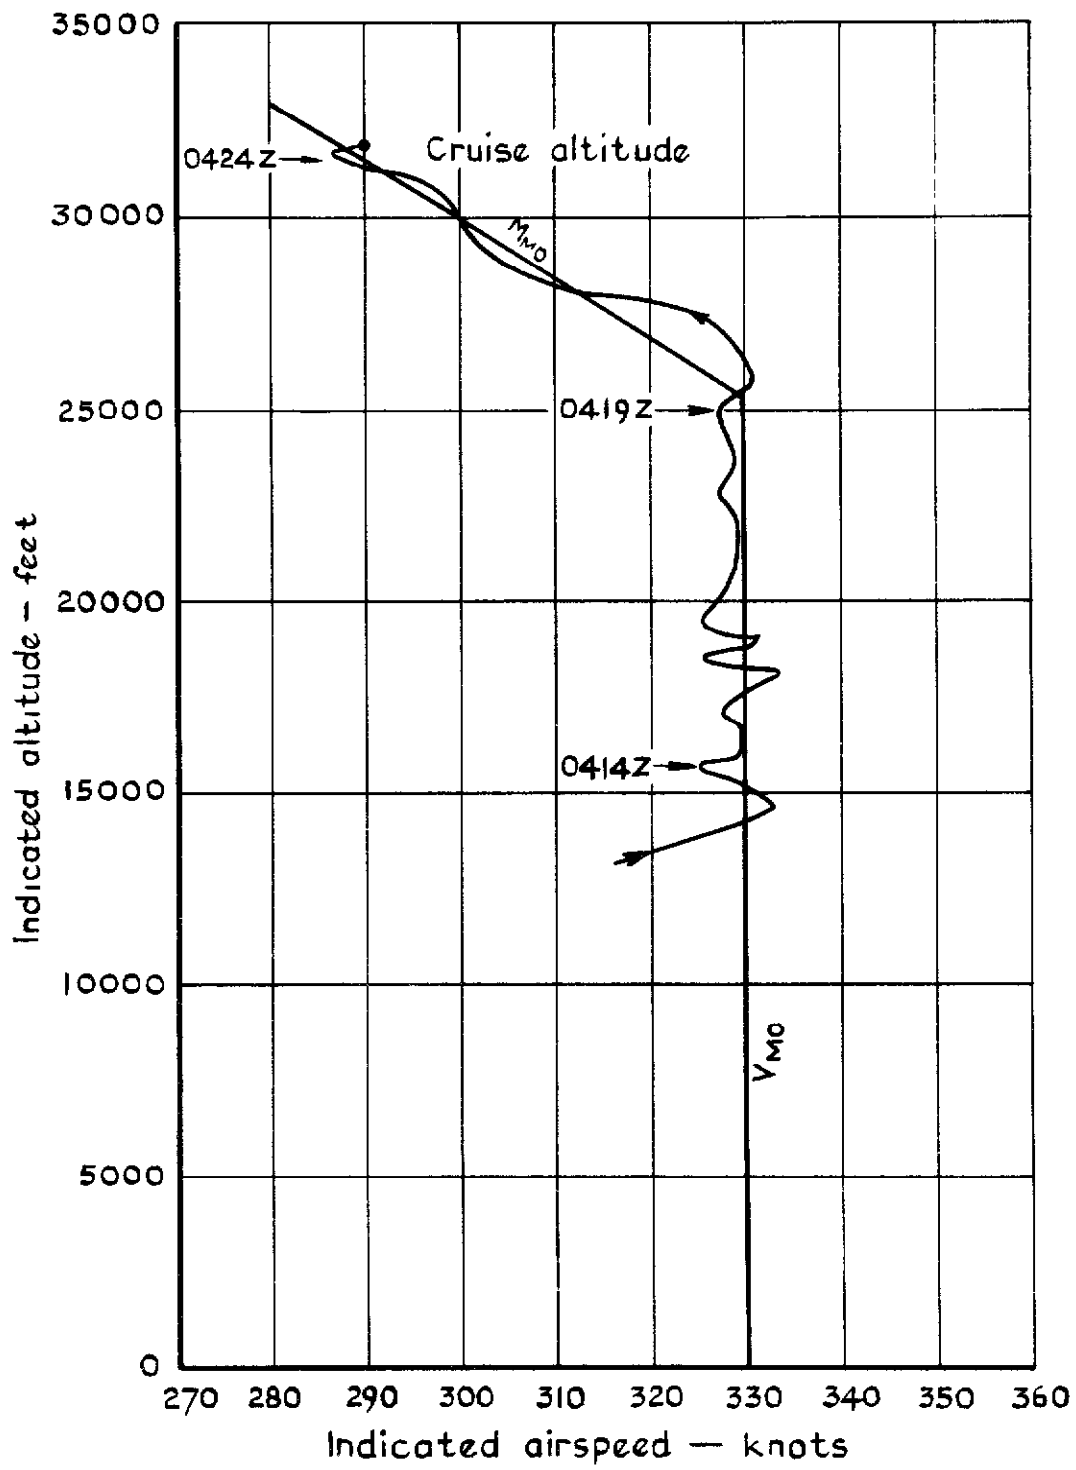
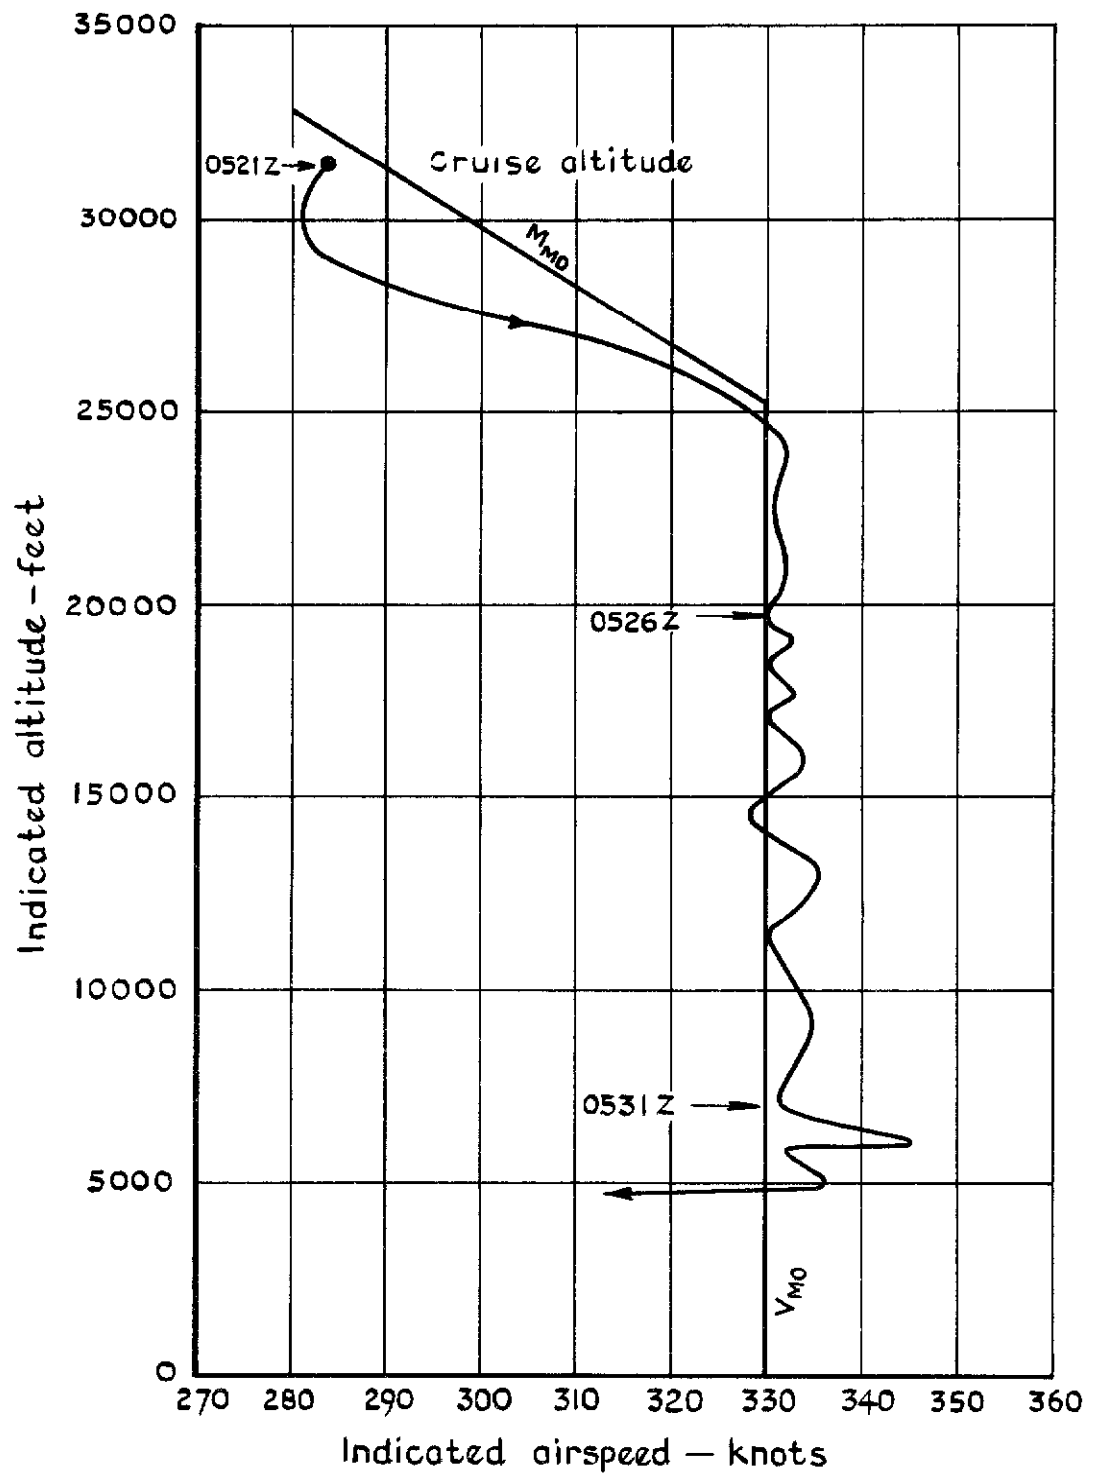
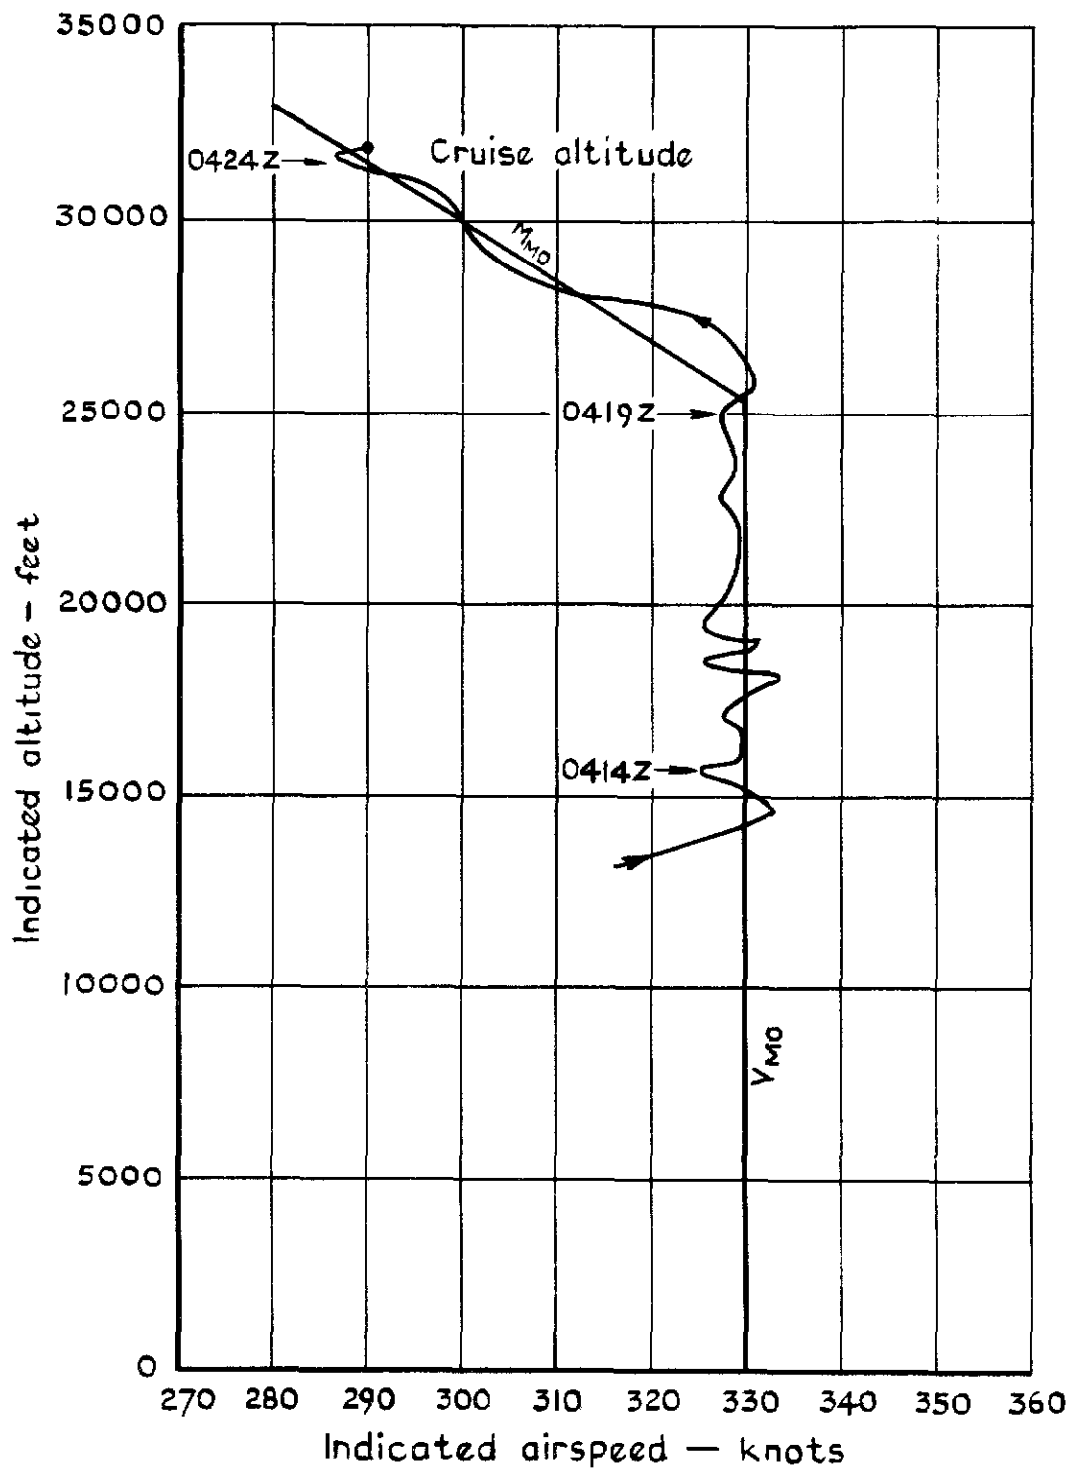
Fig.5a. Event in flight 09626

The exceedences shown in Figs.5a, 5b, 5c and 6 appear to be associated with the maintenance of an airspeed close to the operating boundary.

During the last seven minutes of climb and the first ten minutes of descent several airspeed and Mach number exceedences occurred.

The aircraft was flown to the boundary of the operating envelope, apparently with the assistance of autopilot speed lock.  $V_{MO}$  was not significantly exceeded during the climb but it is probable that the Mach number warning horn sounded at 27000 feet. Limitations were observed in the subsequent cruise, but  $V_{MO}$  was substantially exceeded when descent was temporarily checked at 6000 feet, probably while the pilot was anticipating clearance to flight level 50.

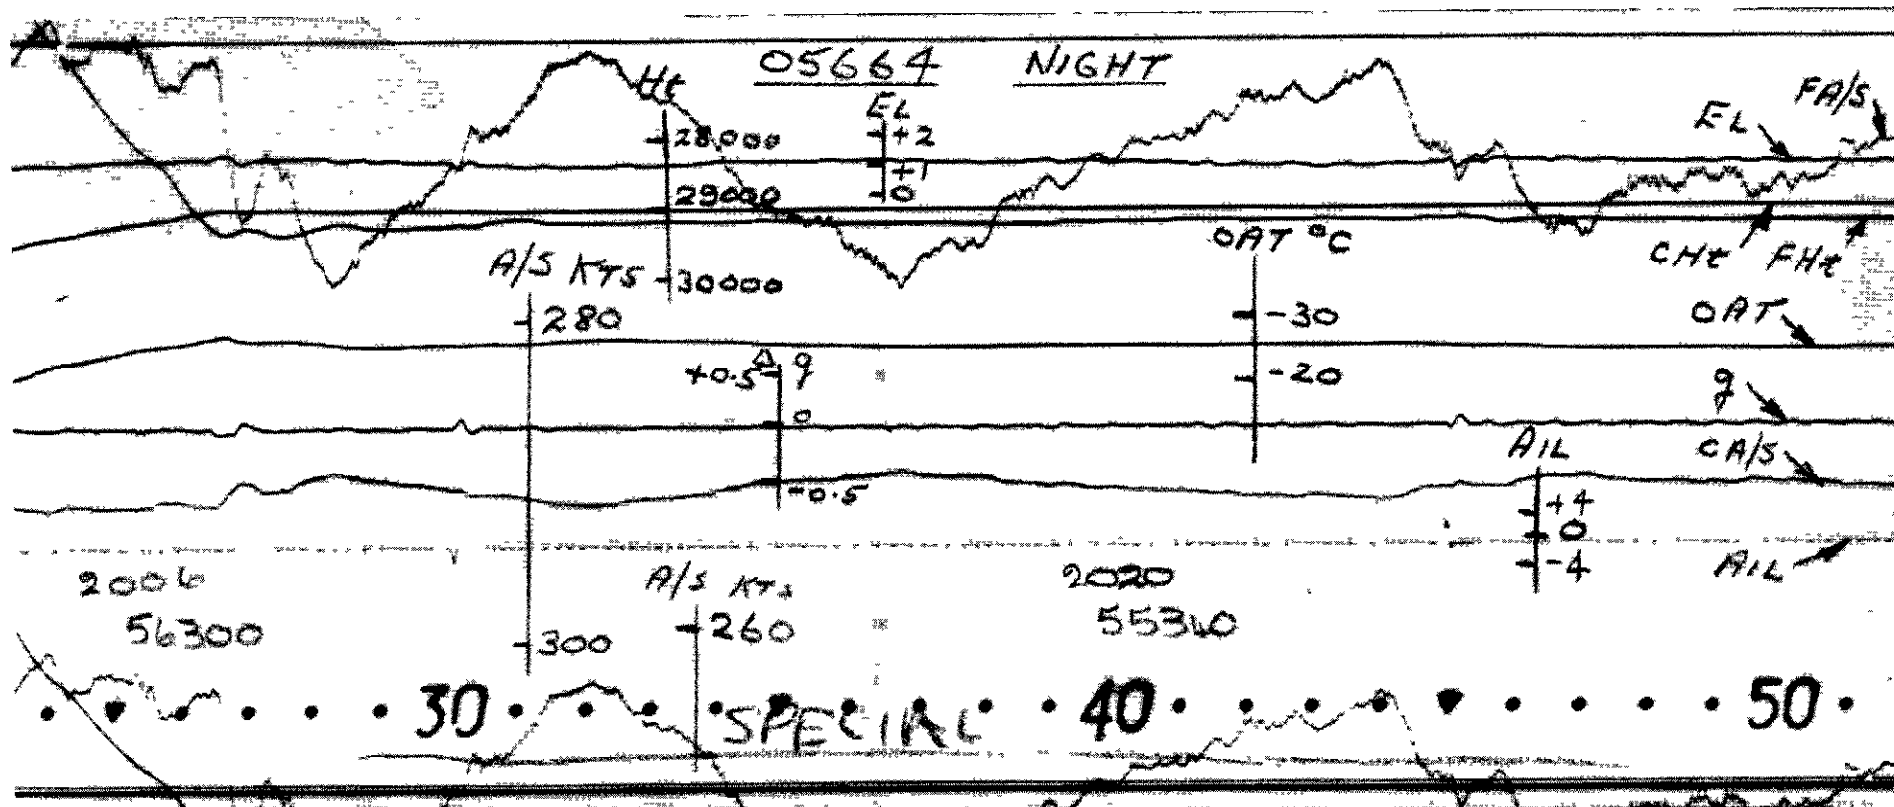
Fig. 6 Event in flight 05664

These exceedences suggest that the throttle settings were not trimmed and monitored with sufficient regard to the flight conditions. Fig.24 shows that it is usual for  $V_{NO}$  to be exceeded by this aircraft type.

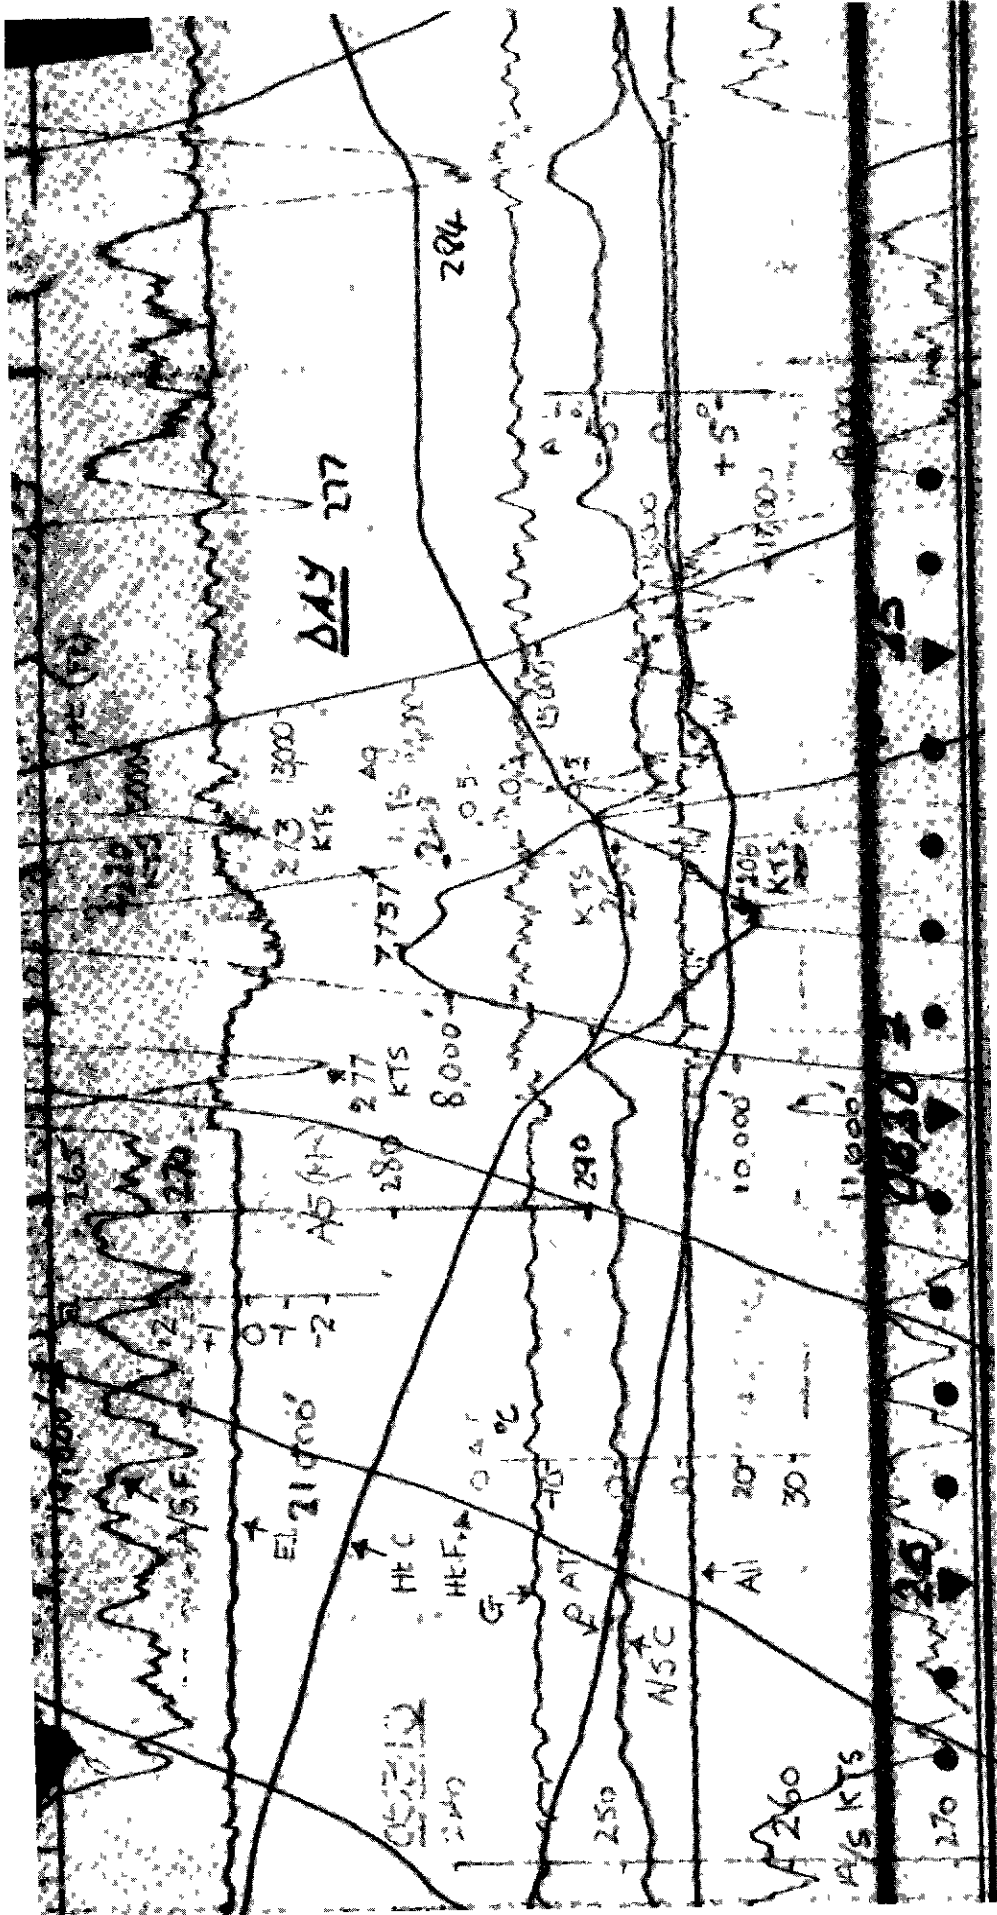
Fig.7. Event in Flight 05310

$V_{NO}$  for this aircraft is 270 knots and  $V_{NE}$  is 300 knots. Wide fluctuations in airspeed occurred once during the descent at about 10000 feet, and three times during the steep climb back to 25000 feet. Airspeeds of 277, 273, 277 and 284 knots were recorded. The surges in airspeed are not associated with the presence of turbulence and may have been due to the particular throttle control technique employed. Fig.24 shows that it is usual for  $V_{NO}$  to be exceeded by this aircraft type.

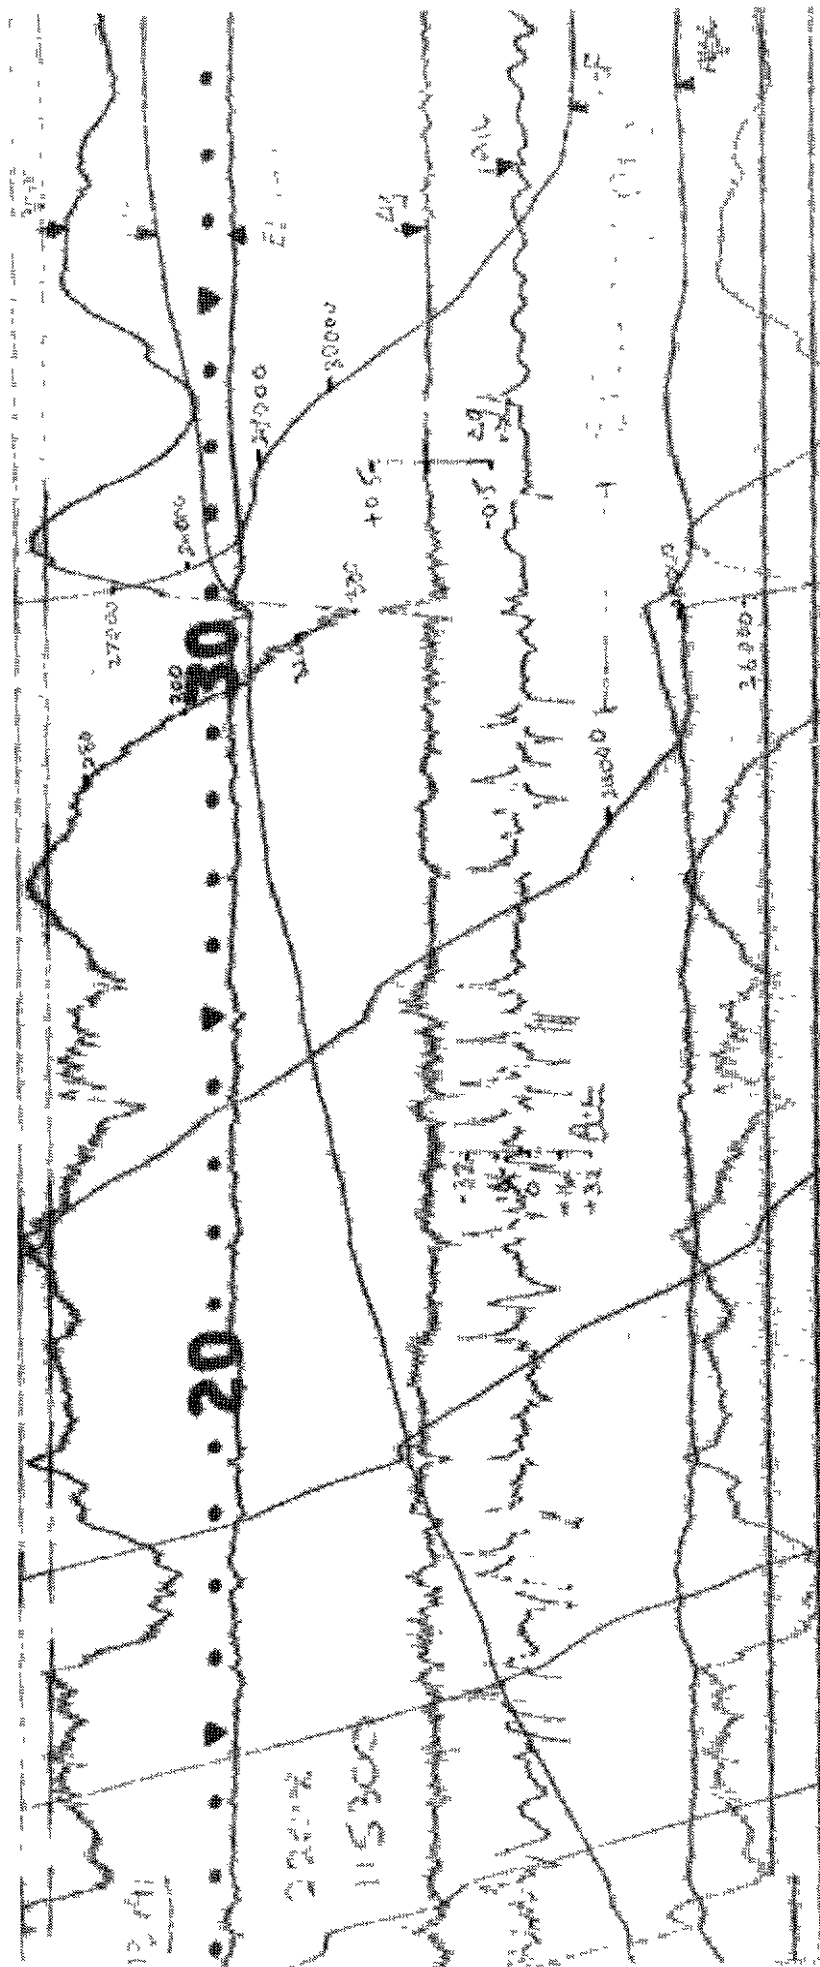
Fig.8. Event in Flight 13791

The recommended climb speed for this aircraft is 280 knots up to 34000 feet, with speeds of up to about 300 knots permitted in the absence of turbulence.  $M_{NO}$  at 25000 feet was 0.852 (360 knots) and  $M_{NE}$  was 0.887 (376 knots).

It is likely that after the aircraft had reached 25000 feet, clearance to a higher altitude was anticipated and throttle settings were not trimmed to maintain a constant speed. Consequently when climb was resumed after two minutes the airspeed had reached 330 knots. This speed is well below  $M_{NO}$  and it is not known why a 0.5 g manoeuvre was used in these circumstances.

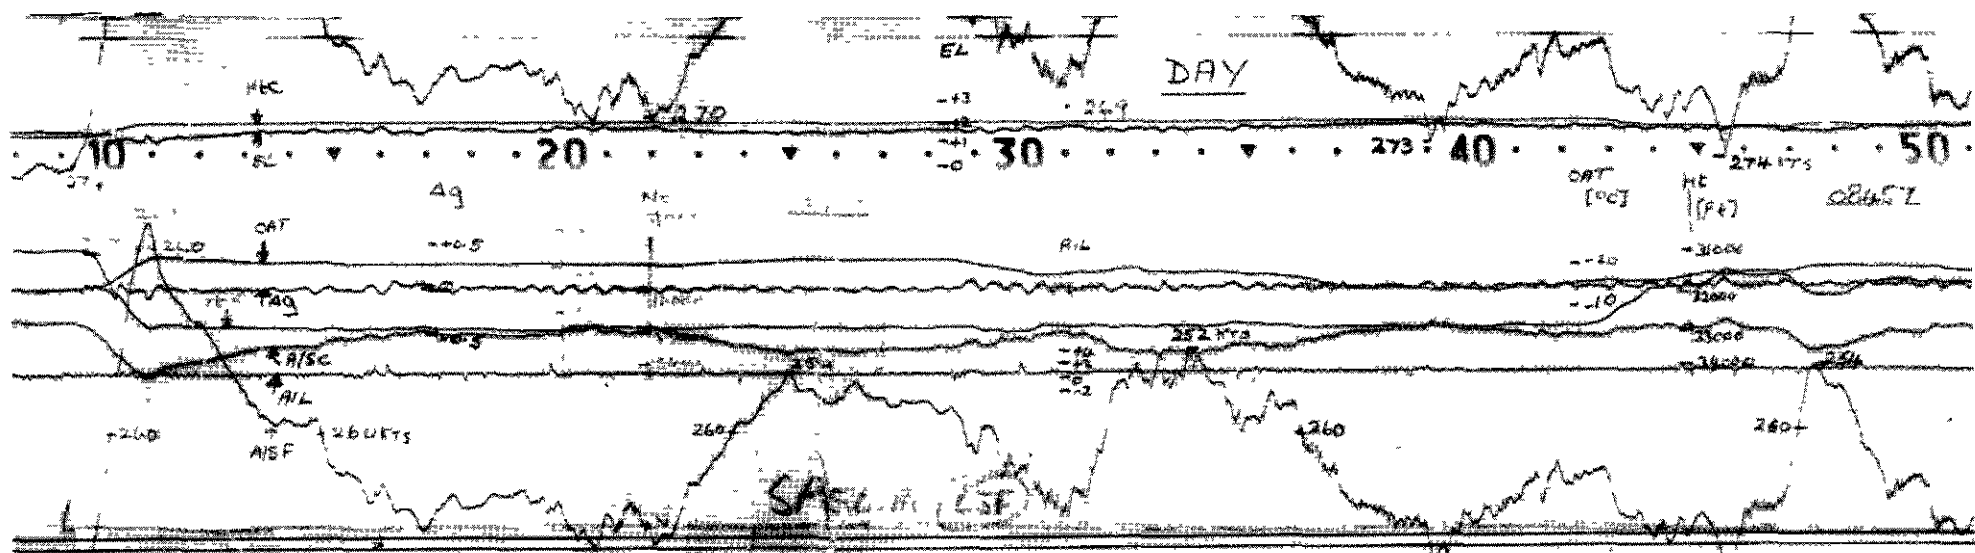
Fig.9. Event in flight 08457

These long period oscillations almost certainly resulted from rather infrequent, and consequently relatively coarse, adjustments to the throttle settings. There was no audible warning of the exceedence of  $M_{NO}$  as would be the case with a  $M_{MO}$  limitation.

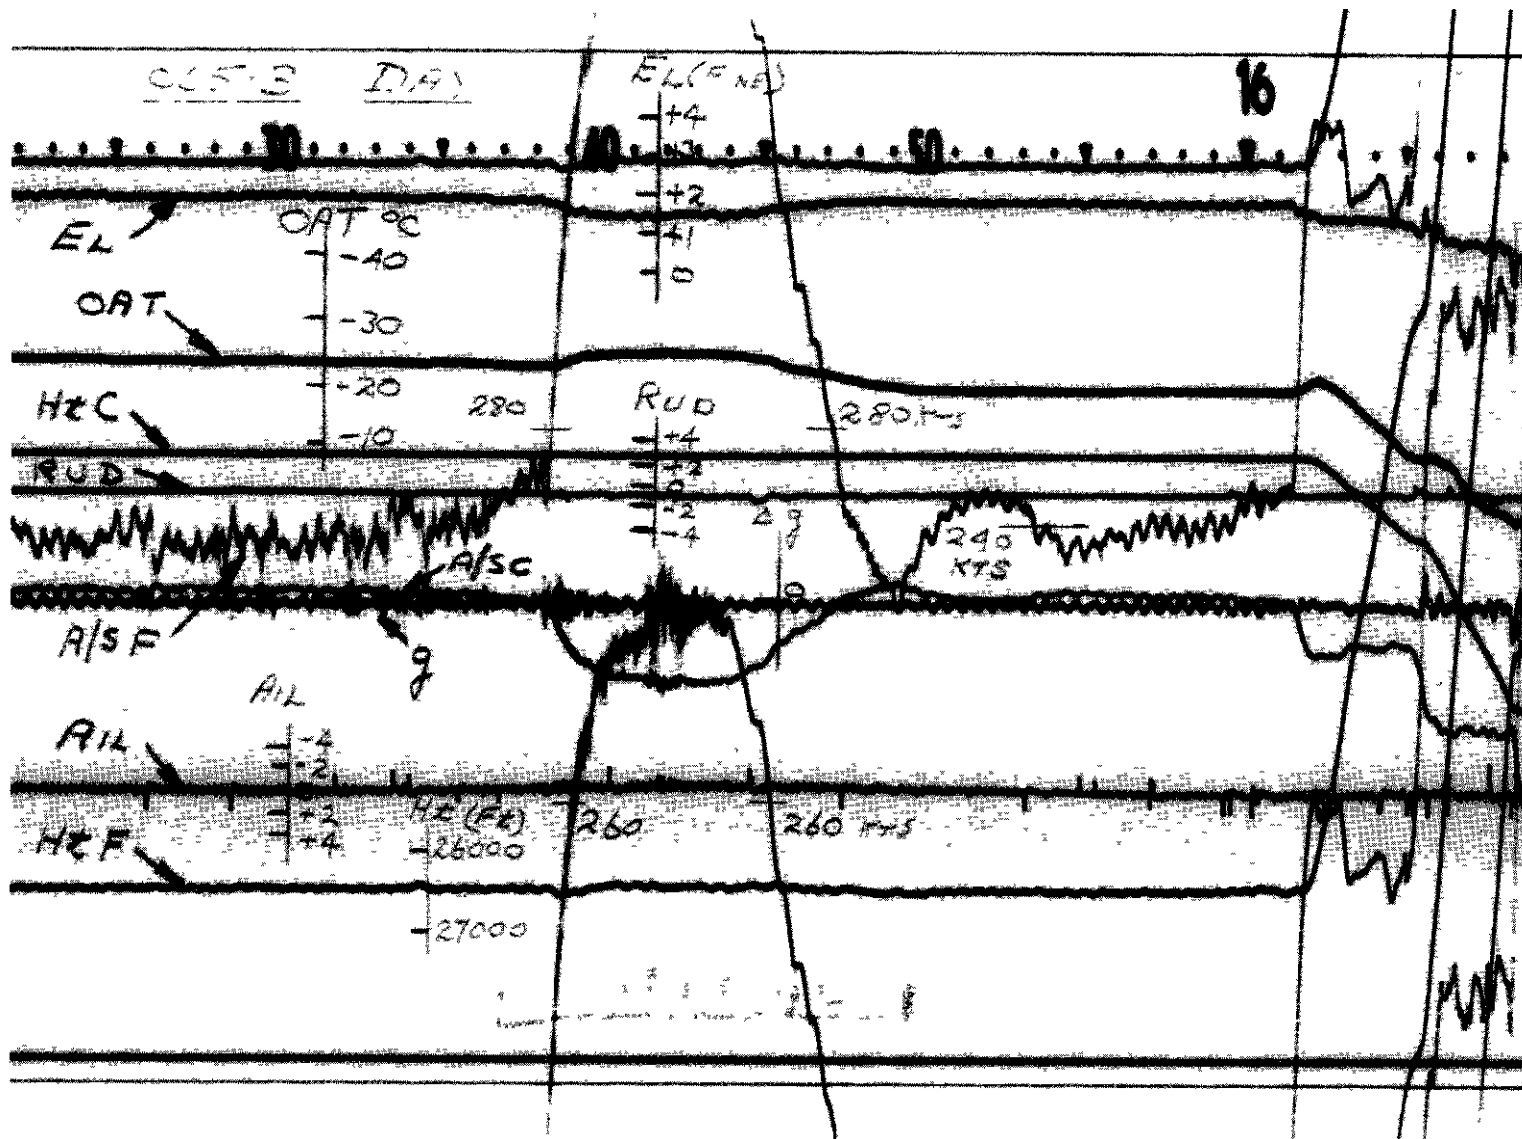
Fig.10. Event in flight 06513

The slight disturbance on the *g* trace, which occurs almost simultaneously with the speed reduction suggests that cloud or cloud tops were seen and appropriate throttling action taken to reduce airspeed in anticipation of turbulence. In the event, the turbulence appears to have been only light.

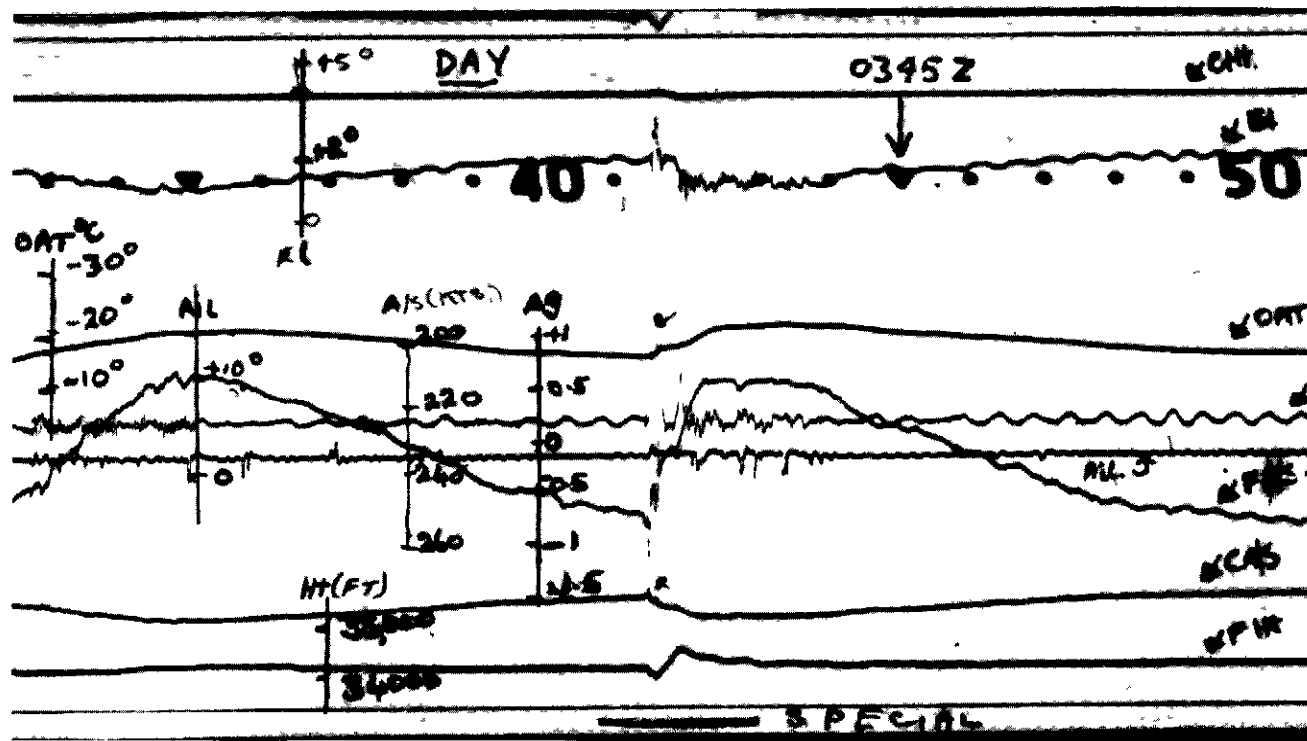
Fig.11. Event in Flight 02732

For many years it has been the recommended practice to reduce speed when turbulence is encountered, preferably before the actual encounter. Doubt has been cast on the advisability of this practice, particularly if speed is reduced by means of a pull-up manoeuvre; the combination of a manoeuvre acceleration and a gust could result in an unacceptably severe load on the aircraft. Figs.11 and 12 give examples of reduction in airspeed accompanied by pull-up manoeuvres in the presence of turbulence, while Fig.10 shows the effect of slowdown procedures initiated before the onset of turbulence and with negligible elevator action.

(vii) 1 minute later a stable manual flight condition was regained; aileron activity reduced to normal after a further 2 minutes. Autopilot was re-engaged a further 2 minutes later.

- (i) the oscillation was caused by the autopilot, in height lock mode,
- (ii) the  $+0.9$  g was caused by an unexpected large gust, as no significant elevator activity can be detected until 2 seconds later,
- (iii) the elevator movement ( $\frac{2}{3}$  degree) alleviated a probable downward acceleration more extreme than  $-0.7$  g,
- (iv) the elevator movement ( $1\frac{1}{2}$  degree) probably contributed to the downward acceleration of  $-0.5$  g,
- (v) the elevator movement probably contributed to the upward acceleration of  $+0.4$  g.

The  $+0.9$  g was experienced at normal cruise speed and was therefore probably unexpected. Indicated airspeed decreased by 40 knots in the next 40 seconds, which was probably due to horizontal wind shear, although it is possible that an engine power reduction contributed to this rapid deceleration, (i.e. about  $0.1$  g).

$V_{NO}$  for this aircraft is 270 knots and this speed must not be exceeded in turbulence.

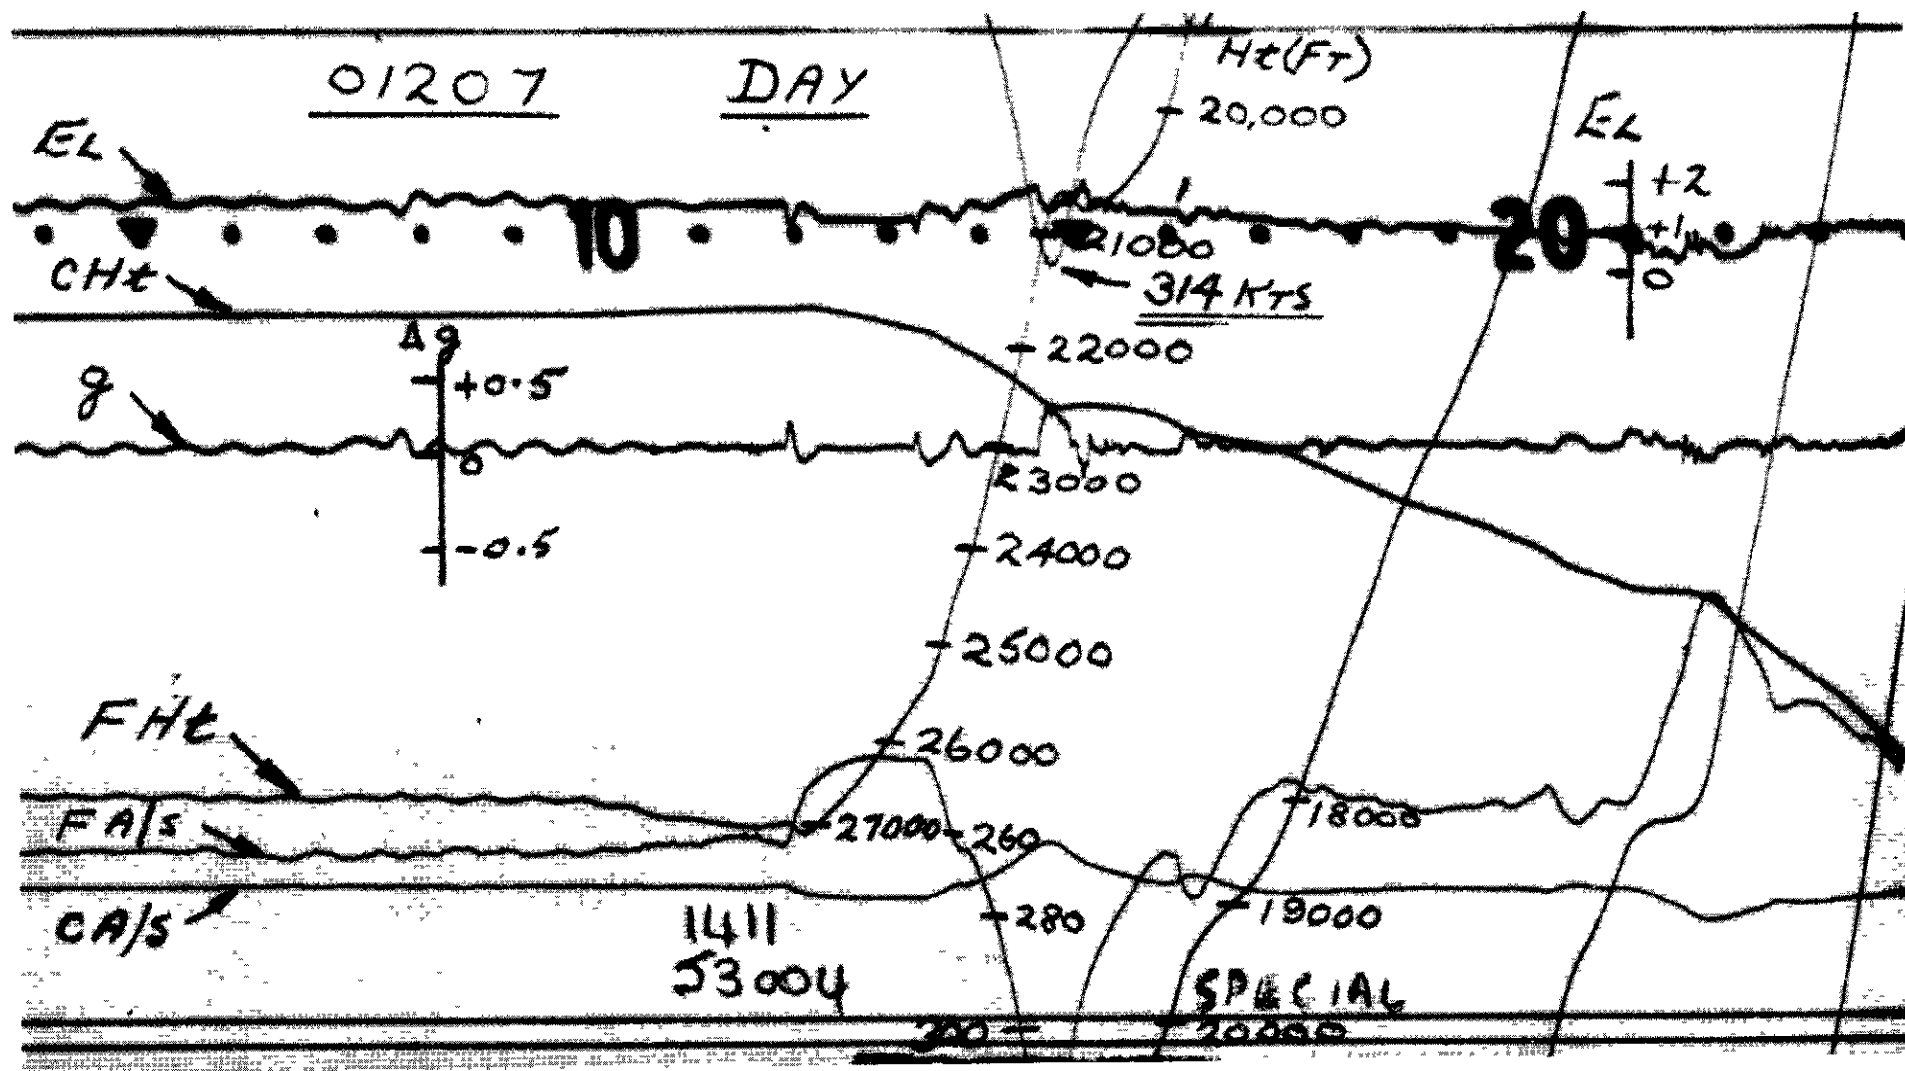
Fig.13 Event in flight 01207

The events shown in Figs.13 and 14 relate to instances during descent in which the airspeed inadvertently exceeded that normally employed by approximately 54 and 46 knots respectively. In the first of these examples  $V_{NE}$  was exceeded by approximately 14 knots.

Approximately  $2\frac{1}{2}$  minutes after the end of cruise the rate of descent had increased to a moderate 1800 feet/minute. However, during this time airspeed was permitted to increase rapidly and the overspeed warning horn almost certainly operated before speed was decreased by checking the descent with a 0.3 g manoeuvre.

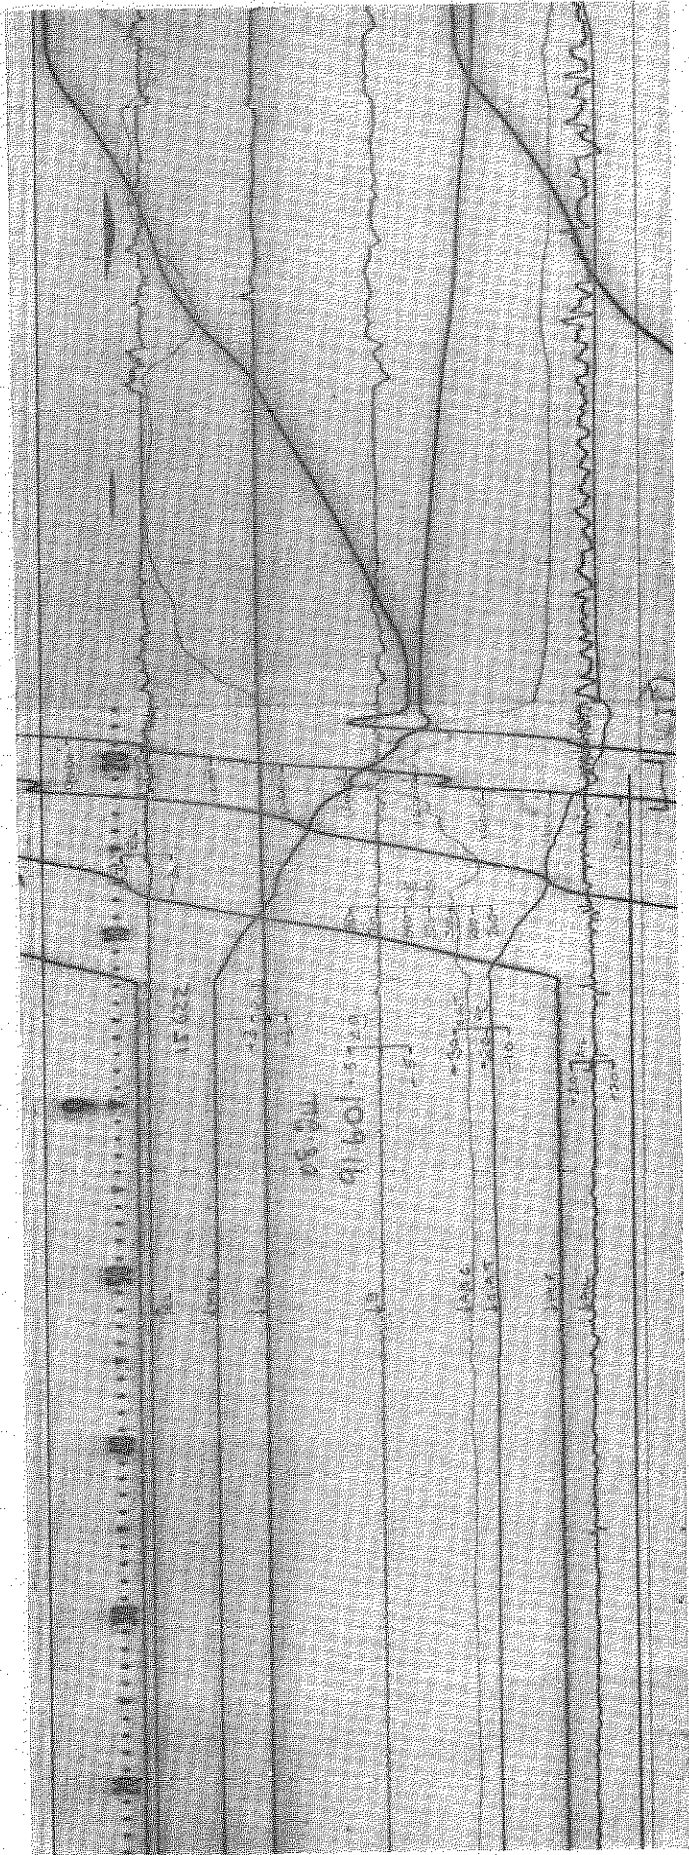
Fig.14. Event in Flight 15622

Since there is no evidence of turbulence, a slight increase in airspeed to about 320 knots may well have been intended. However, it appears that airspeed increased sufficiently rapidly to result in an inadvertent exceedence of  $V_{MO}$  before the crew were alerted, possibly by the operation of overspeed warning horn, at about 364 knots.
