AERONAUTICAL RESEARCH COUNCIL

Civil Aircraft Airworthiness  
Data Recording Programme.  
Special Events Related  
to Airspeed Control Practices  
(February 1963 to February 1966)

*CAADRP Special Events Working Party*

June 1969

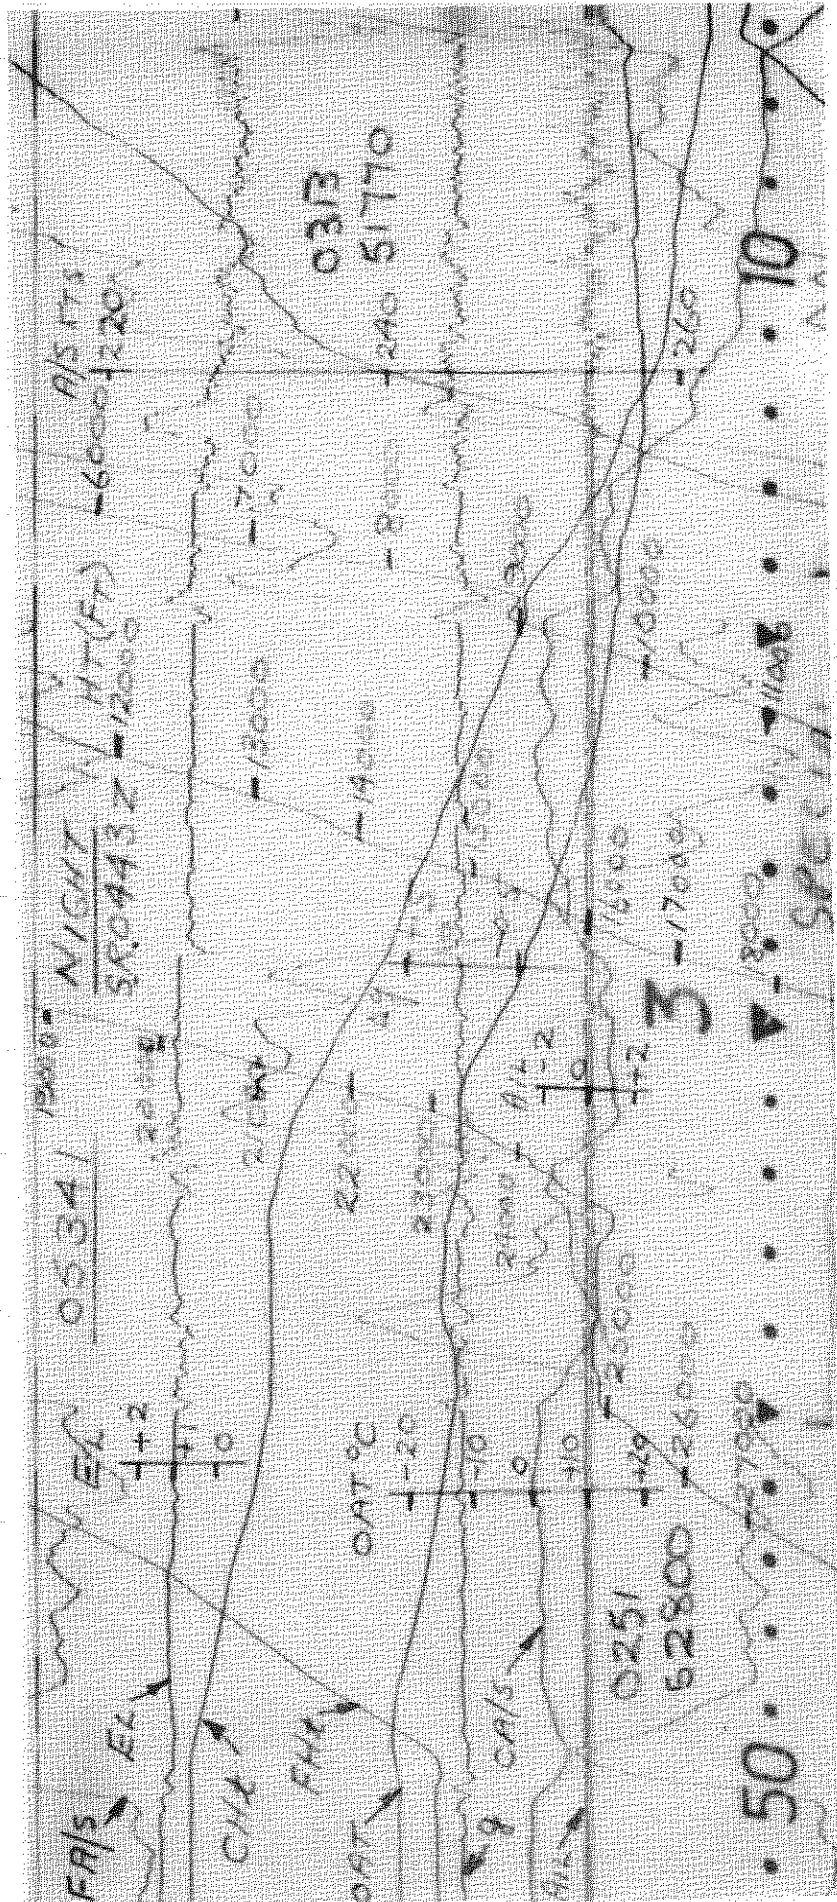
Fig.15 Event in flight 05341

The aircraft was apparently given initial clearance to descend from the cruise altitude to flight level 250. The fluctuations in airspeed are almost certainly associated with rather infrequent changes in throttle setting.  $V_{NO}$  for this aircraft is 270 knots up to 32000 feet.
