AERONAUTICAL RESEARCH COUNCIL  
REPORTS AND MEMORANDA

# Water Performance of a Four-Engined Flying Boat with Step Fairings of Length 3, 6 and 9 Times the Step Depth

*Reports and Memoranda No. 2868*

*April, 1941*

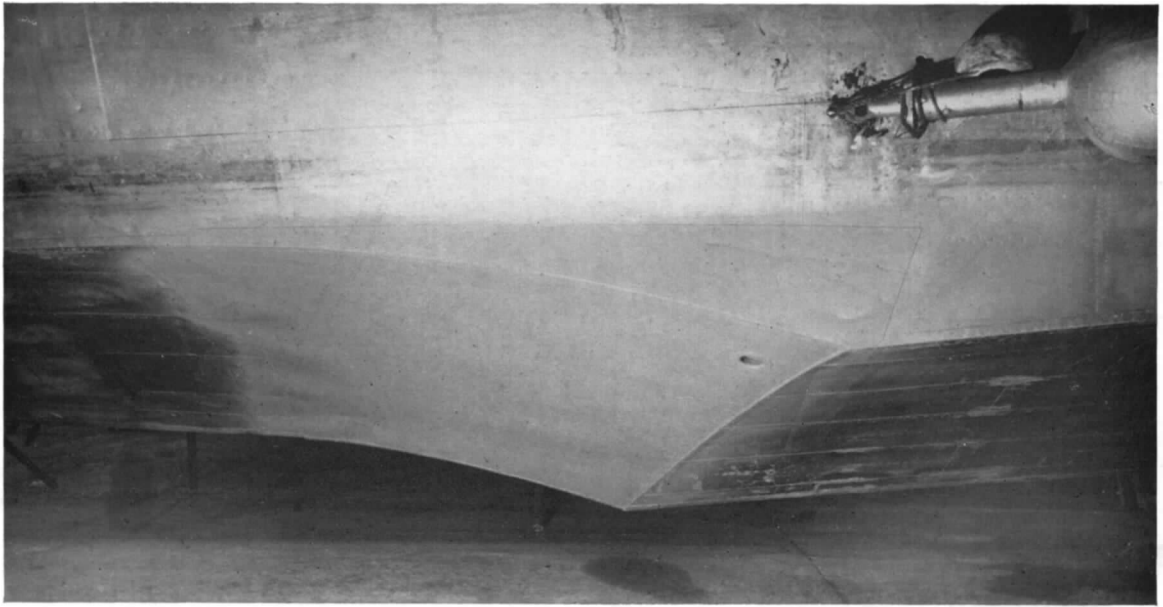
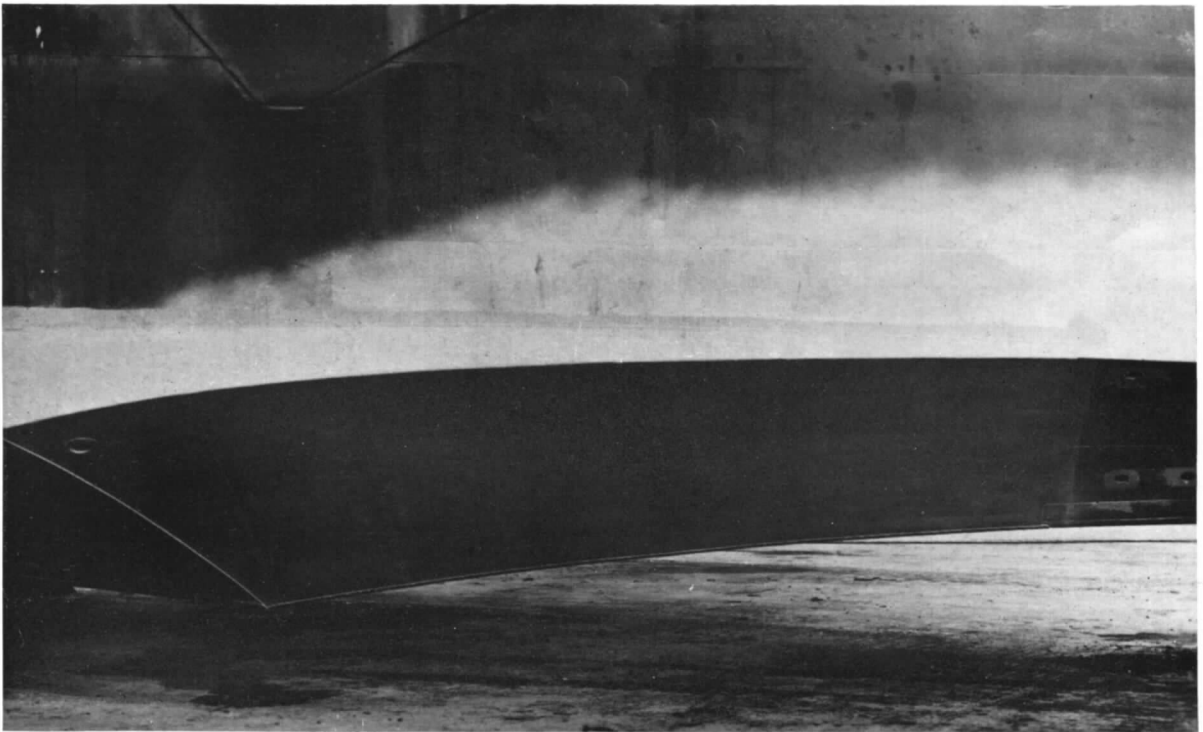
FIG. 4. Step fairings 2 and 3.

Fairing 2 (1 : 6).

Fairing 3 (1 : 9).

2. *Range of Investigation.*—Fig. 1 shows a general arrangement drawing of the *Sunderland*, and Table 1 gives general data. The fairings fitted were of nominal 1 : 3, 1 : 6 and 1 : 9 gradient\* and sketches of these with dimensions are given in Figs. 2 and 3. Photographs of the 1 : 6 and 1 : 9 fairings are shown in Fig. 4. For constructional reasons, it was convenient to finish the fairings on a transverse section and the fore-and-aft angle of the fairings is therefore greater at the keel than at the chine. For convenience, these fairings are respectively called fairings 1, 2 and 3 on the figures and henceforward.

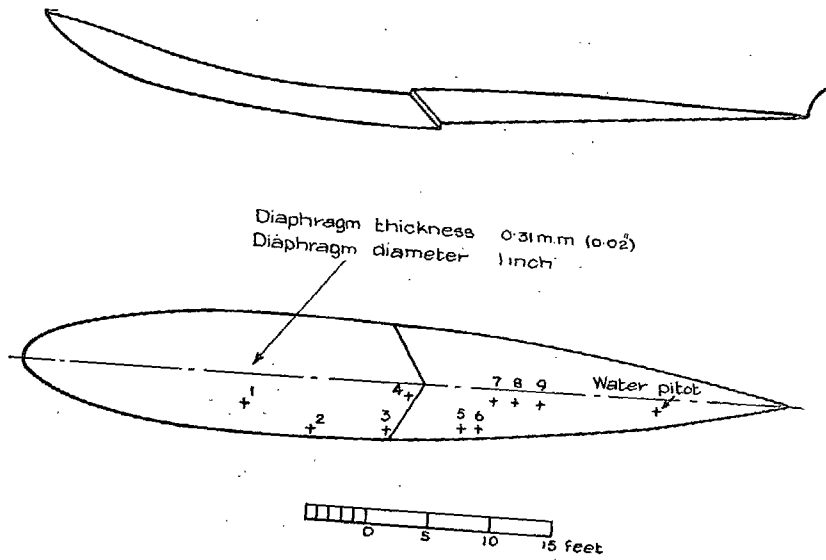
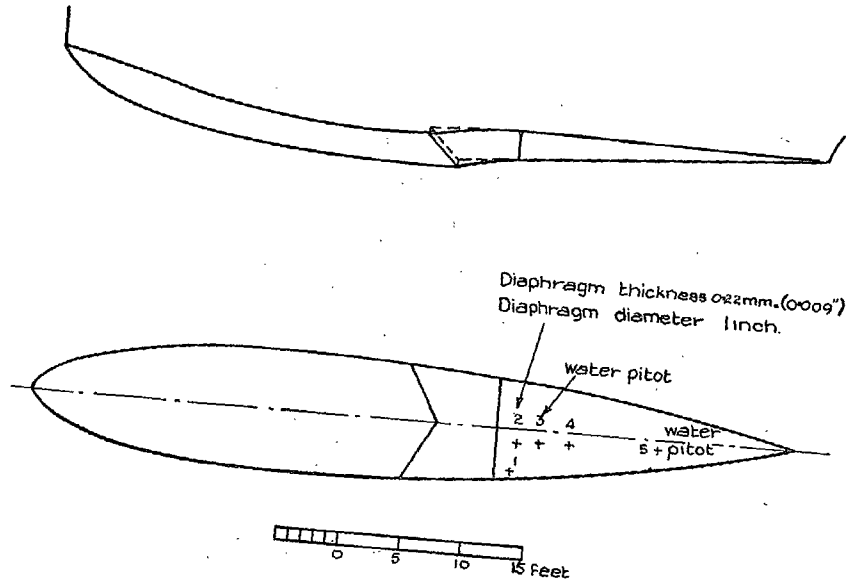
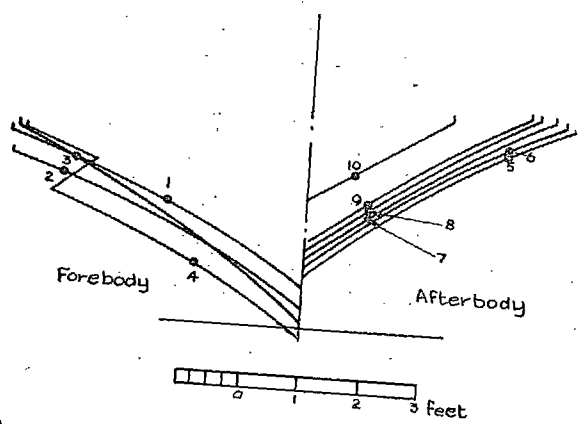
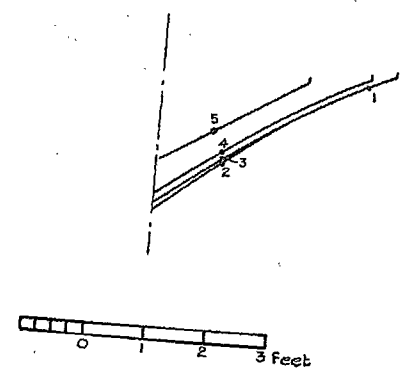
FIG. 5. Position of pressure diaphragms. No fairing.

FIG. 6. Position of pressure diaphragms. Faired step 2.

The associated effect of the fairings on the water flow over the hull bottom was also investigated. The positions and dimensions of the recorders are shown in Figs. 5, 6 and 7. Static and dynamic pressure measurements were first made at a number of stations on the fore and after bodies with no fairings and then on the afterbody only with fairings 2 and 3. In the last case, one forebody station was recorded to correlate forebody and afterbody flows. It was thought possible that the water flow might be adhering to the afterbody even when no static pressures were recorded, and so in later tests some of the diaphragm instruments were adapted to measure pitot pressure.

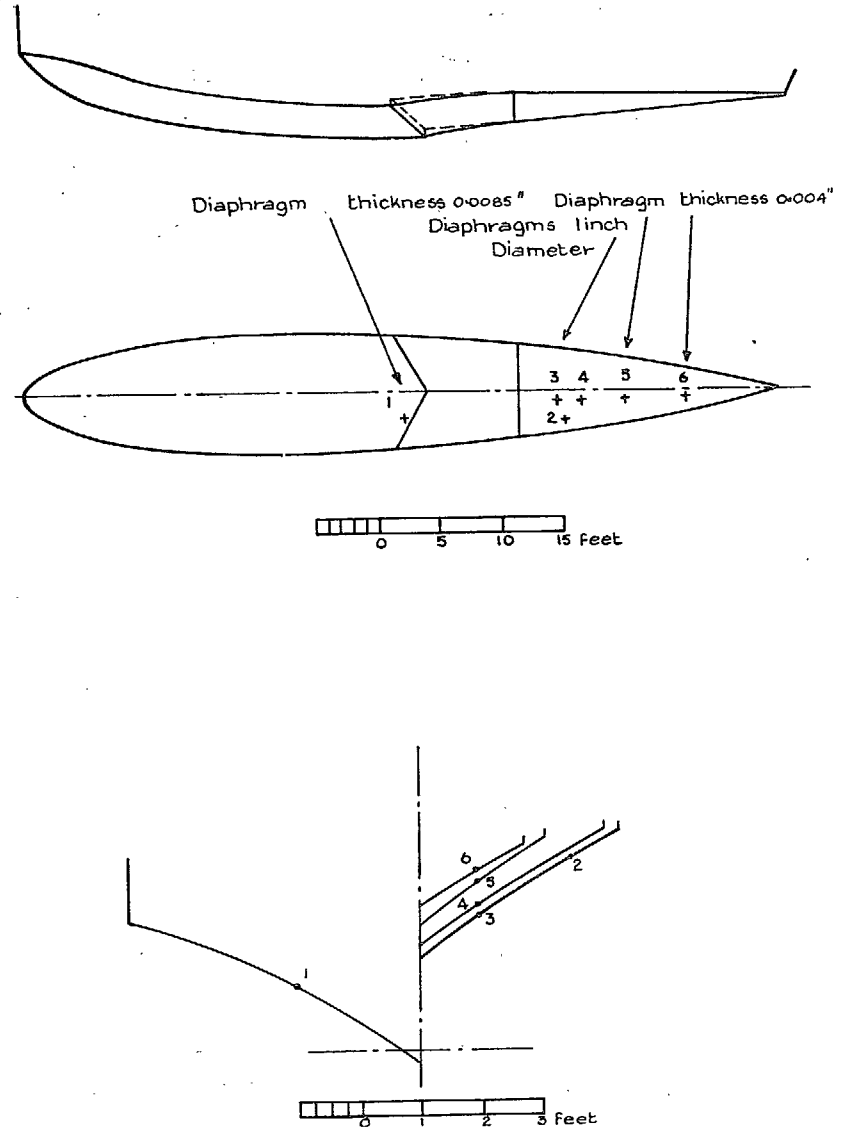
FIG. 7. Position of pressure diaphragms. Faired step 3.

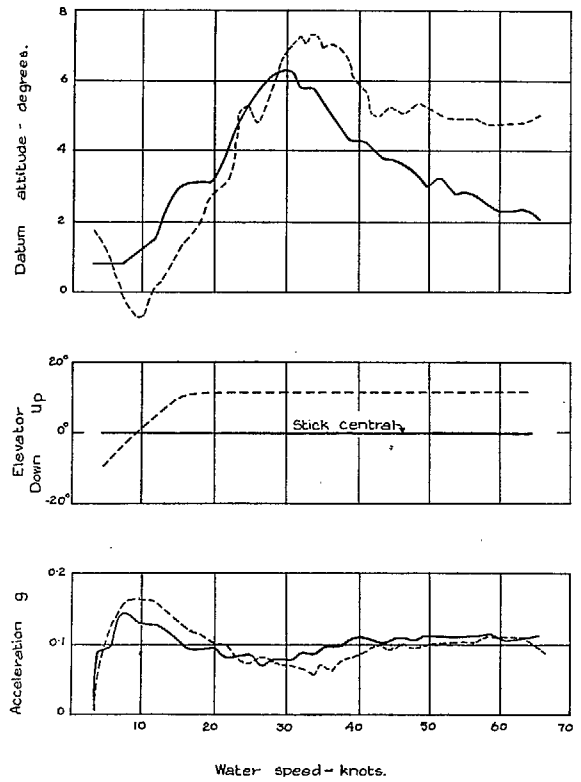
FIG. 8. Take-offs with faired step 1. 43,000 lb. 0 deg flap. Wind speed 5 knots.

3. *Results of Acceleration, Attitude and Stability Measurements.*—Results for fairing 1 are given in Figs. 8 to 11. These were all made at a weight of 43,000 lb. The take-offs were made with and without  $\frac{1}{3}$  flap and landings with zero flap. Steady runs were made, with zero flap and stick fully back, at water speeds ranging from 20 to 50 knots. The only porpoising obtained in these runs was of 2 deg amplitude and the normal smooth type and occurred at 52 knots.

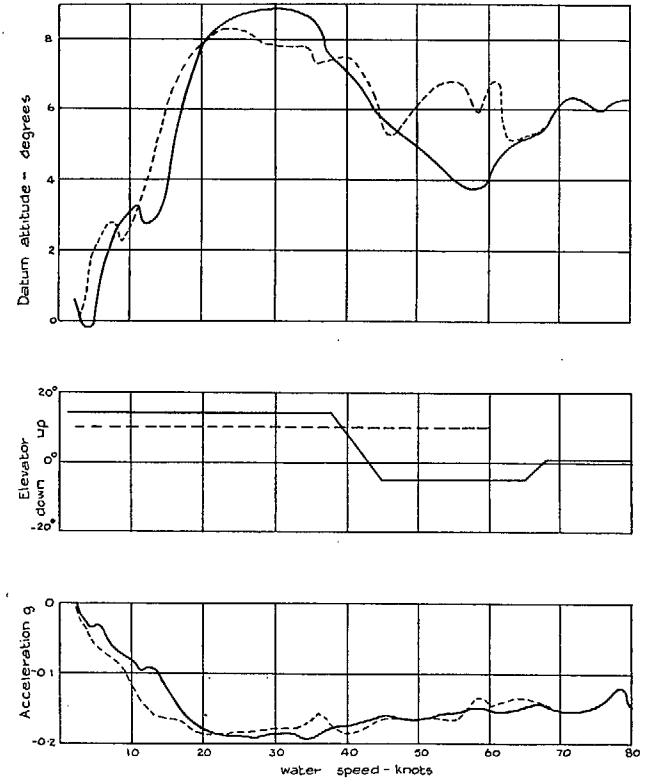
FIG. 10. Landings with faired step 1. 43,000 lb. 0 deg flap. Wind less than 5 knots.

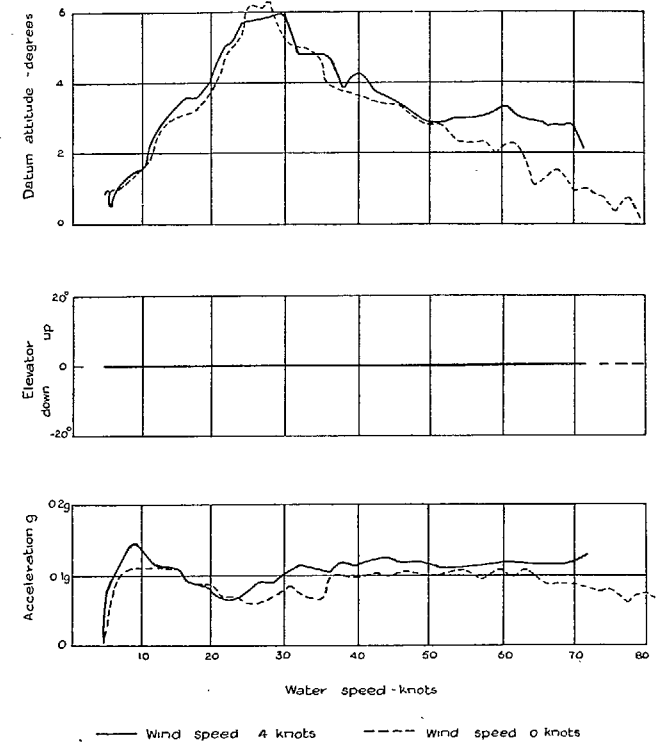
FIG. 12. Take-offs with faired step 2. 43,000 lb. 0 deg flap.

Results for fairing 2, of loop runs and take-offs at 43,000 lb, are given in Figs. 12 to 14, and of take-offs with  $\frac{1}{3}$  flap and landings with full flap at 50,000 lb in Figs. 15 and 16.

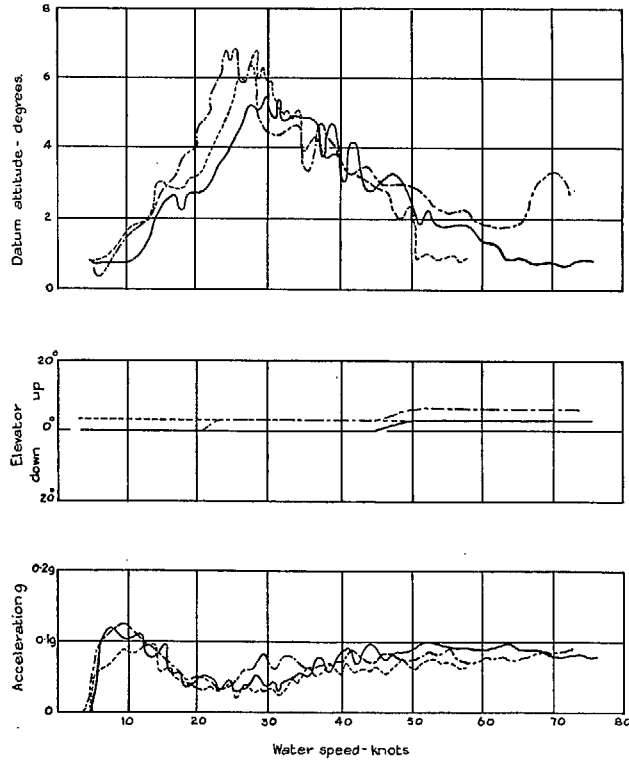
FIG. 15. Take-offs with faired step 2. 50,000 lb. 1/3rd flap. Wind speed 3 knots.

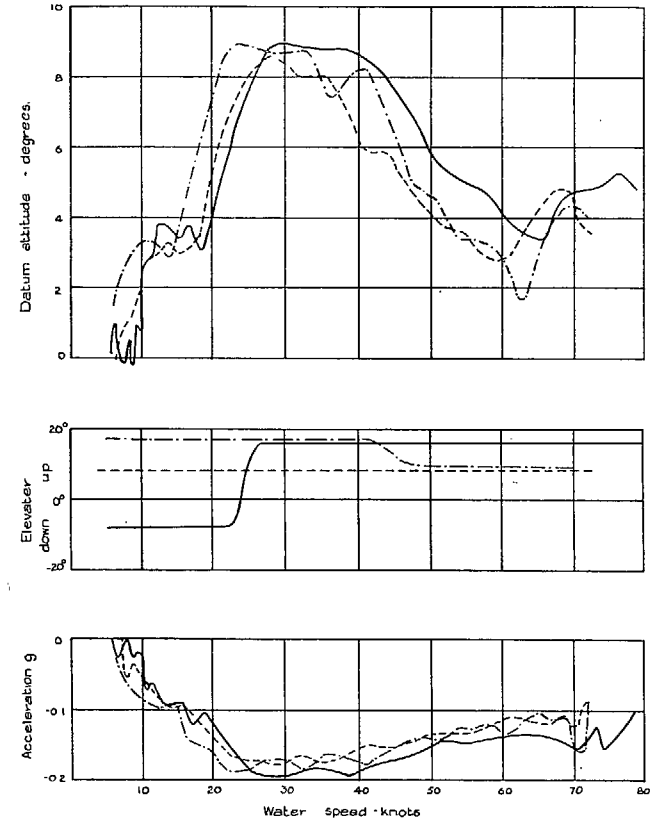
FIG. 16. Landings with faired step 2. 50,000 lb. Full flap. Wind speed 3 knots.

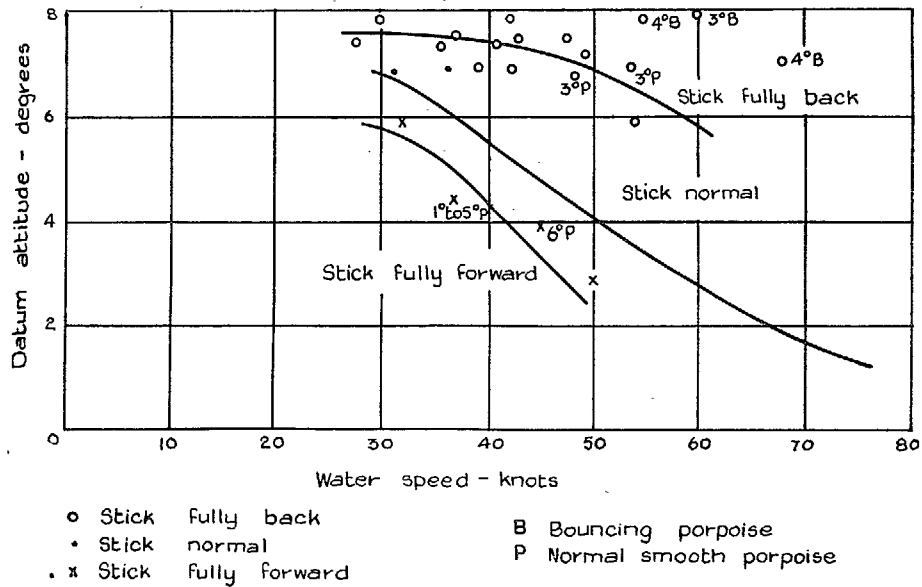
FIG. 17. Steady runs with faired step 2. 43,000 lb. 0 deg flap. Wind less than 4 knots. When porpoising occurred the amplitude reached is shown.

The mean steady-run attitude and porpoising points for fairing 2, over the full range of elevator angle and water speed, are given in Fig. 17.

Fairing 2, however, produced a bouncing porpoise at high attitudes and at high speeds during steady-speed taxiing runs, but as may be seen from Figs. 14 to 17, this instability was outside the attitude range of normal take-off and landing runs. This was confirmed by a large number of take-offs and landings made but not recorded.

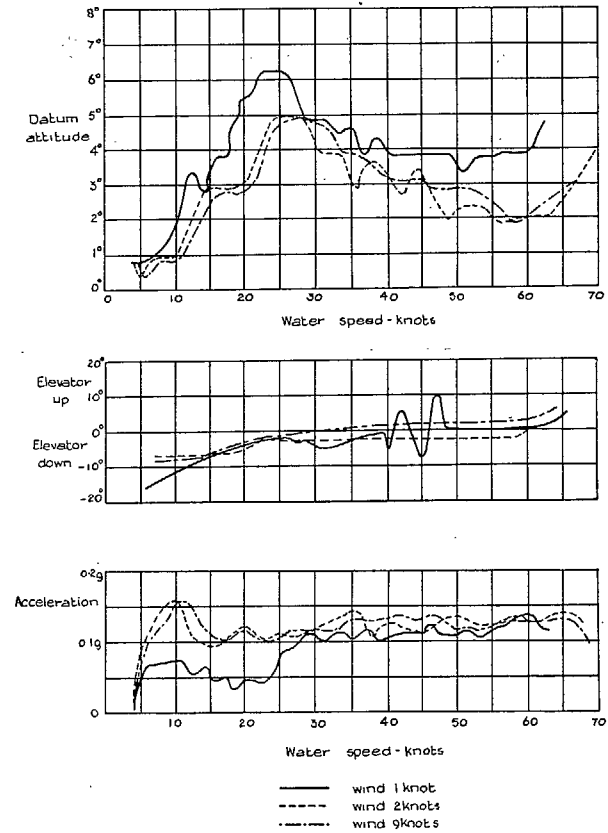
FIG. 18. Take-offs with faired step 3. 42,000 lb. 1/3rd flap.

Results for fairing 3 are given in Figs. 18 to 20 for take-offs and landings at weights of 38,000 to 43,000 lb. The take-offs were made with  $\frac{1}{3}$  flap and the landings with full flap. The steady-run results at 43,000 lb are shown in Fig. 21.

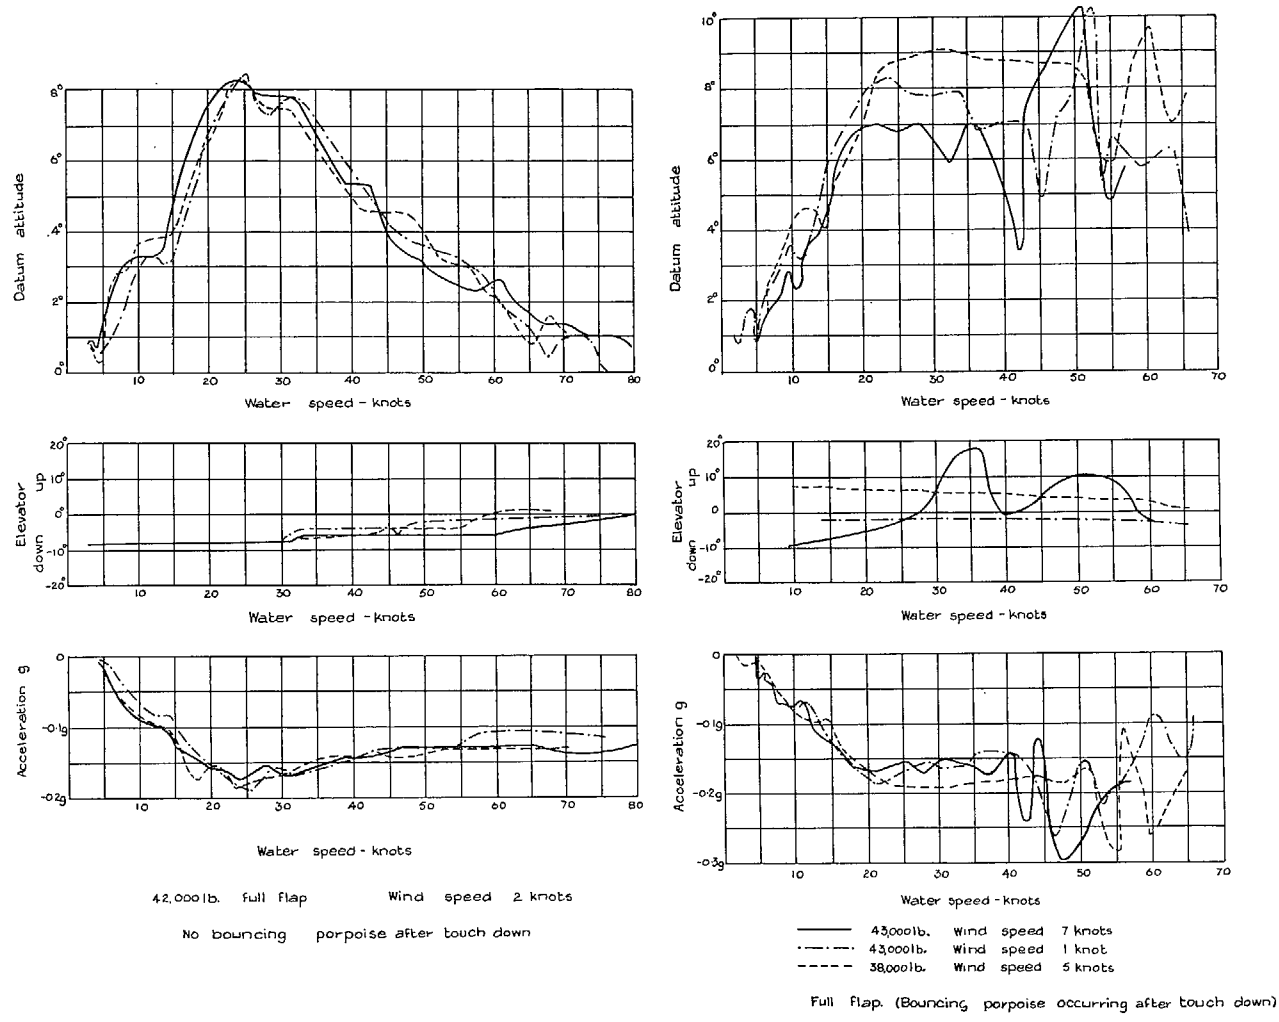
FIG. 19. Landings with faired step 3.

Typical landings are shown in two groups in Fig. 19. The first group gives landings at fine angles and the second at coarse angles. It will be seen that no porpoising occurs if the landings are made at a fine attitude. This is illustrated in Fig. 20 where attitudes at touch-down on all recorded landings have been plotted against true air speed. It will be seen that a bouncing type of porpoising occurs if the attitude at touch-down is greater than 3 deg, but that the run is steady if the attitude is less than 2 deg.

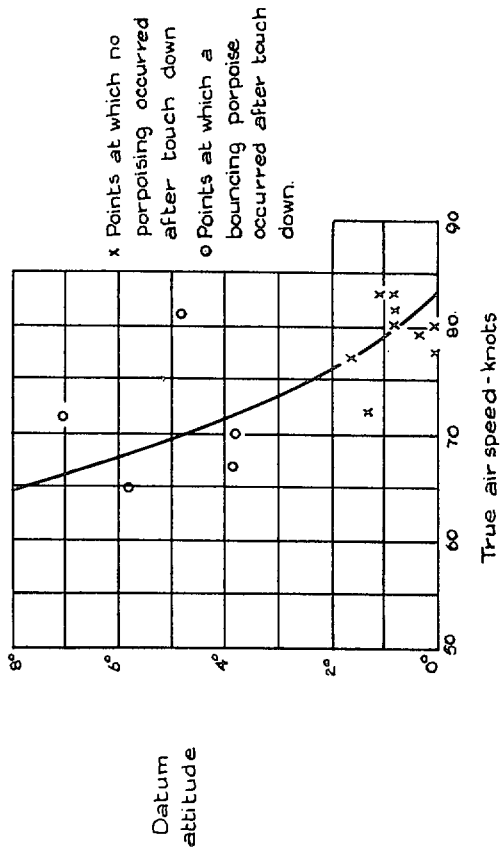
FIG. 20. Landing speed against attitude—landings with faired step 3. 38,000 to 43,000 lb. Full flap. Wind speed 1 to 7 knots.

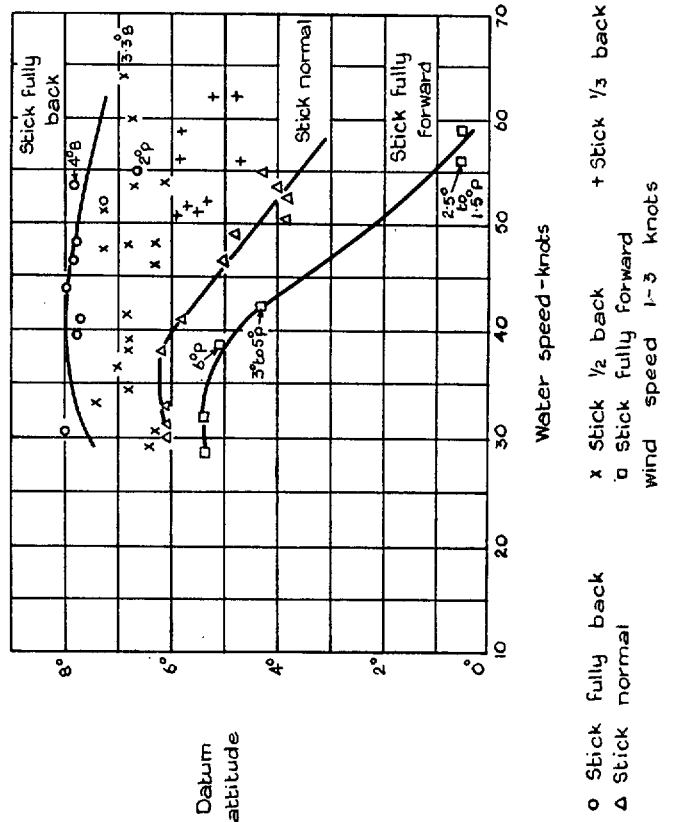
FIG. 21. Steady runs with faired step 3. 43,000 lb. 0 deg flap.

Fairing 3 also produced a bounce porpoise at high speeds and attitudes during steady-speed taxiing runs, but this also occurred in both take-off and landing runs. The steady-run results are little different from the 1 : 6 fairing results (Fig. 22), but did not cover the speed/attitude range at which take-off and landing bounce-porpoising was found.

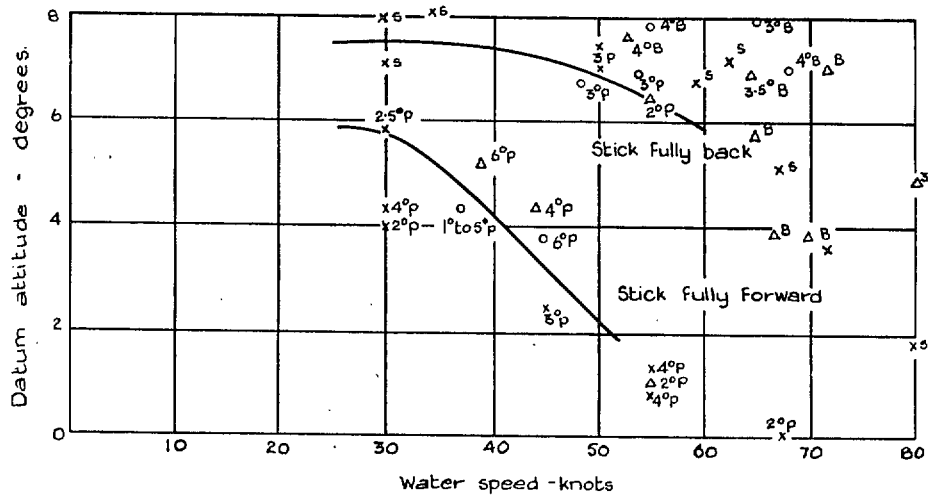
FIG. 22. Mean attitude curves with faired step 2. 43,000 lb. 0 deg flap. Porpoising points for no fairing and faired steps 2 and 3.

In Fig. 22, all the porpoising points measured in steady run and landing conditions, for no fairing and fairings 1, 2 and 3, are plotted around the mean-attitude curves found for fairing 2.

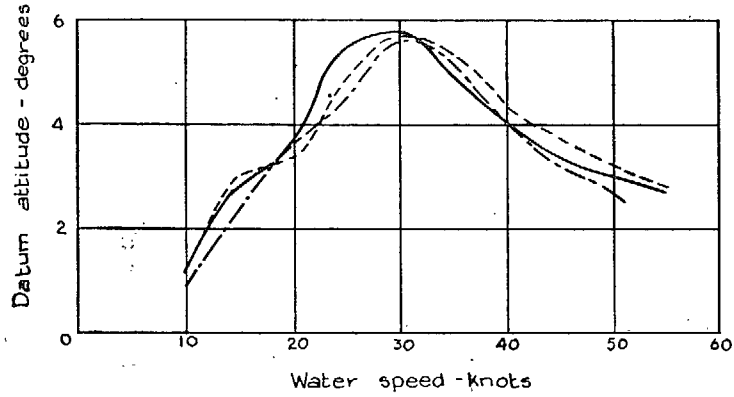
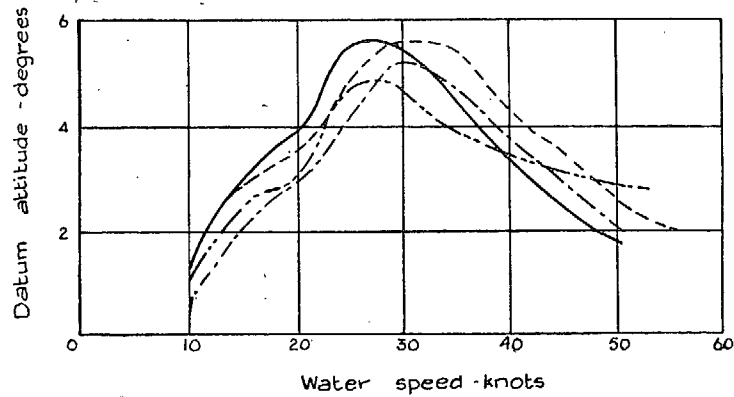
Mean take-off attitude with flaps 0° and elevator neutral  
 - - - - K 4774 faired step 1 wind 5 knots  
 ——— K 4774 faired step 2 wind 0-4 knots  
 - · - · L 2158 no fairing wind 9 knots

Mean take-off attitude with 1/3 flaps and elevator neutral  
 - - - - K 4774 faired step 1 wind speed 5 knots  
 ——— K 4774 faired step 2 wind speed 0-5 knots  
 - · - · K 4774 faired step 3 wind speed 1-9 knots  
 - · - · L 2158 no fairing wind speed 3 knots

FIG. 23. Take-off attitude comparisons with no fairing and fairings 1, 2 and 3 at 43,000 lb.

3.1. *Effect of Fairing on Attitude.*—Mean curves of attitude against water speed and zero elevator angle during take-off with no flap, and with  $\frac{1}{3}$  flap for no fairing and fairings 1, 2 and 3, are shown in Fig. 23.

The effect of the fairings on the attitude is negligible, the differences being within the experimental error. Fairings 2 and 3 appear to reduce the hump speed by 3 to 5 knots.

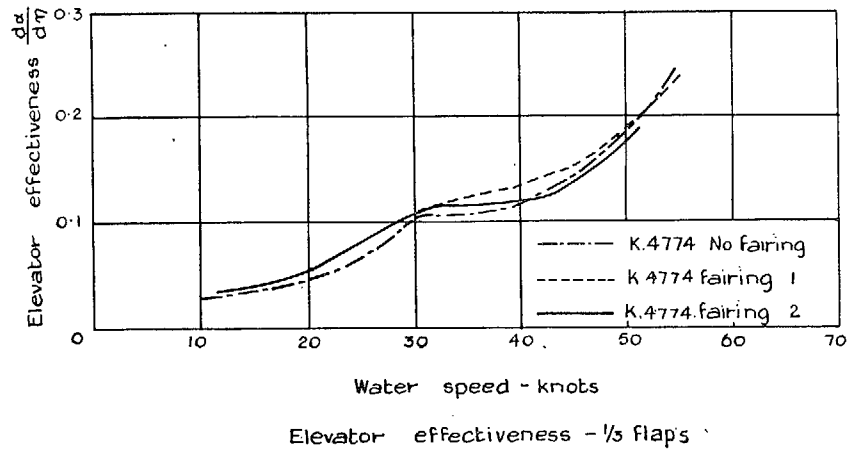
Elevator effectiveness - Zero Flaps

Elevator effectiveness - 1/3 flaps

FIG. 24. Comparison of elevator effectiveness in take-off with no fairing and fairings 1 and 2 at 43,000 lb.

3.2. *Effect of Fairing on Hull Pitching Moments.*—Elevator effectiveness curves for take-off are given in Fig. 24. These are identical, within experimental error, for no fairing and fairings 1 and 2.

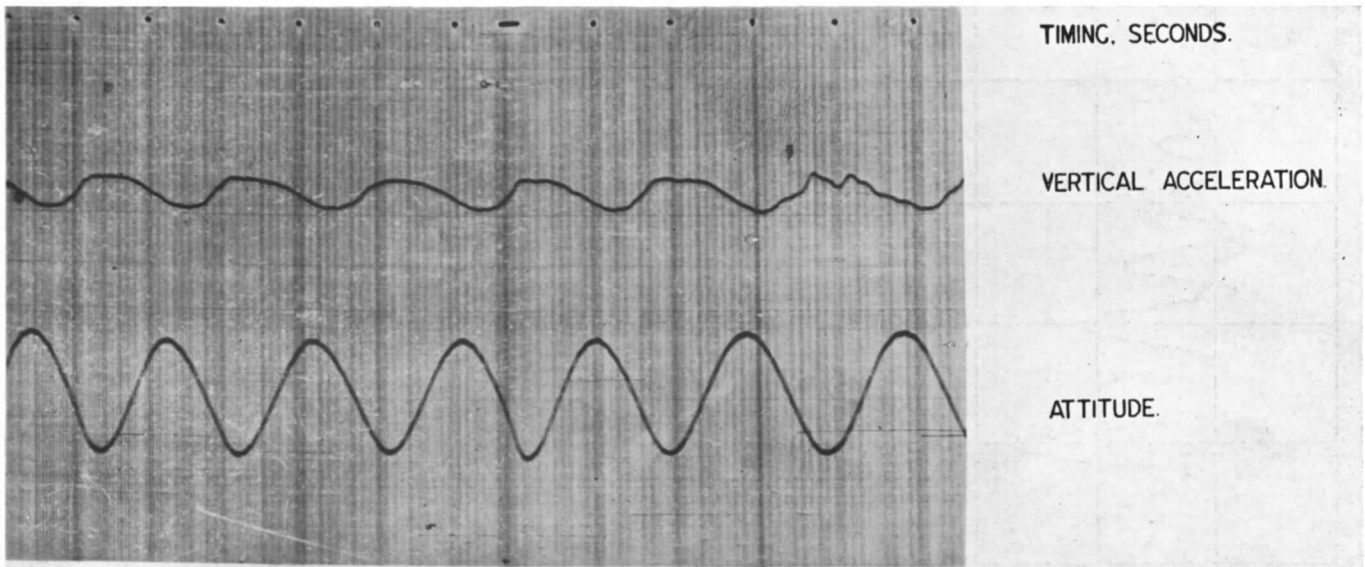
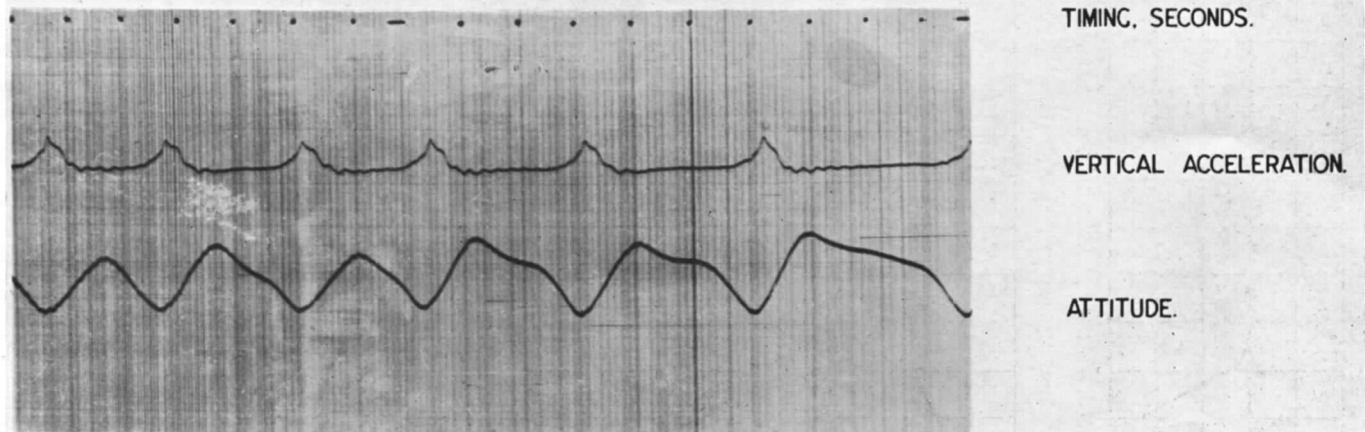
NORMAL PORPOISING WITH STICK FULLY FORWARD  
FOR ANALYSIS SEE FIG. 27

BOUNCING PORPOISING WITH STICK FULLY BACK  
FOR ANALYSIS SEE FIG 27

FIG. 26. Enlargements of gyro accelerometer records in porpoising runs with faired step 2. 43,000 lb. 0 deg flap.

Attitude and acceleration records taken from the gyro accelerometer are shown in Fig. 26 to give a comparison of an ordinary forebody porpoising run at low attitude and a bouncing porpoising run at high attitude. In Fig. 27, attitude and vertical acceleration, velocity and displacement curves are given for a complete forebody (ordinary) porpoise and an afterbody (bouncing) porpoise. Photographs of a bouncing porpoise taken from a cine-film are shown in Fig. 34. The bounce porpoise is similar for fairings 2 and 3.

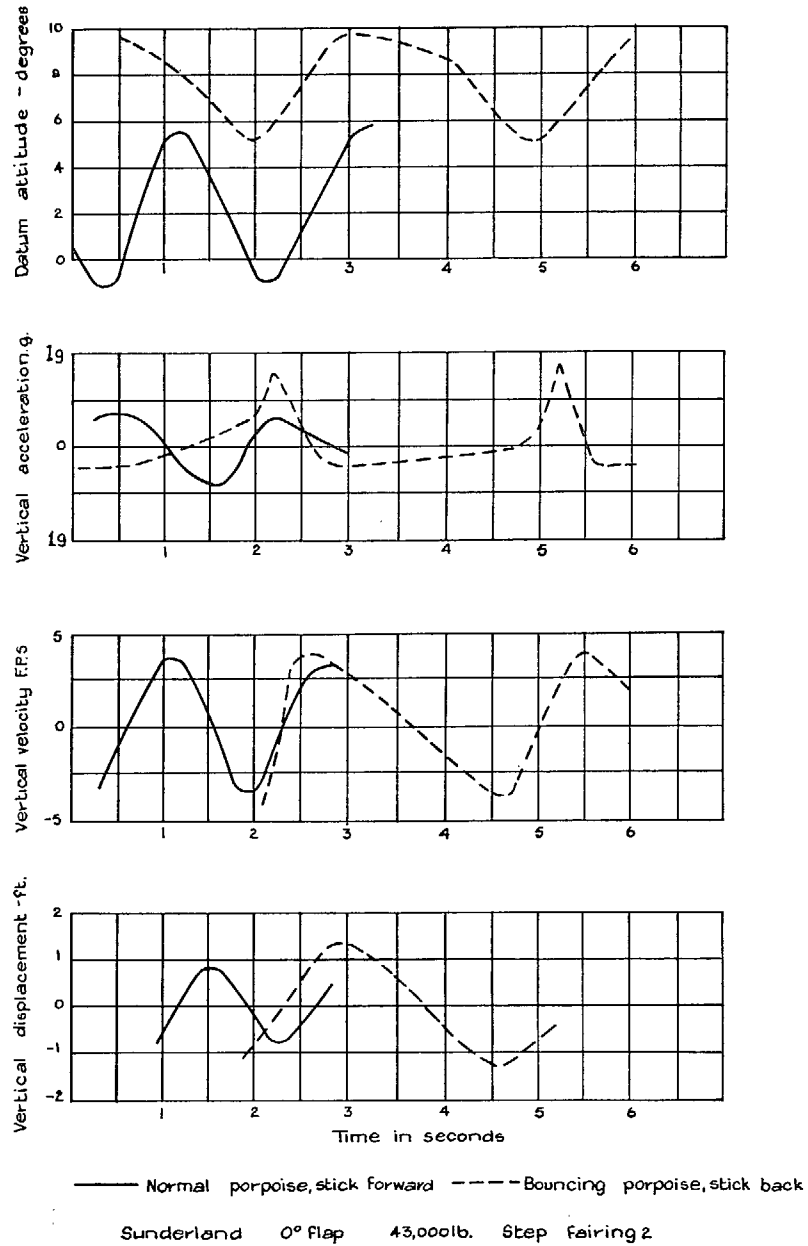
FIG. 27. Analysis of normal porpoising, stick forward, and bouncing porpoising, stick back.

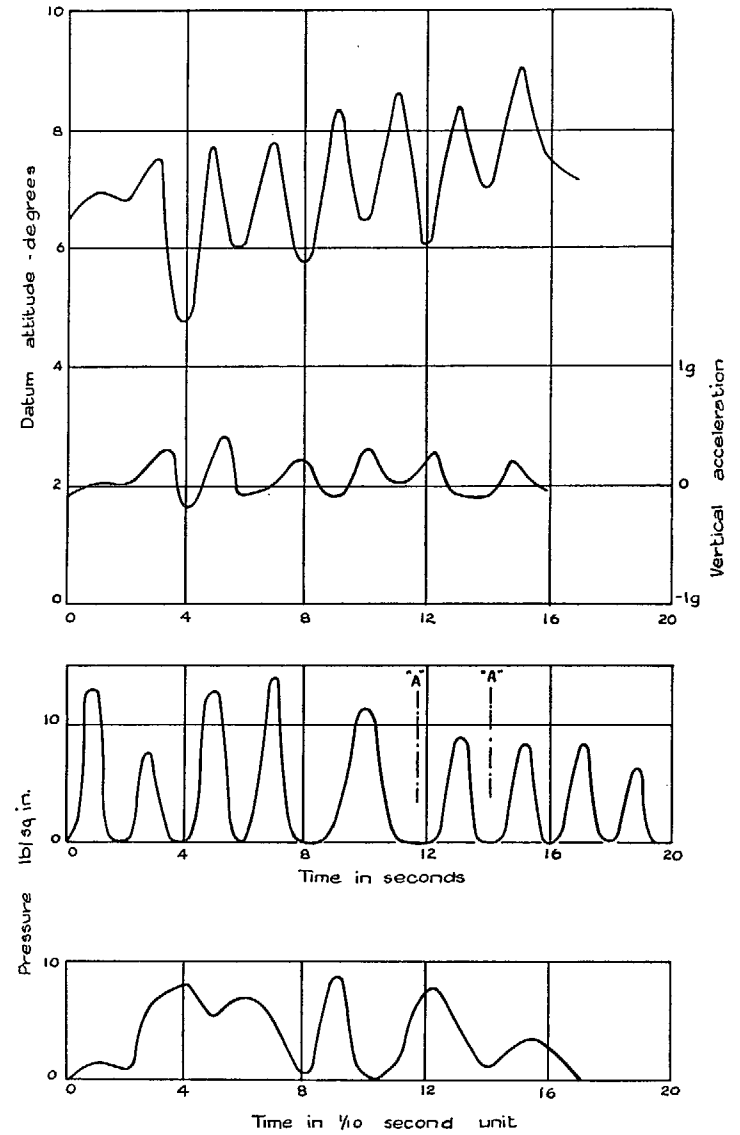
Detail of typical peak pressure shown above A-A

Sunderland No fairing 0° Flaps 43,000lb

FIG. 28. Pressures on forebody at station 4 in normal porpoising run at 50 knots water speed. Stick fully back.

The pressure records observed forward of the step during porpoising were of a complex oscillatory character and in some cases consisted of intermittent peak ranges. A typical mean-pressure curve and a typical detailed range are shown in Fig. 28, drawn on a time basis. The highest pressures were found in the vicinity of the step, in stick-back runs, when only a small area of the hull was immersed. In low-attitude runs, pressures are smaller but were spread over a larger area. During porpoising, the flow surges backward and forward as the attitude increases and decreases. Fig. 28 illustrates this at Position 4, which is nearly on the step. Atmospheric pressure was recorded on all diaphragms stationed behind the step, and at Station 10 which was a pitot instrument. These results indicate that in this smooth type of porpoising, with the stick fully forward, the afterbody is clear of the water and, with the stick fully back, clear as far back as Station 10.

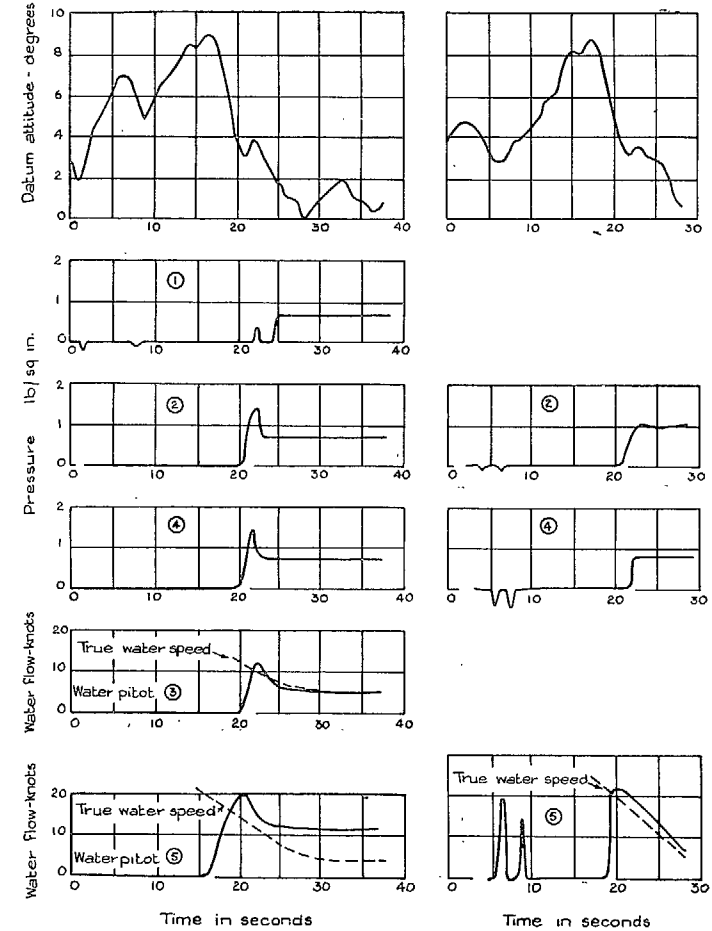
Sunderland L-2158 No fairing 43,000 lb  
 Landing full Flap Wind 3 knots

Sunderland K-4774 (fairing 2) 50,000 lb  
 Landing full Flap Wind 3 knots

FIG. 30. Static and pitot records behind the step during landings with and without step fairing.

4.2.2. *Results of take-off and landing measurements.*—Flow conditions in take-offs and landings made over the normal range of elevator angles showed no change from the results obtained with no step fairing. A take-off with stick back and a landing with stick back after touchdown are shown respectively in Figs. 29 and 30, together with results for no fairing. It appears that the presence of the fairing does not affect planing at normal attitudes in take-offs and landings.

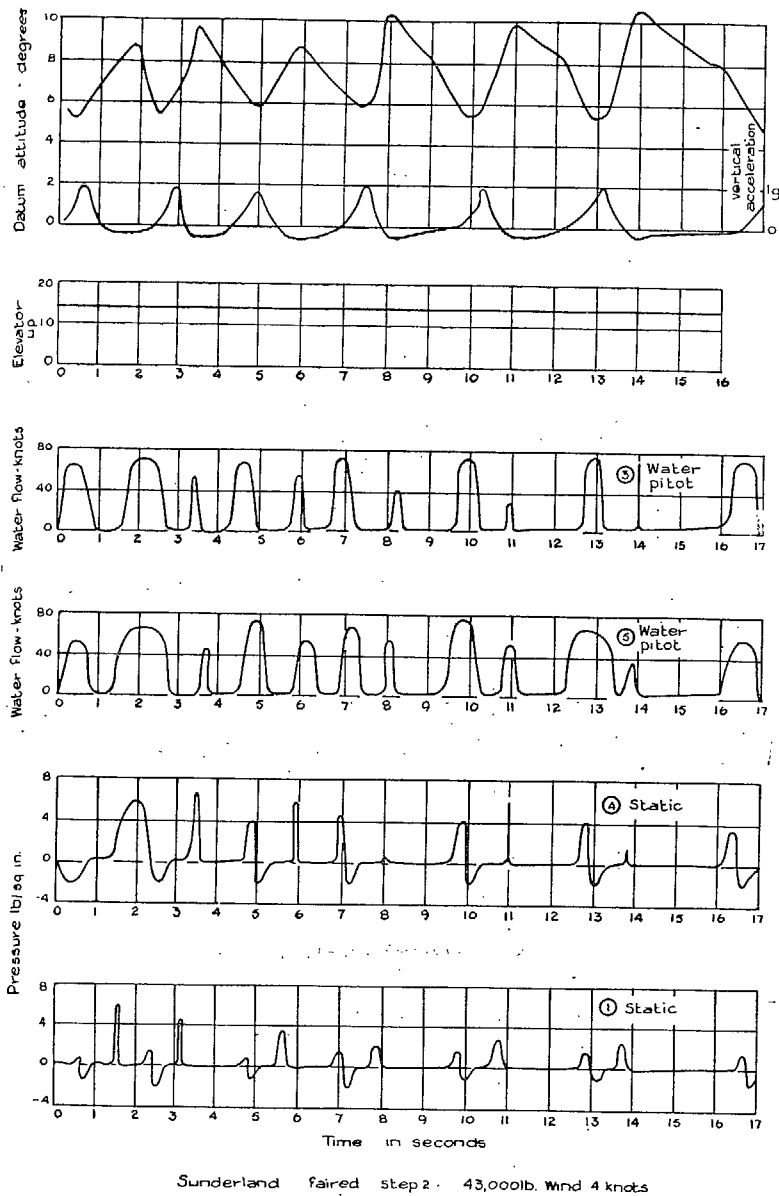
FIG. 31. Bouncing porpoise run. 0 deg flap. Water speed 55 knots. Stick back. Attitude and vertical acceleration curves with static and pitot records on afterbody.

The attitude, vertical acceleration and pressures for one of these runs are shown in Fig. 31. The analysis for one typical bounce is shown in Fig. 32. The pitot pressures have been converted into approximate speeds of water flow. The motion during a typical bouncing porpoise is shown by stills taken from a cine-film record in Fig. 34. It may be seen that at the static stations, pressures are built up as the flying boat reaches its minimum attitude on the water (A), and are immediately followed by suction as the attitude begins to increase. The water pitot records show that the pressure increases as the water flow attaches itself to the afterbody, and the suction occurs as the flow detaches itself.

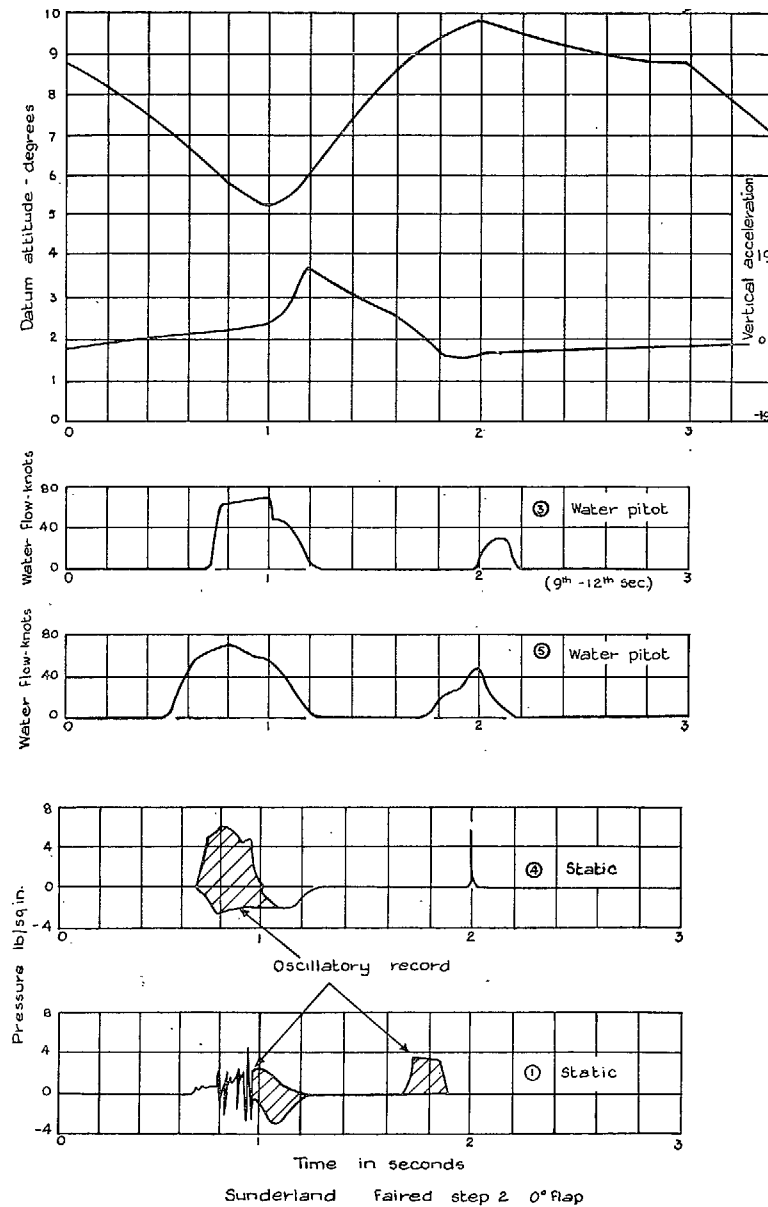
FIG. 32. Water flow over afterbody during bouncing porpoise from 9th to 12th sec period of Fig. 31.

These suction appear to aggravate the increase in attitude which is taking place and ultimately the flying boat lifts clear of the water (B and C).

Pressures occur at all stations as the maximum attitude is reached, which is just before the flying boat becomes airborne. The flying boat is in the airborne state for a comparatively short time ( $\frac{1}{2}$  to 1 sec) (D). It then touches the water again (E), the attitude decreases to a minimum (G) and the whole process is repeated. The period for a complete porpoise of this type varies between 2 and 3 sec.

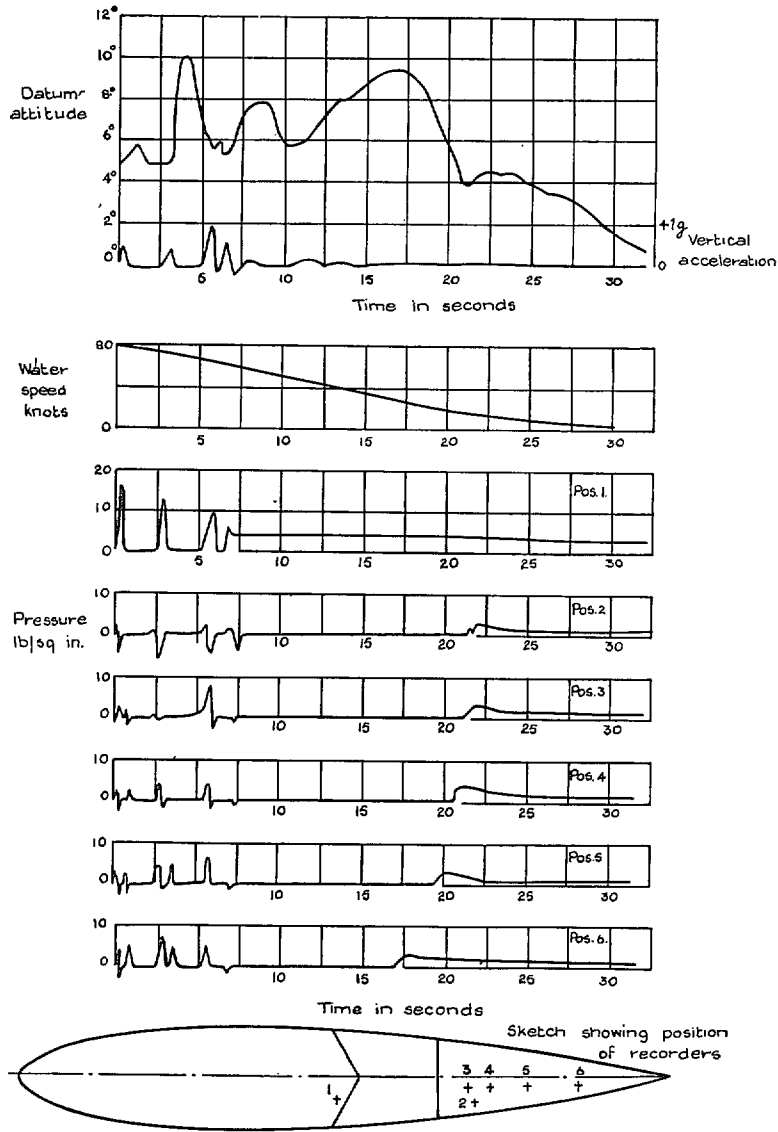
FIG. 33. Pressure records during a landing on which a bouncing porpoise occurred. Faired step 3. 43,000 lb. Full flap. Wind speed 1 knot.

When a bouncing porpoise occurred in landing, pressures and suction were recorded on the afterbody stations. Fluctuating positive pressures were recorded on the forebody station. Fig. 33 shows an analysis of one of these landings. The pressure and suction records behind the step, shown here, are very similar to those found during a bouncing porpoise in a steady-speed run at high attitude both with the 1 : 9 and 1 : 6 fairings.
