AERONAUTICAL RESEARCH COUNCIL

Civil Aircraft Airworthiness  
Data Recording Programme.  
Special Events Related  
to Airspeed Control Practices  
(February 1963 to February 1966)

*CAADRP Special Events Working Party*

June 1969

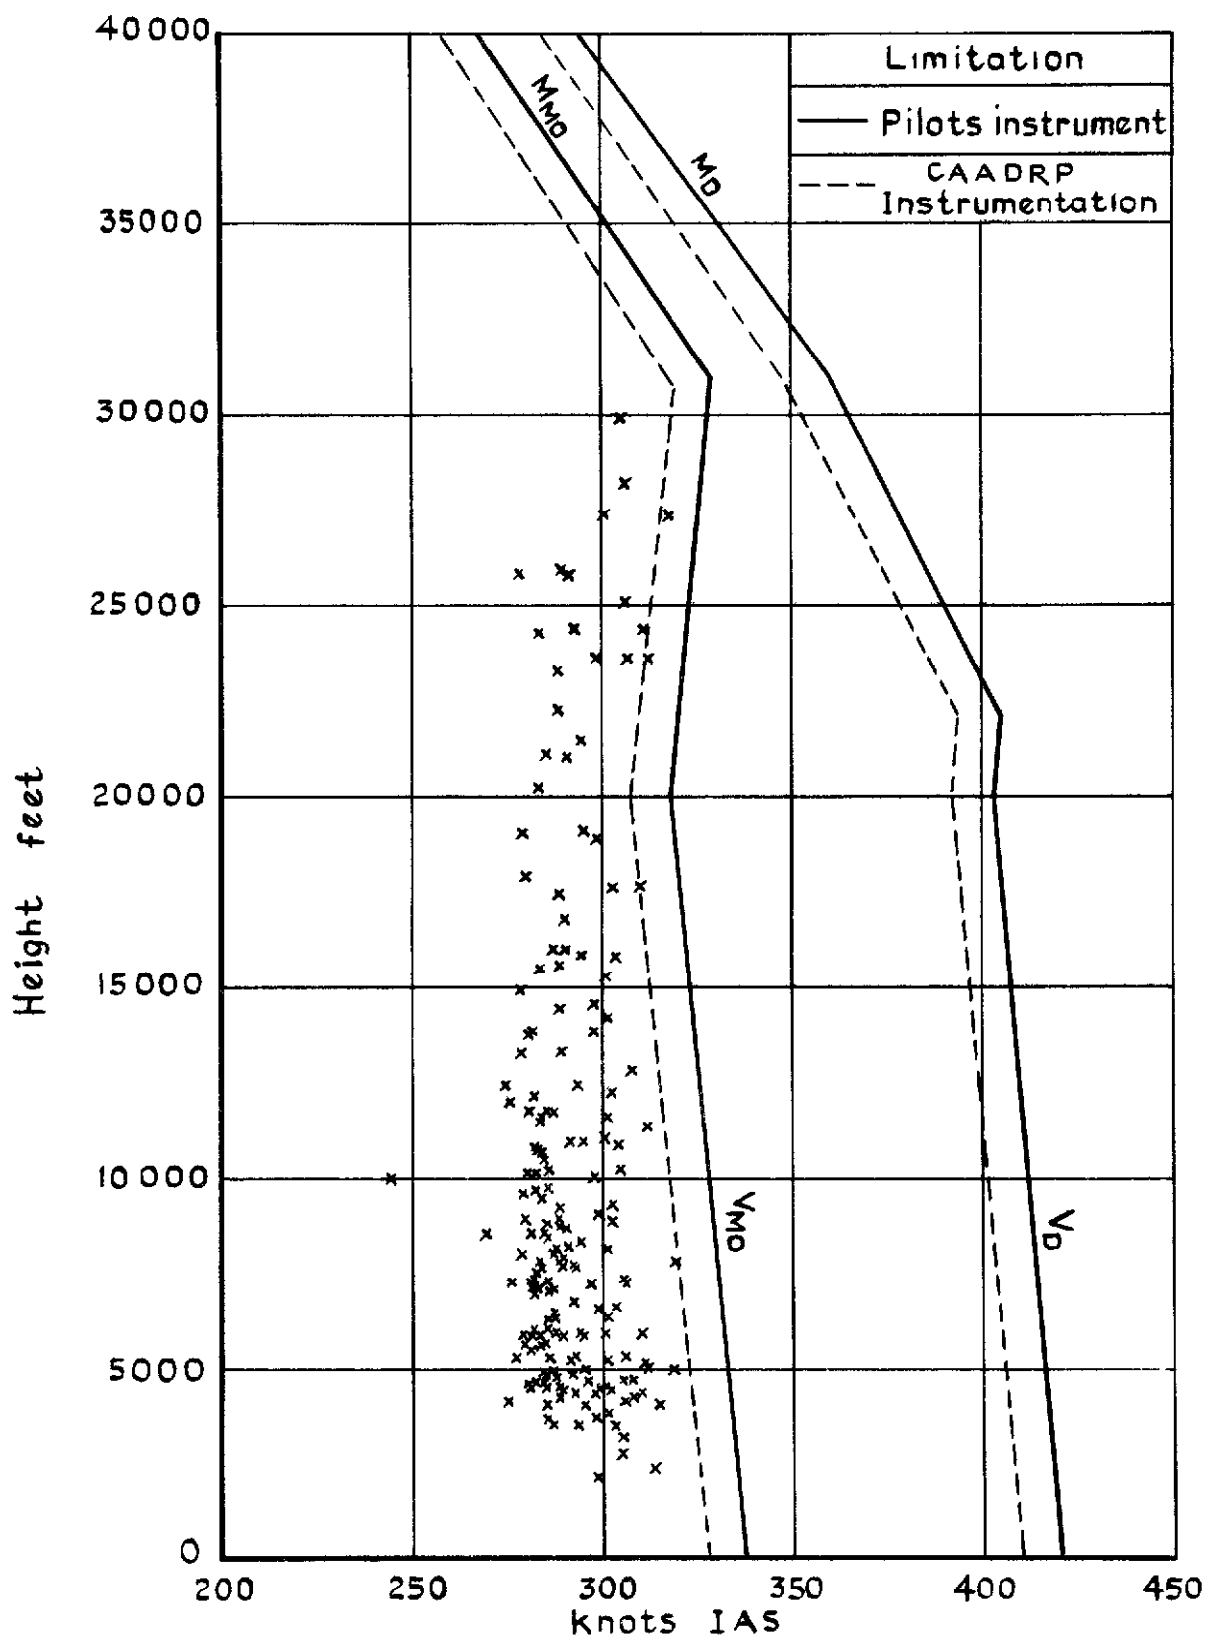
Fig.16. Event in Flight 15902

Fig.16 illustrates the use of a high airspeed in descent down to 3000 feet altitude, followed by a moderate pull-up manoeuvre to effect the reduction of airspeed necessary before flap operation.

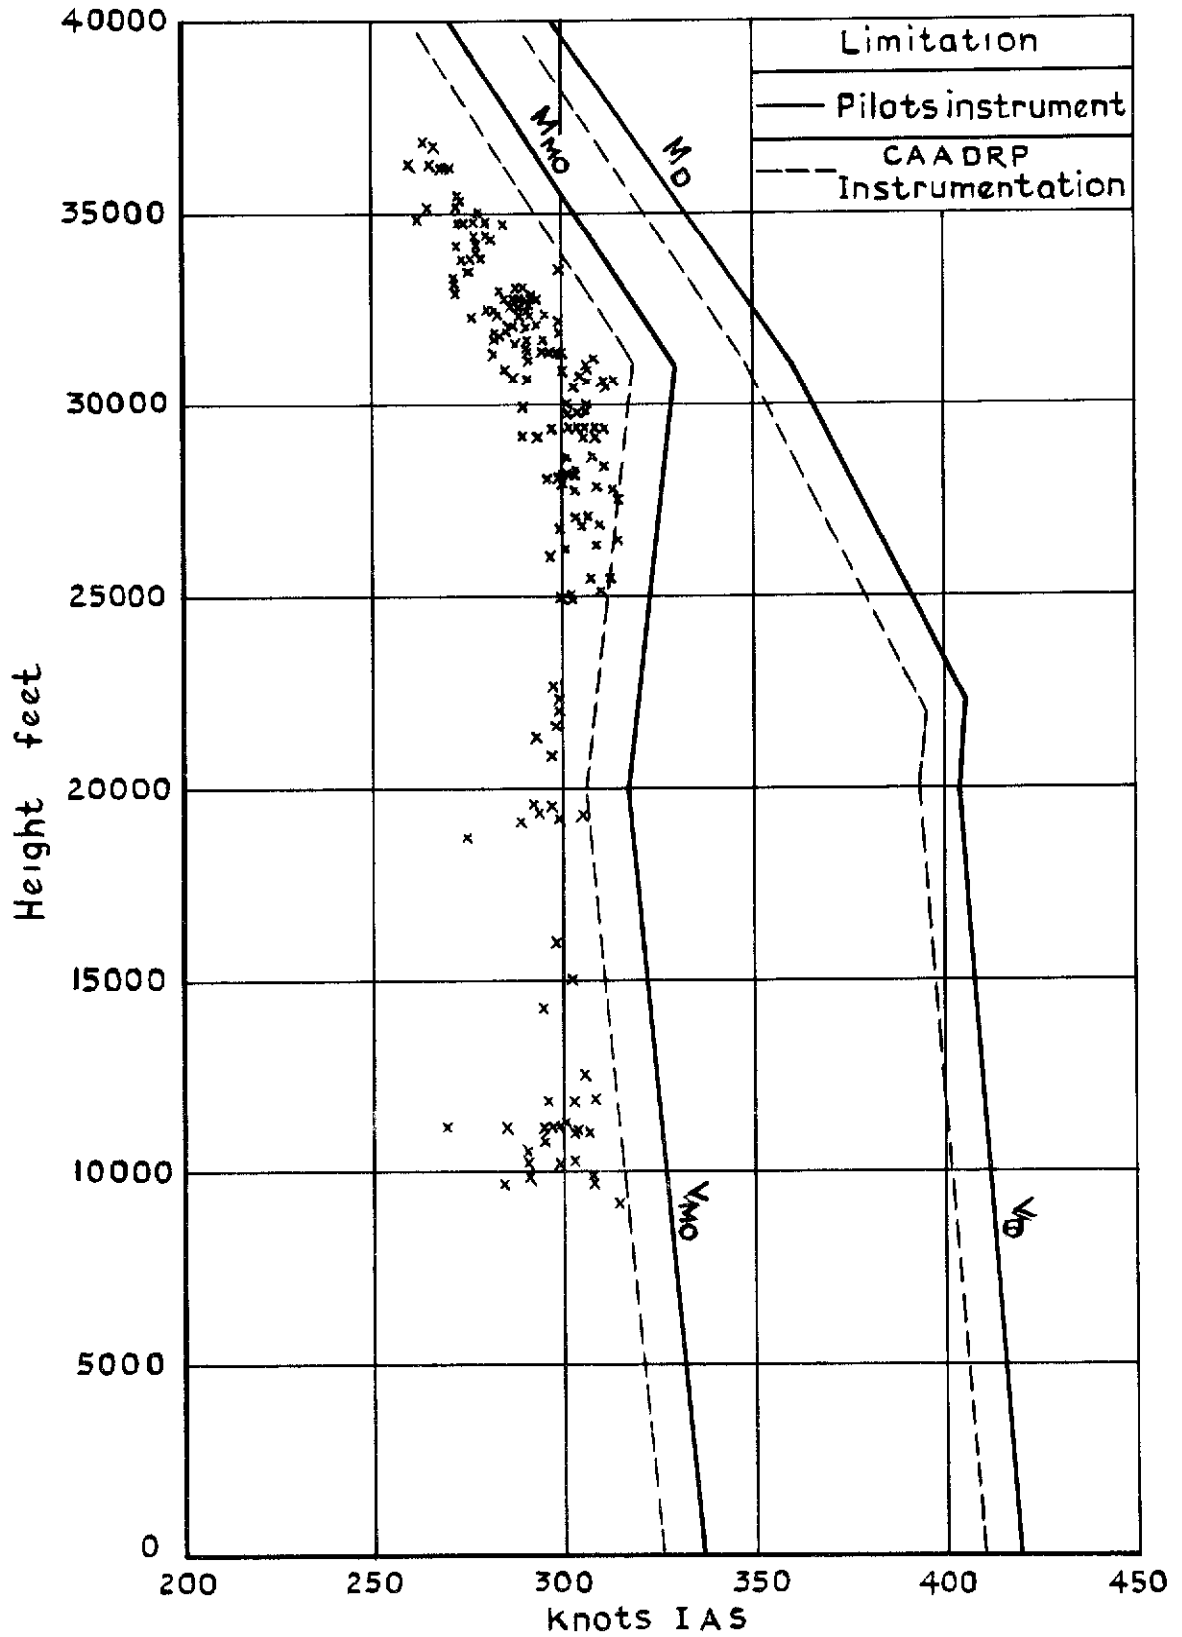
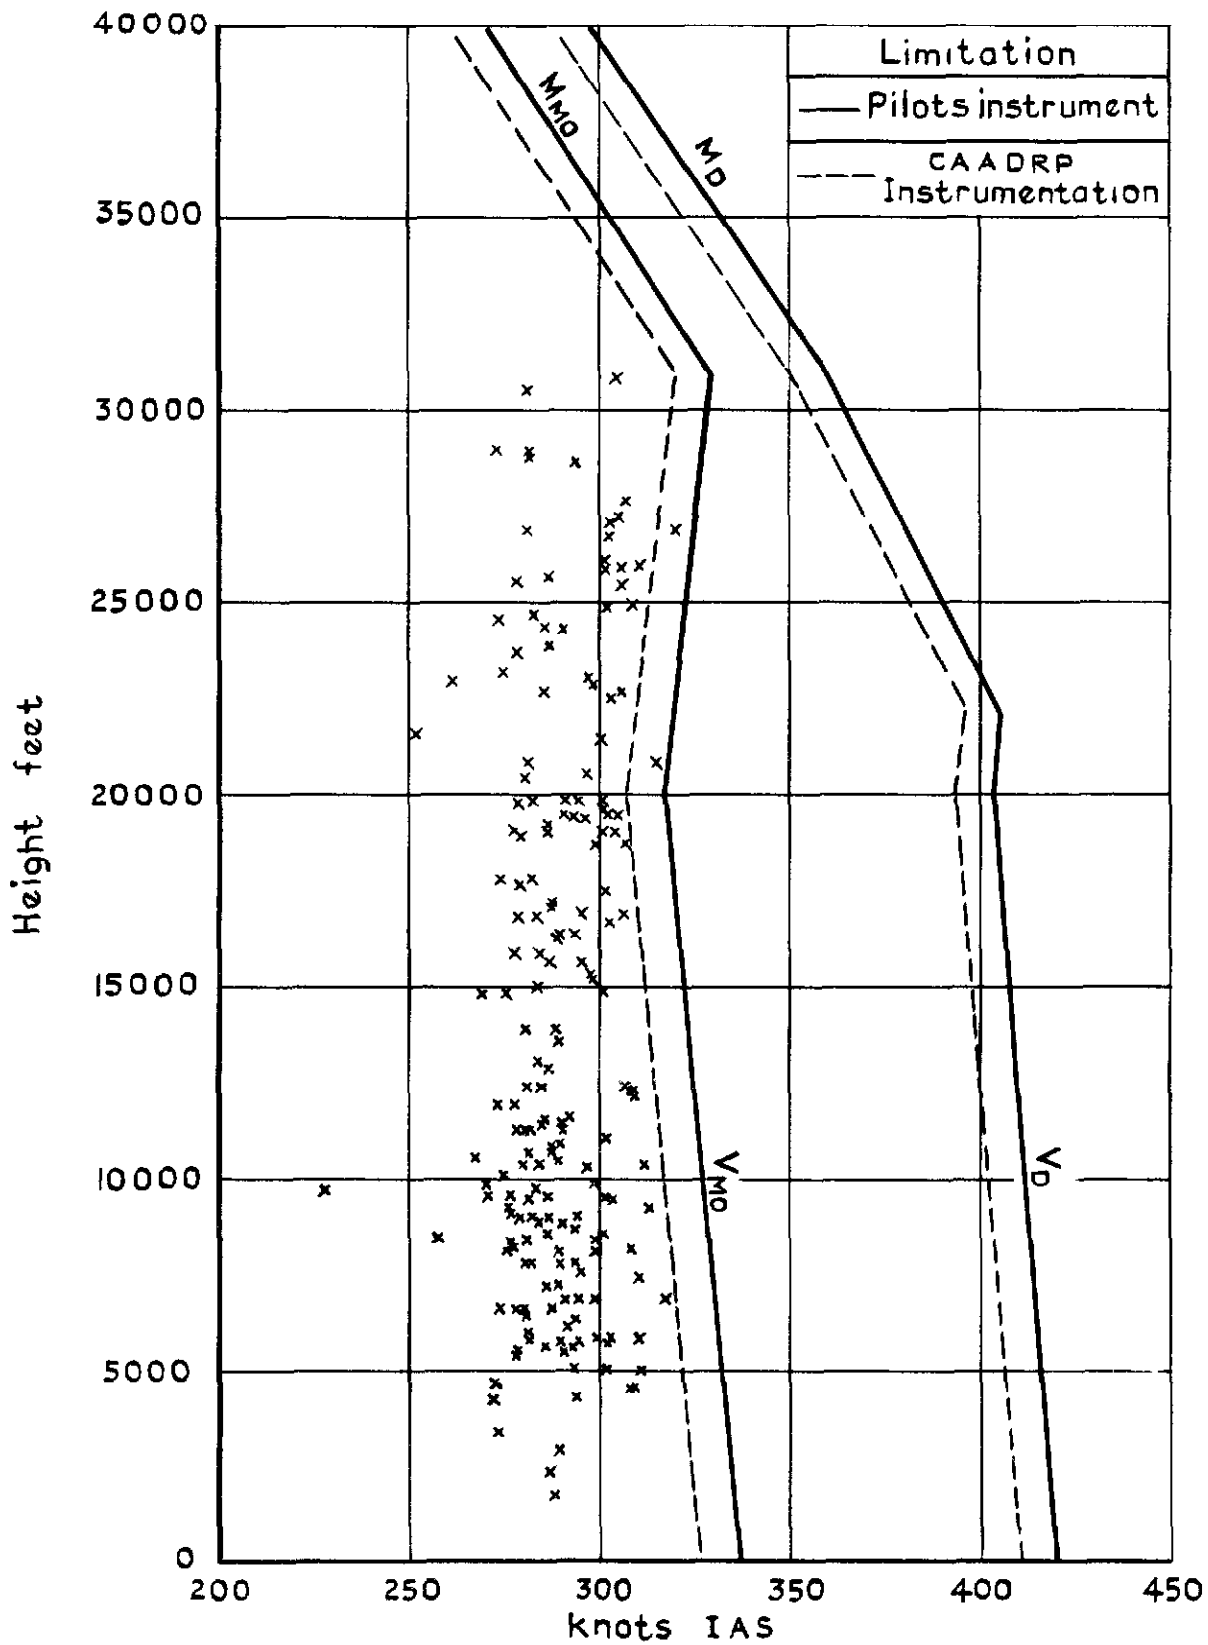
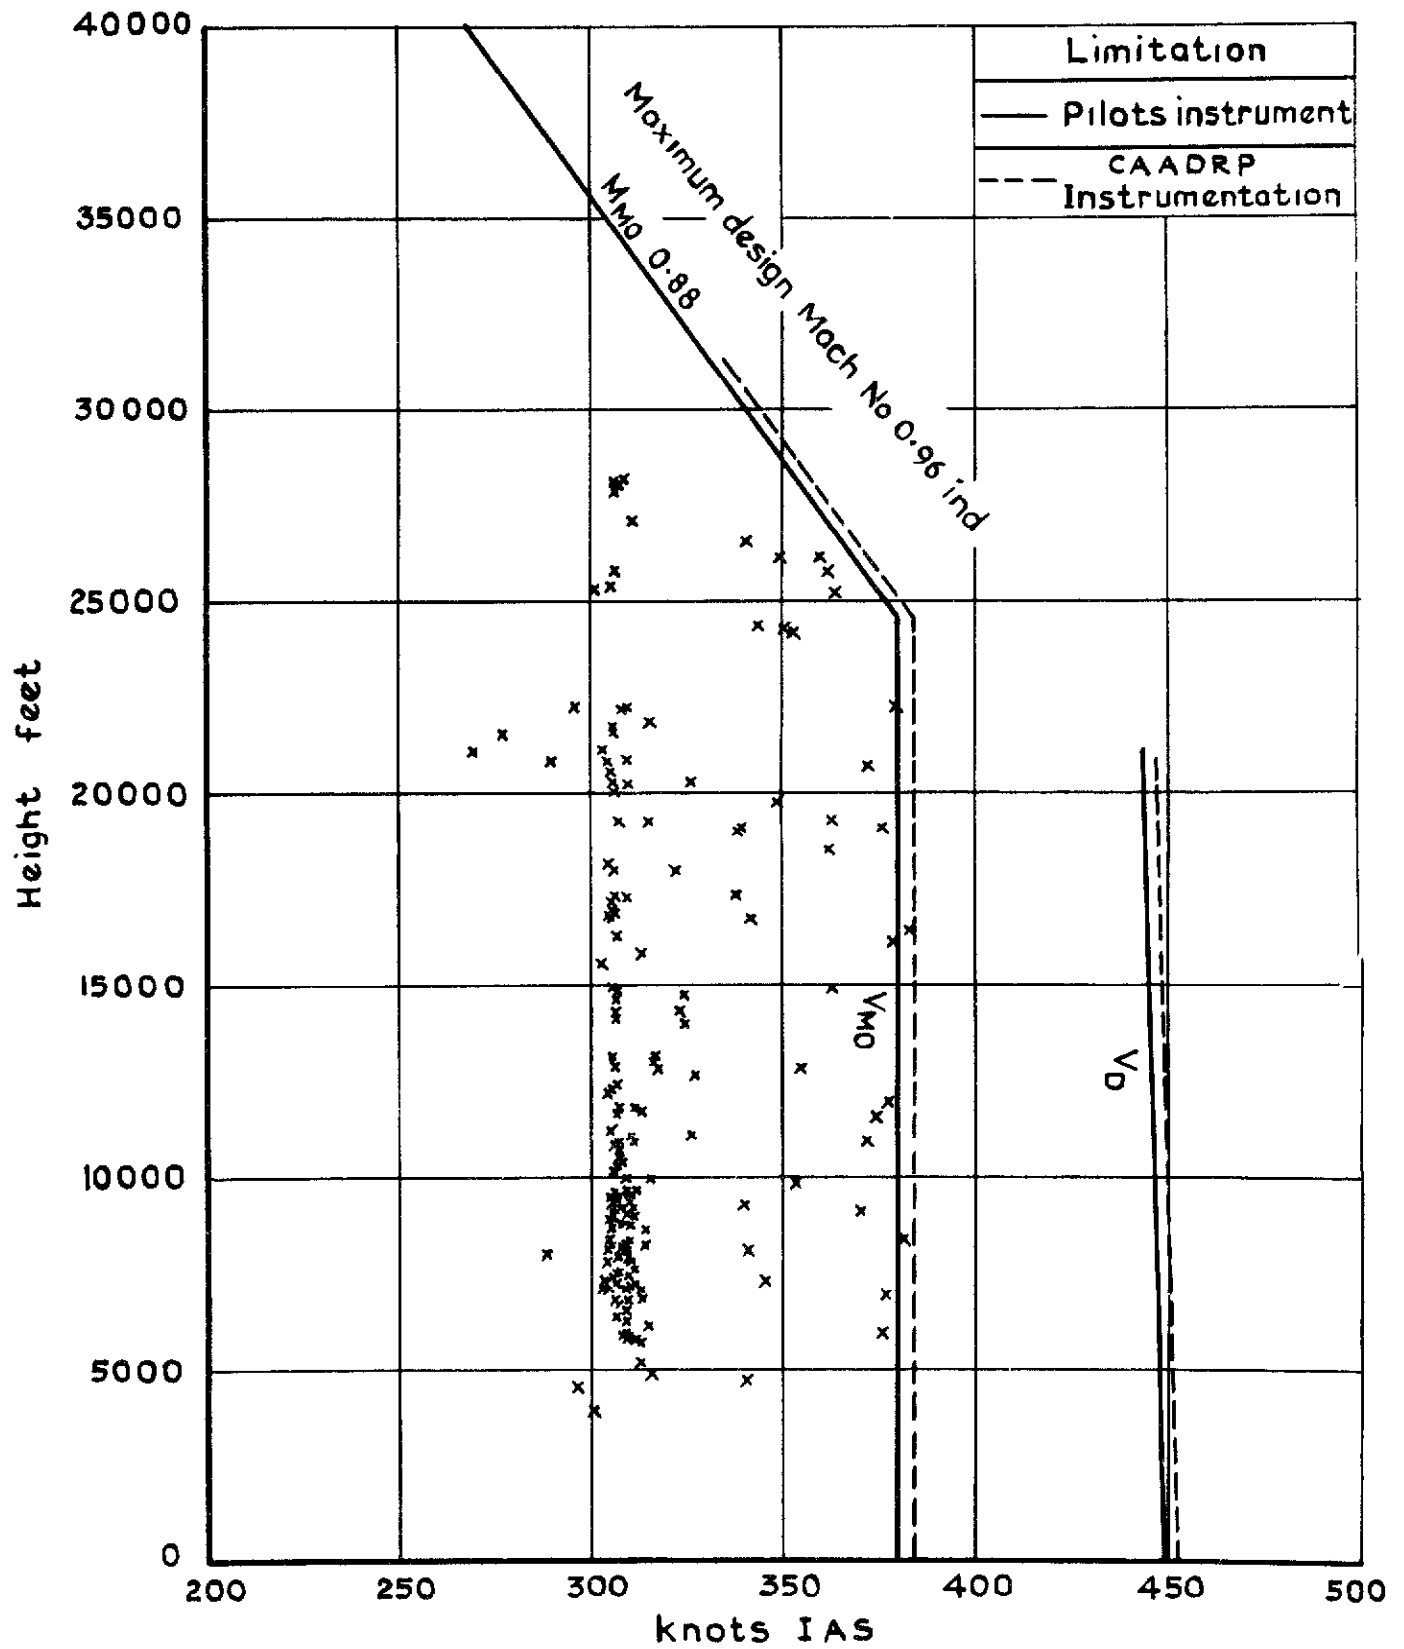
It should be noted that the pitot-static system used for the recorder on types A and B is not identical with that used for the pilot's instruments. However, in these flight conditions, the indicated speed difference is not excessive. The CAADRP installation indicates about 10 knots less on Type A and 3 to 5 knots more on Type B than the pilot's instrument. These differences are taken from flight observations on the flight deck; allowance has been made for them in Figs.17 to 22 and is indicated by the dotted line.

The usual operating speed was well within the maximum operating boundary and hence the number of occasions when the boundary was reached or passed was very small, even after allowing for the difference between pilot's instrument and CAADRP airspeed information. (Figs.17, 18, 19).

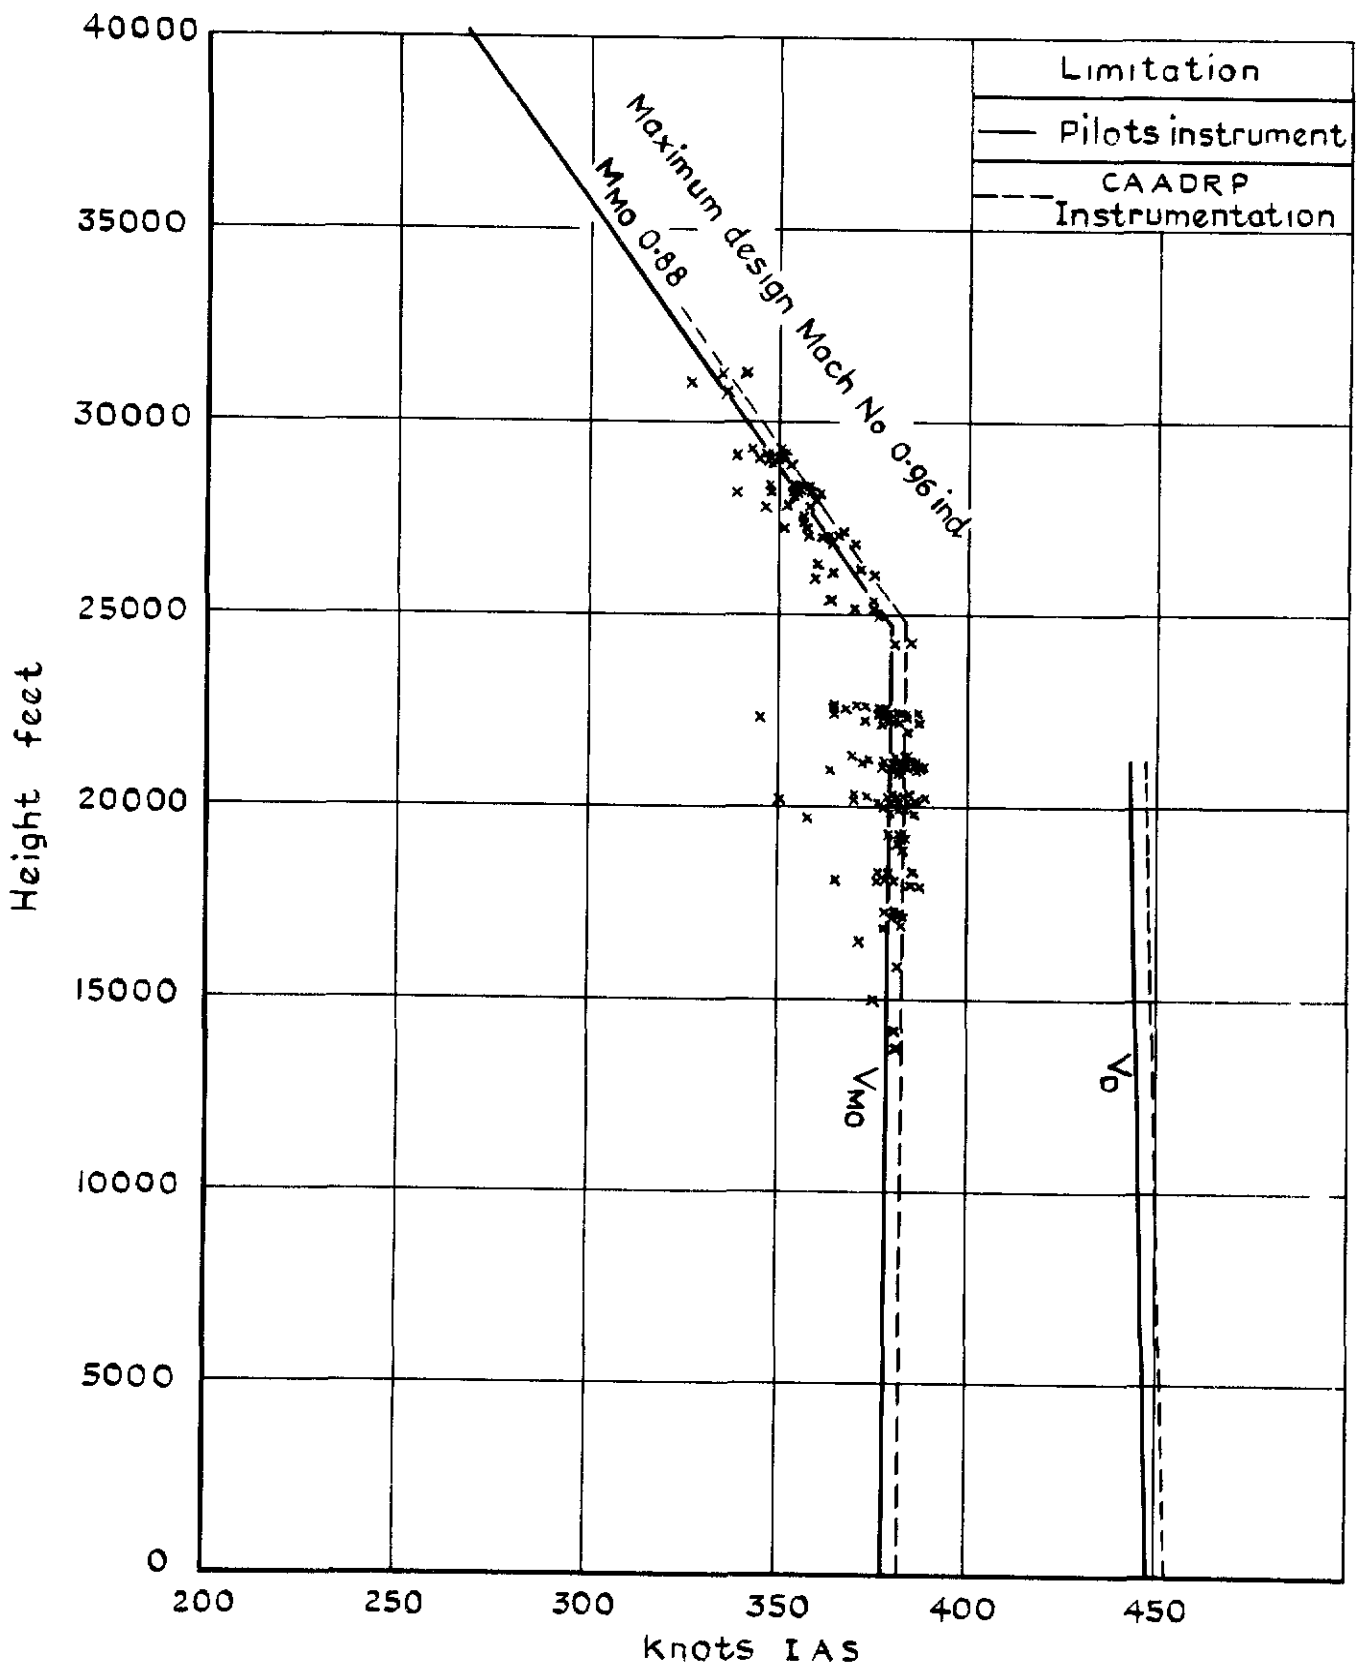
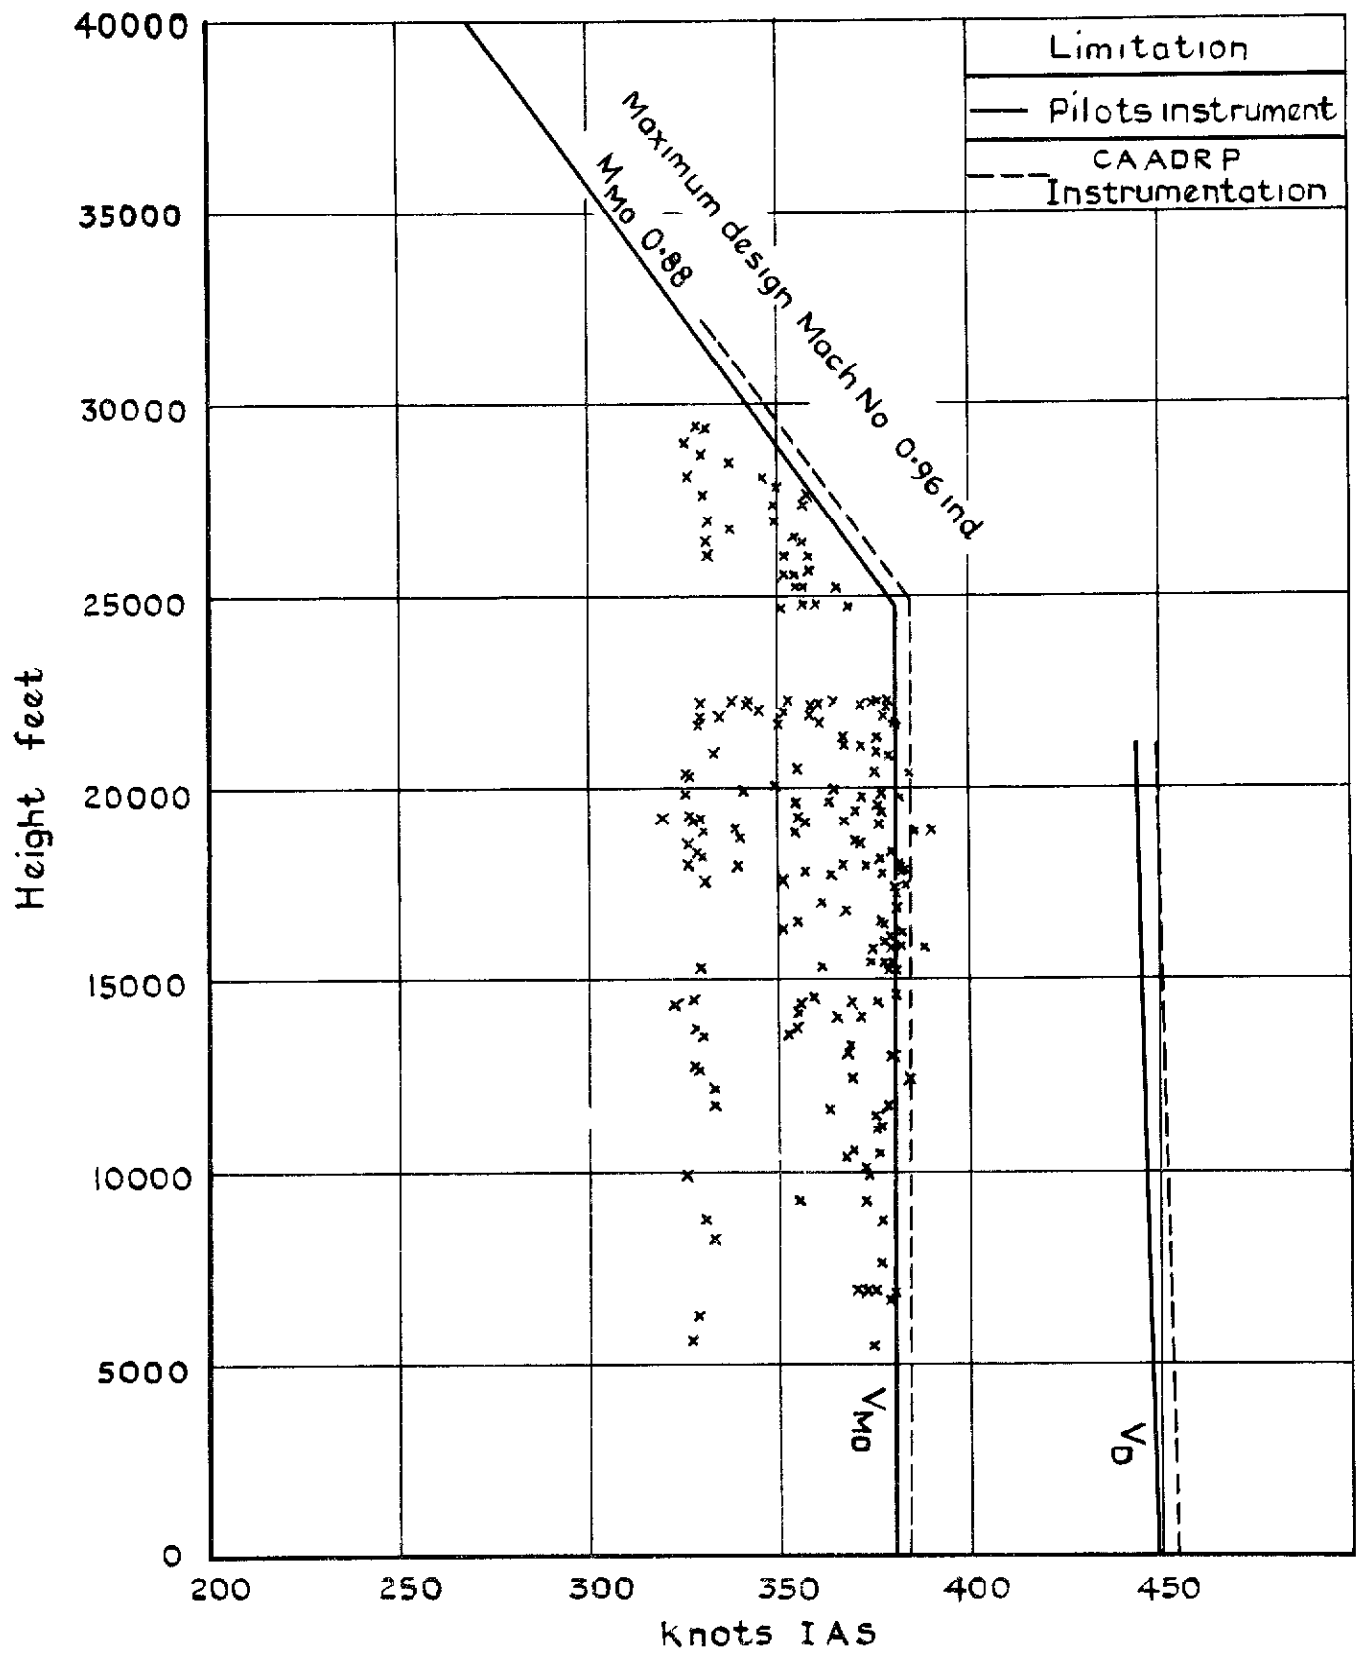
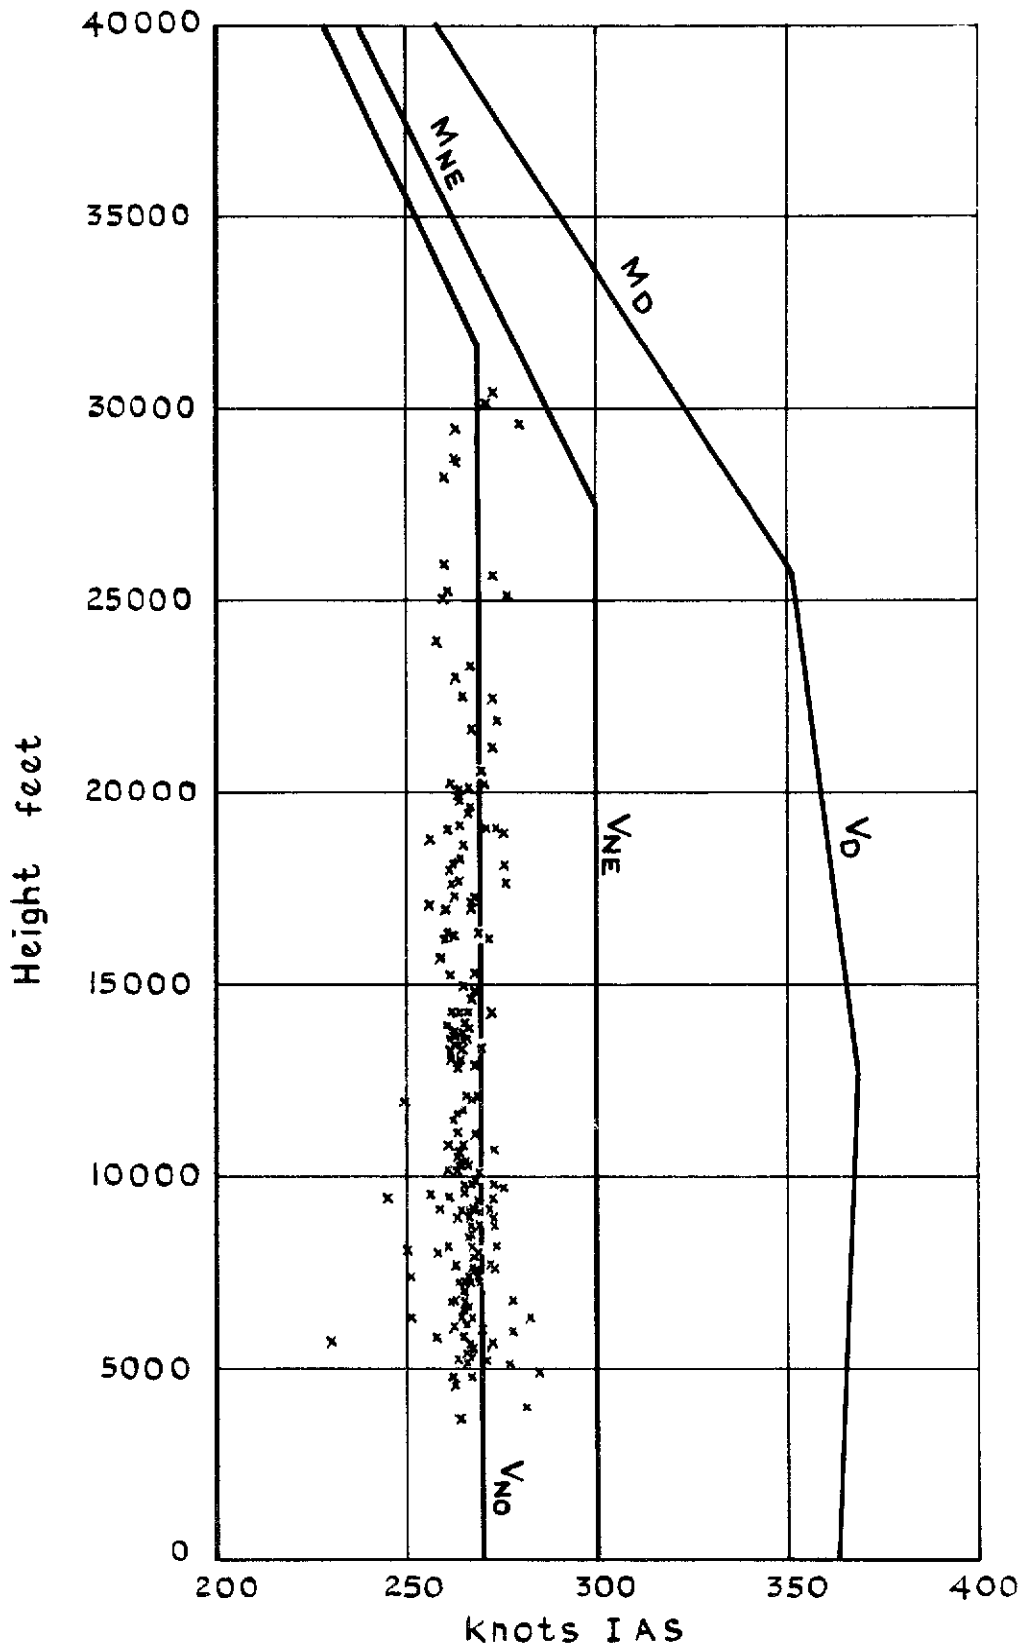
The maximum operating boundary was occasionally reached during climb. Cruise and descent were conducted at or very close to the boundary and hence there were a large number of occasions when the limit was exceeded. However, the limit was never exceeded by more than about 5-7 knots. (Figs.20, 21, 22)

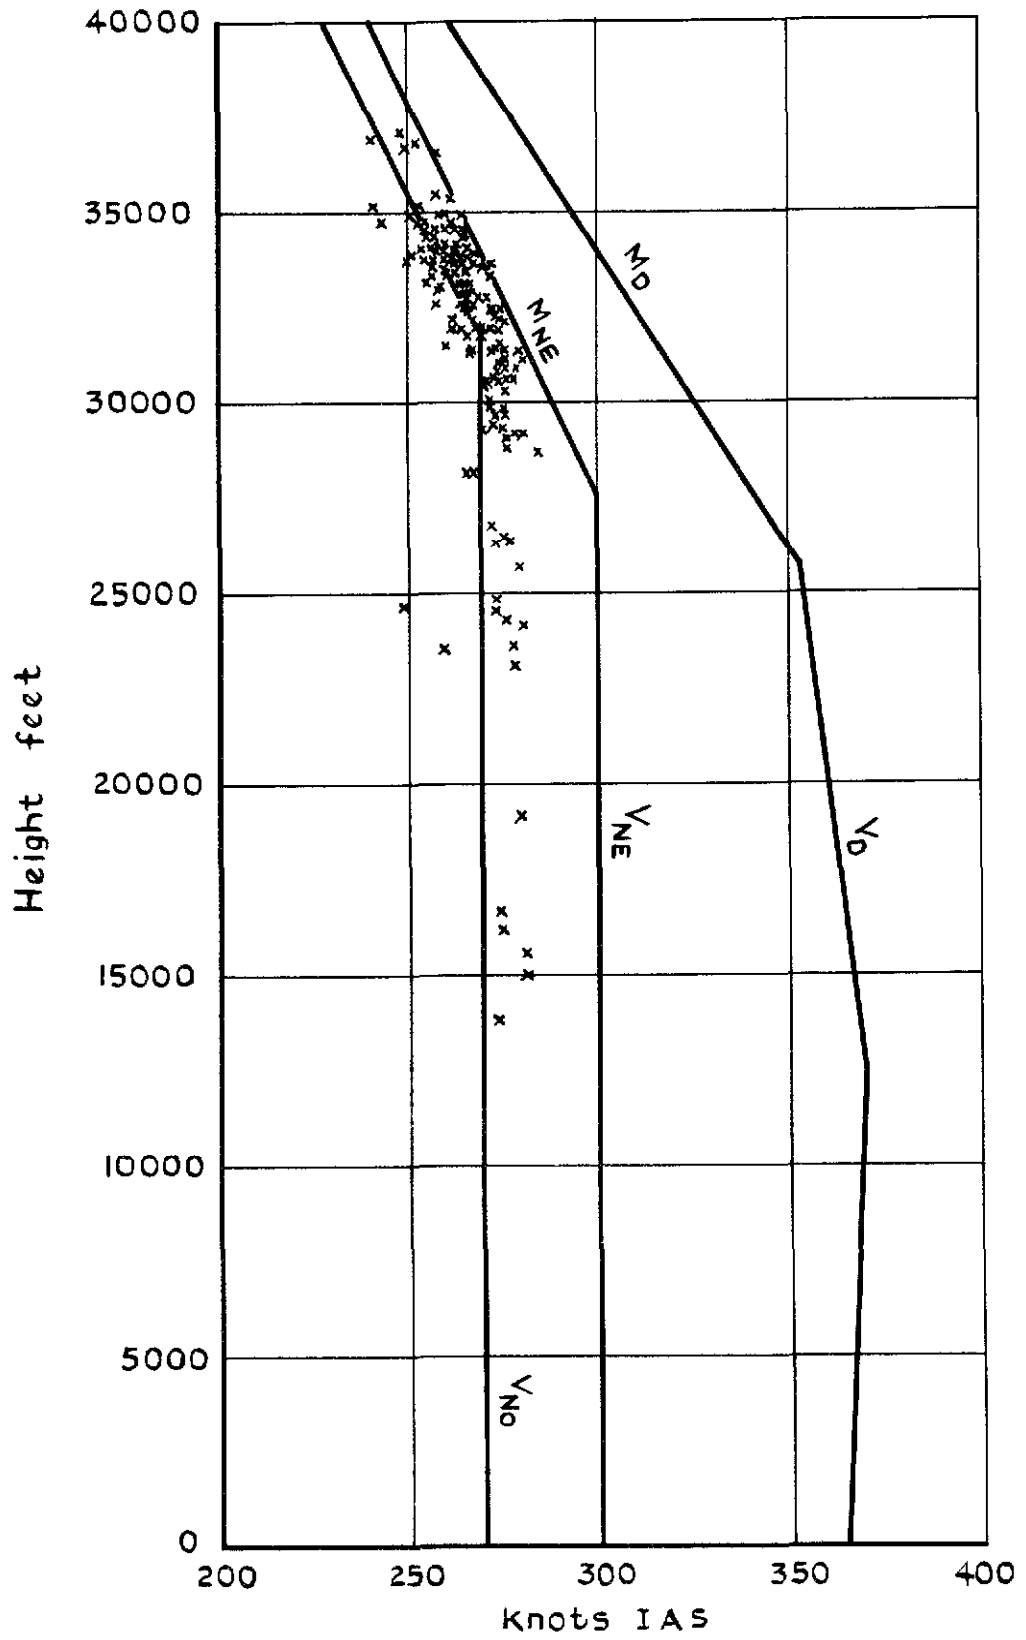
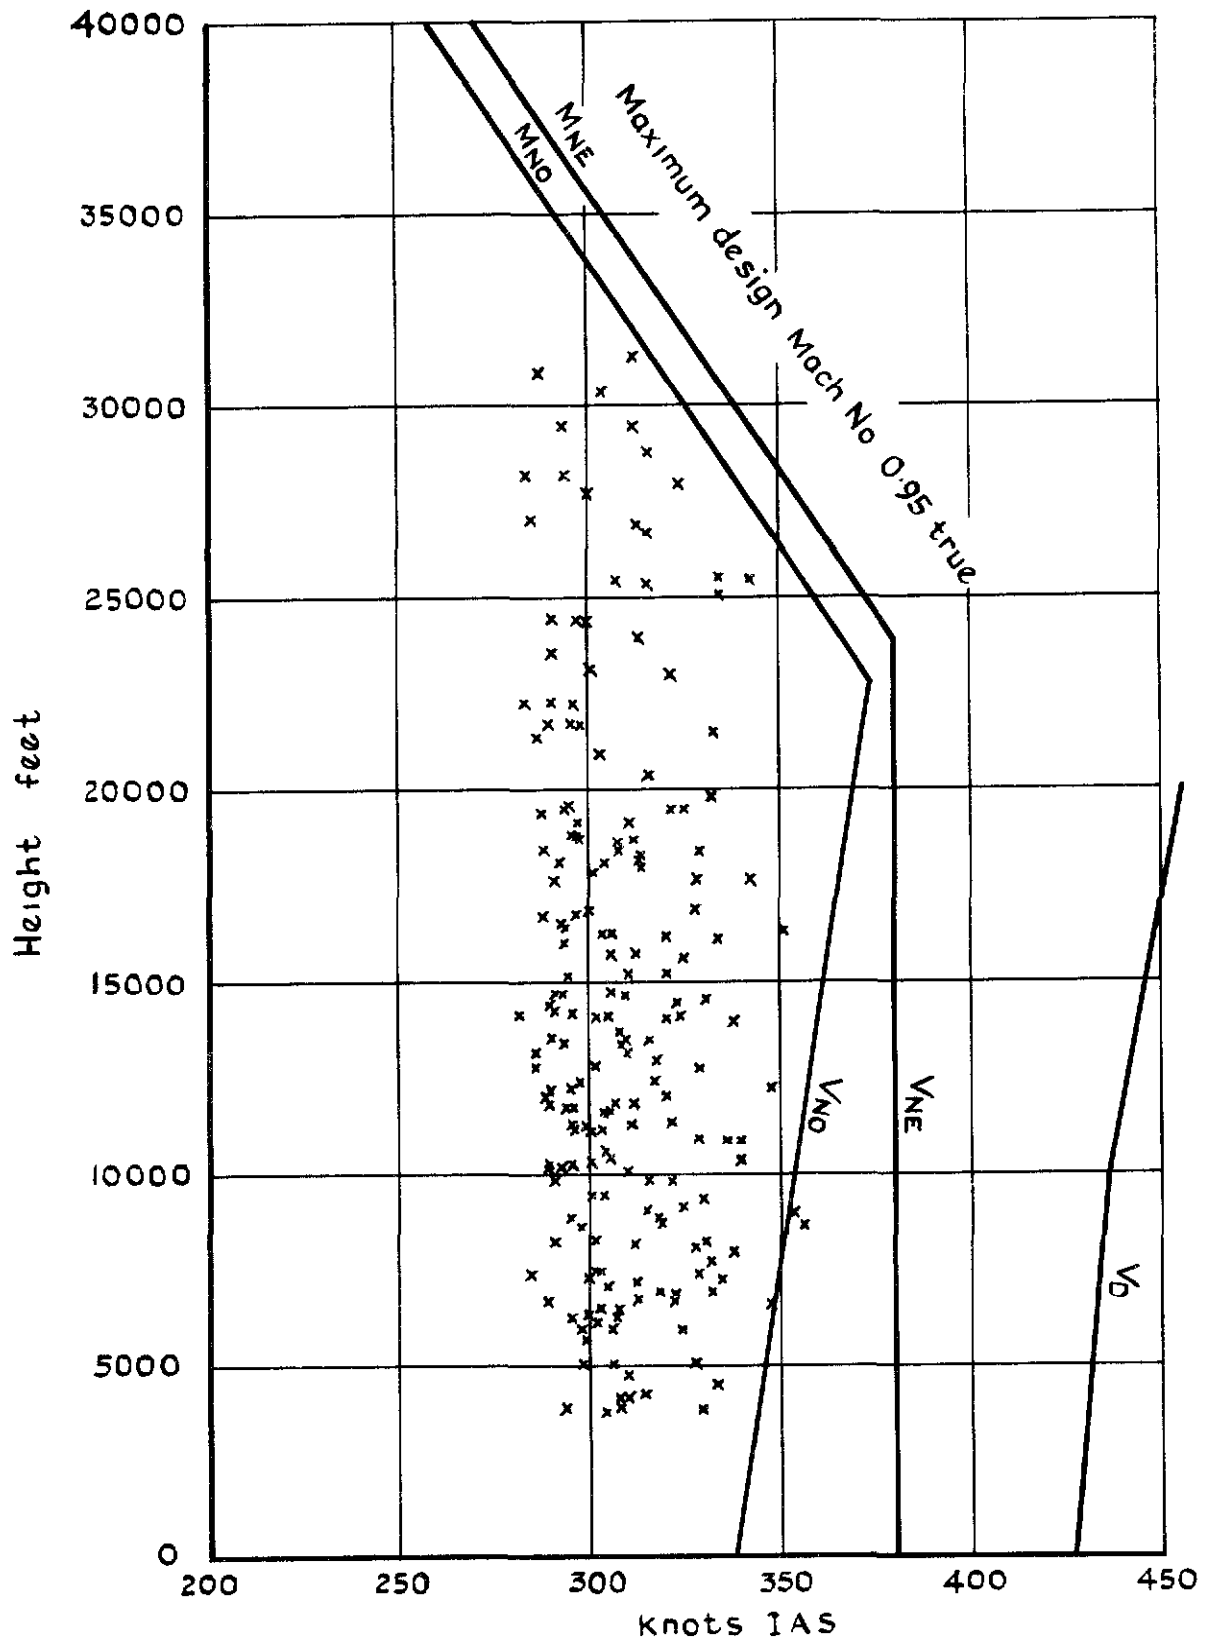
The normal operating boundary was passed fairly frequently in all phases of flight; this could be deliberate operation. The  $M_{NE}$  boundary was occasionally exceeded by a small amount in cruise. (Figs.23, 24, 25).

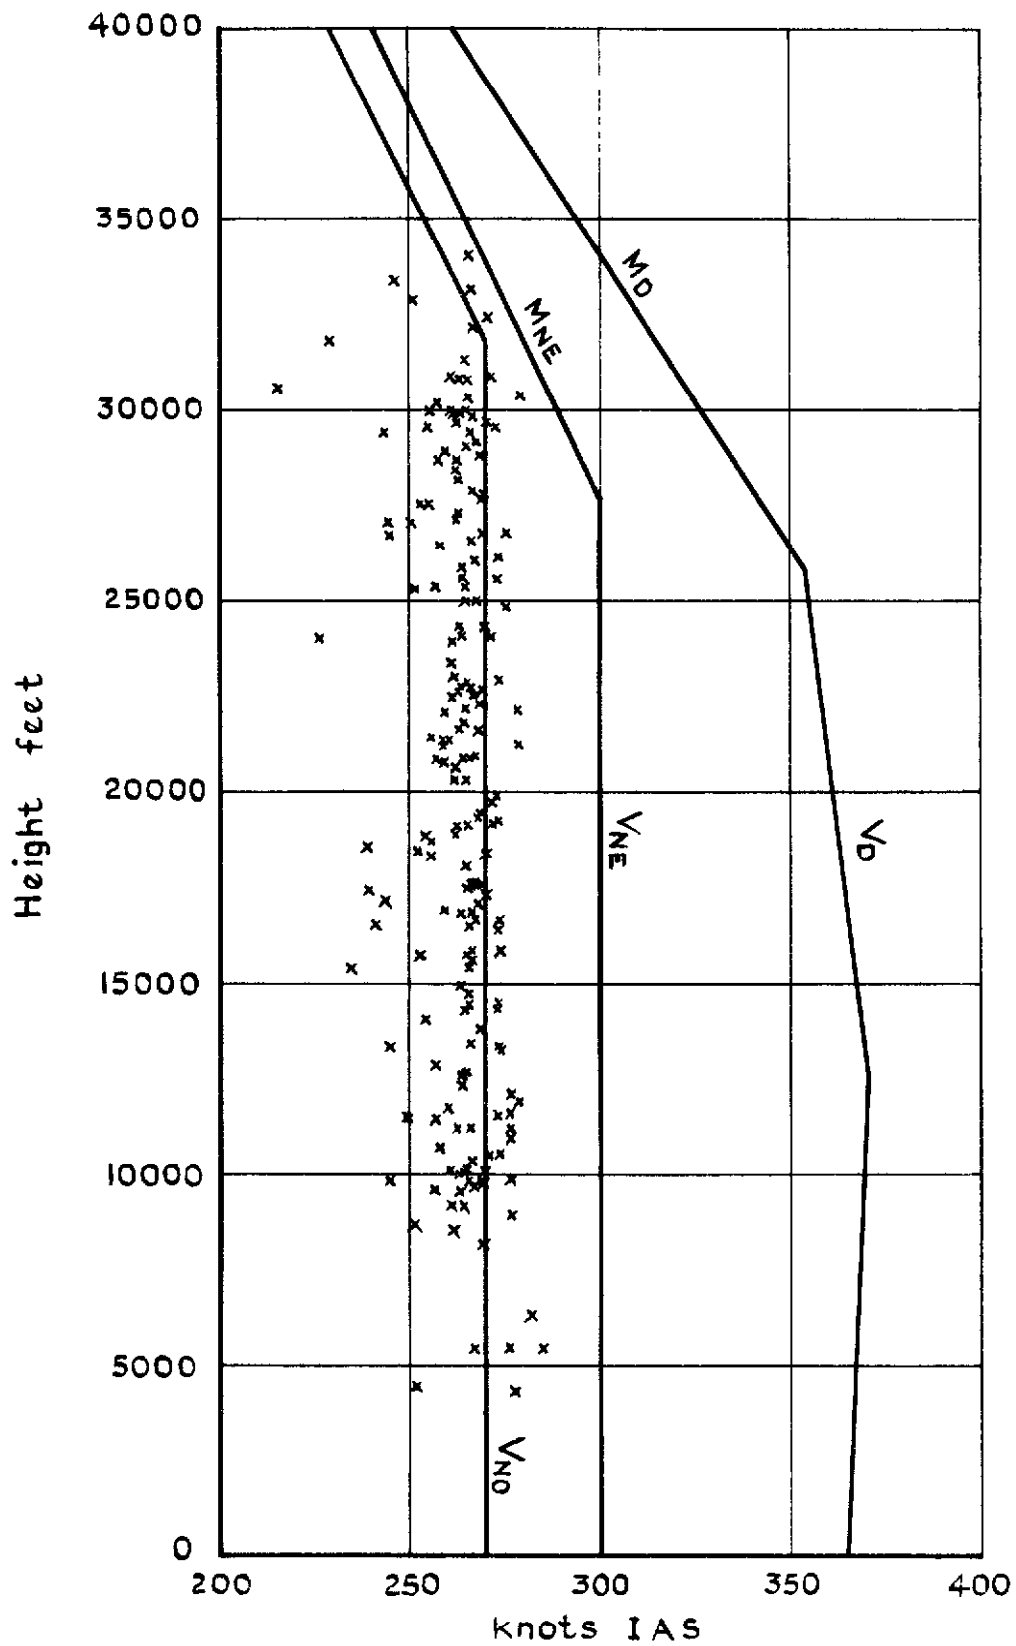
Fig.24 Maximum speed v height aircraft C—cruise

These exceedences suggest that the throttle settings were not trimmed and monitored with sufficient regard to the flight conditions. Fig.24 shows that it is usual for  $V_{NO}$  to be exceeded by this aircraft type.

$V_{NO}$  for this aircraft is 270 knots and  $V_{NE}$  is 300 knots. Wide fluctuations in airspeed occurred once during the descent at about 10000 feet, and three times during the steep climb back to 25000 feet. Airspeeds of 277, 273, 277 and 284 knots were recorded. The surges in airspeed are not associated with the presence of turbulence and may have been due to the particular throttle control technique employed. Fig.24 shows that it is usual for  $V_{NO}$  to be exceeded by this aircraft type.
