AERONAUTICAL RESEARCH COUNCIL

Civil Aircraft Airworthiness  
Data Recording Programme.  
Special Events Related  
to Airspeed Control Practices  
(February 1963 to February 1966)

*CAADRP Special Events Working Party*

June 1969

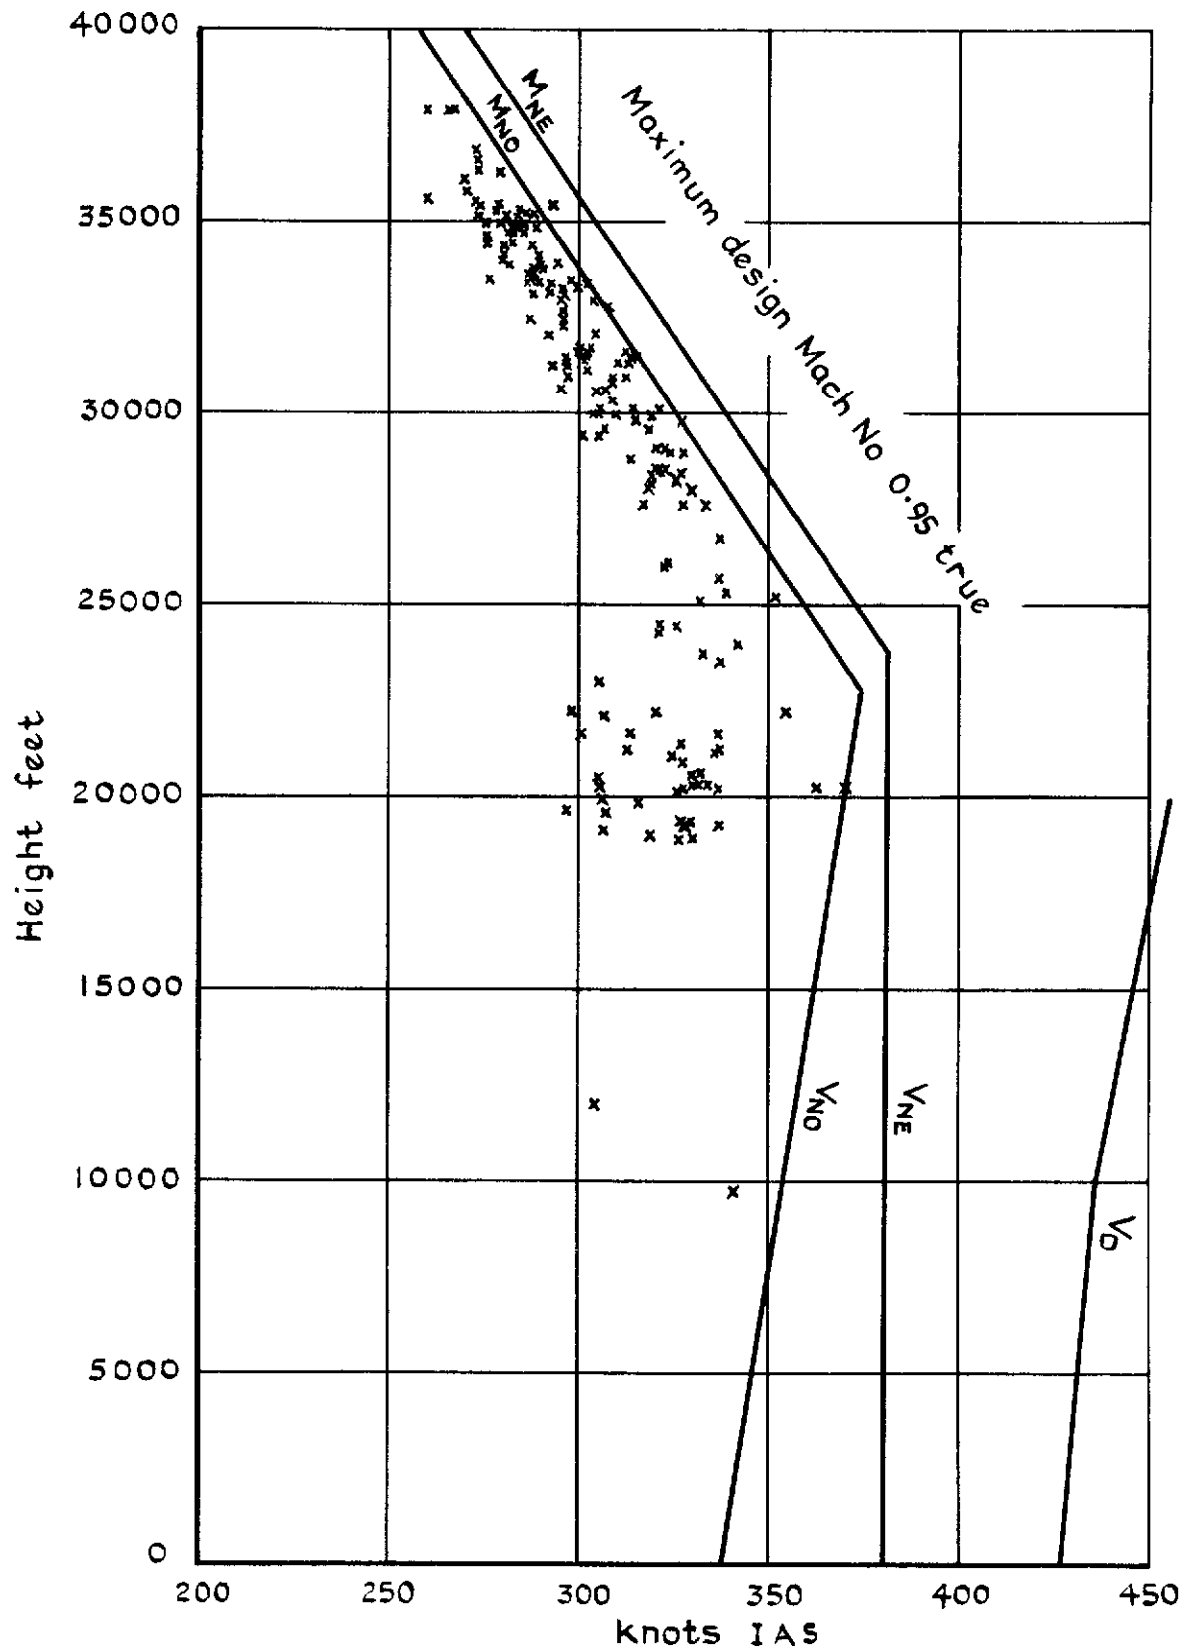
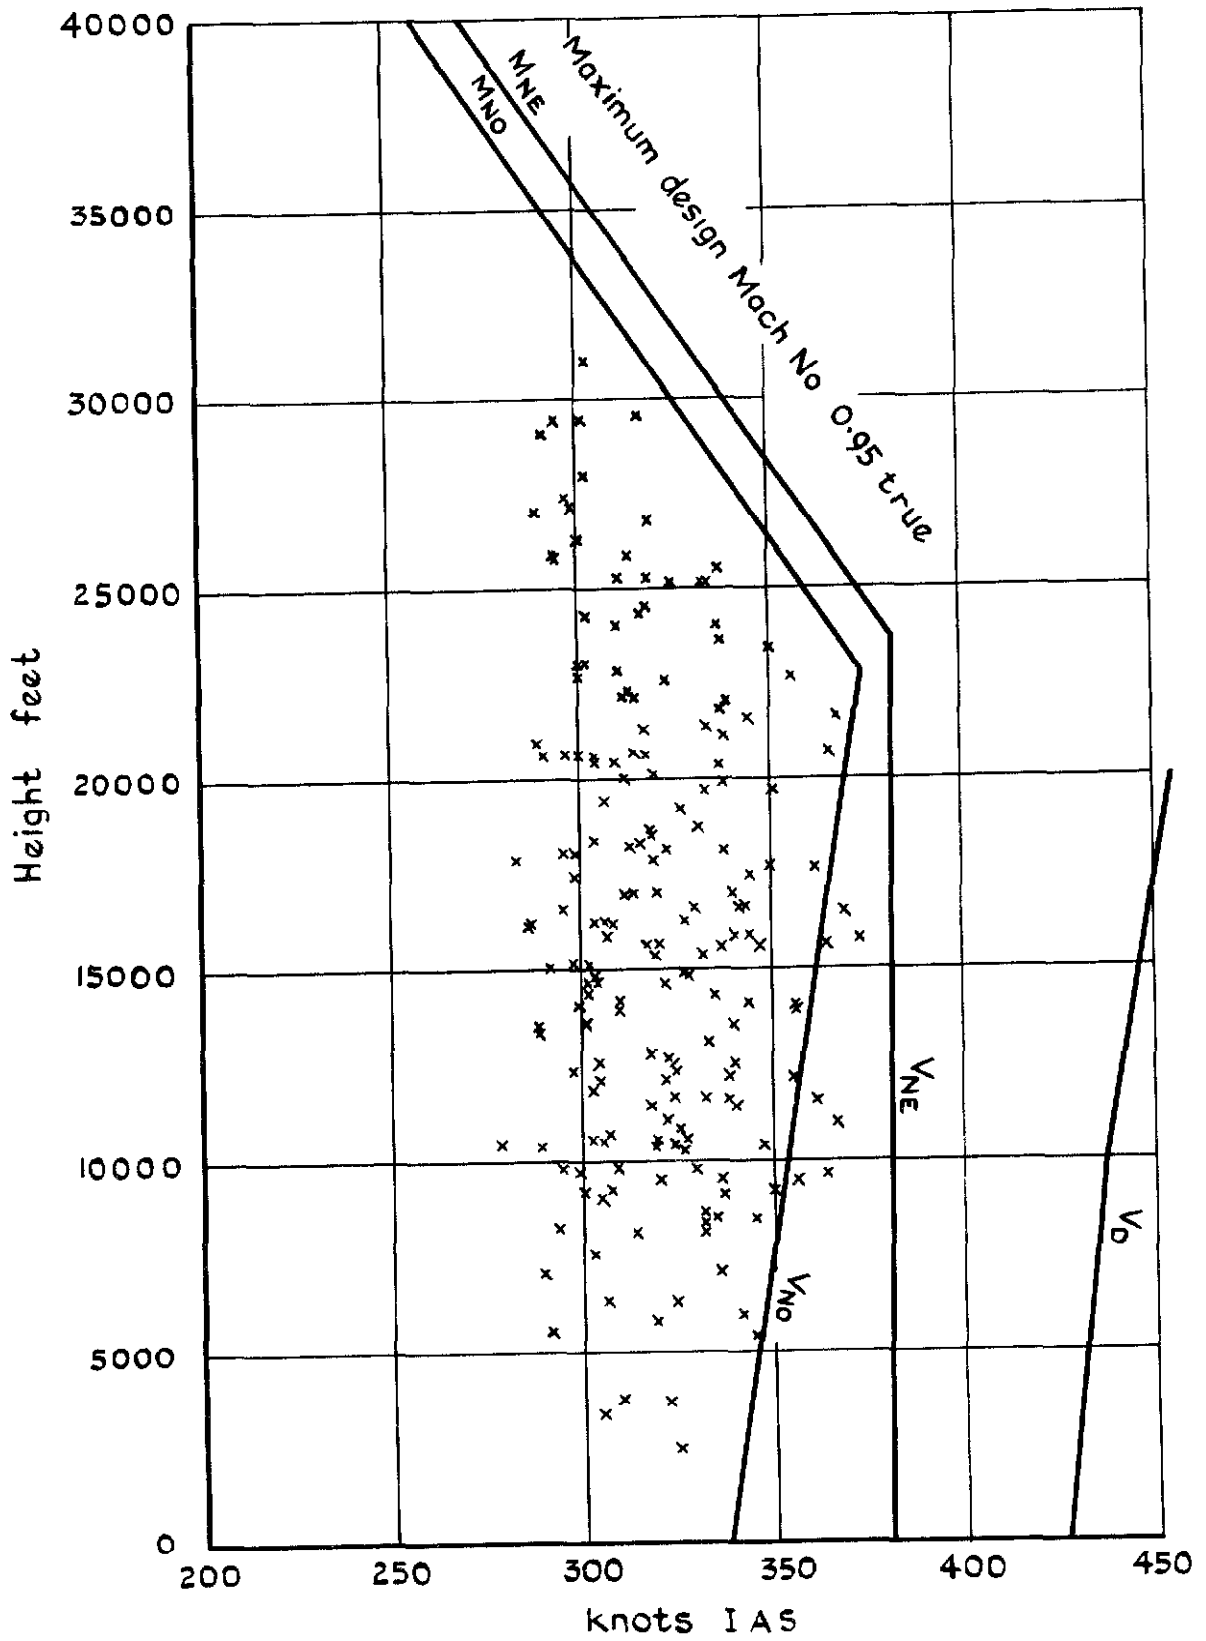
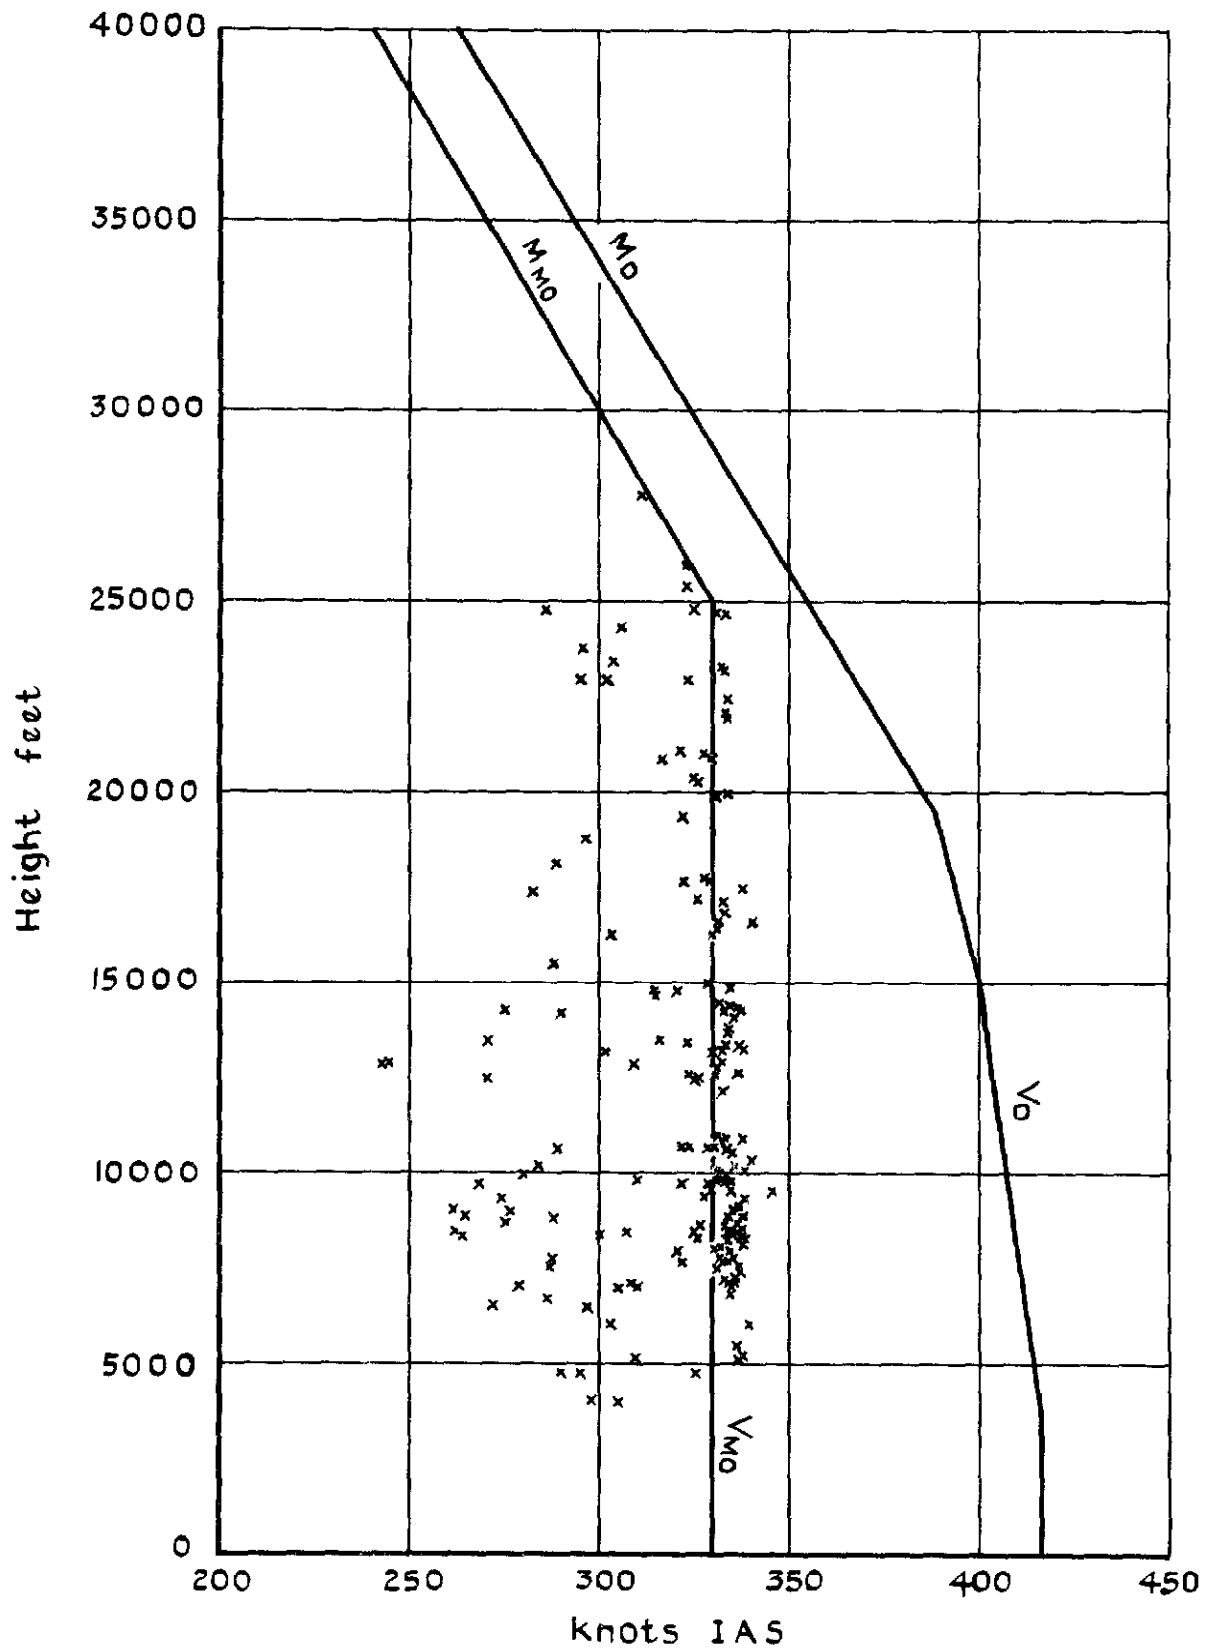
The usual operating speed was well within the normal operating boundary and hence the number of occasions when it was crossed was very small, and the never exceed boundary was never reached. (Figs.26, 27, 28).

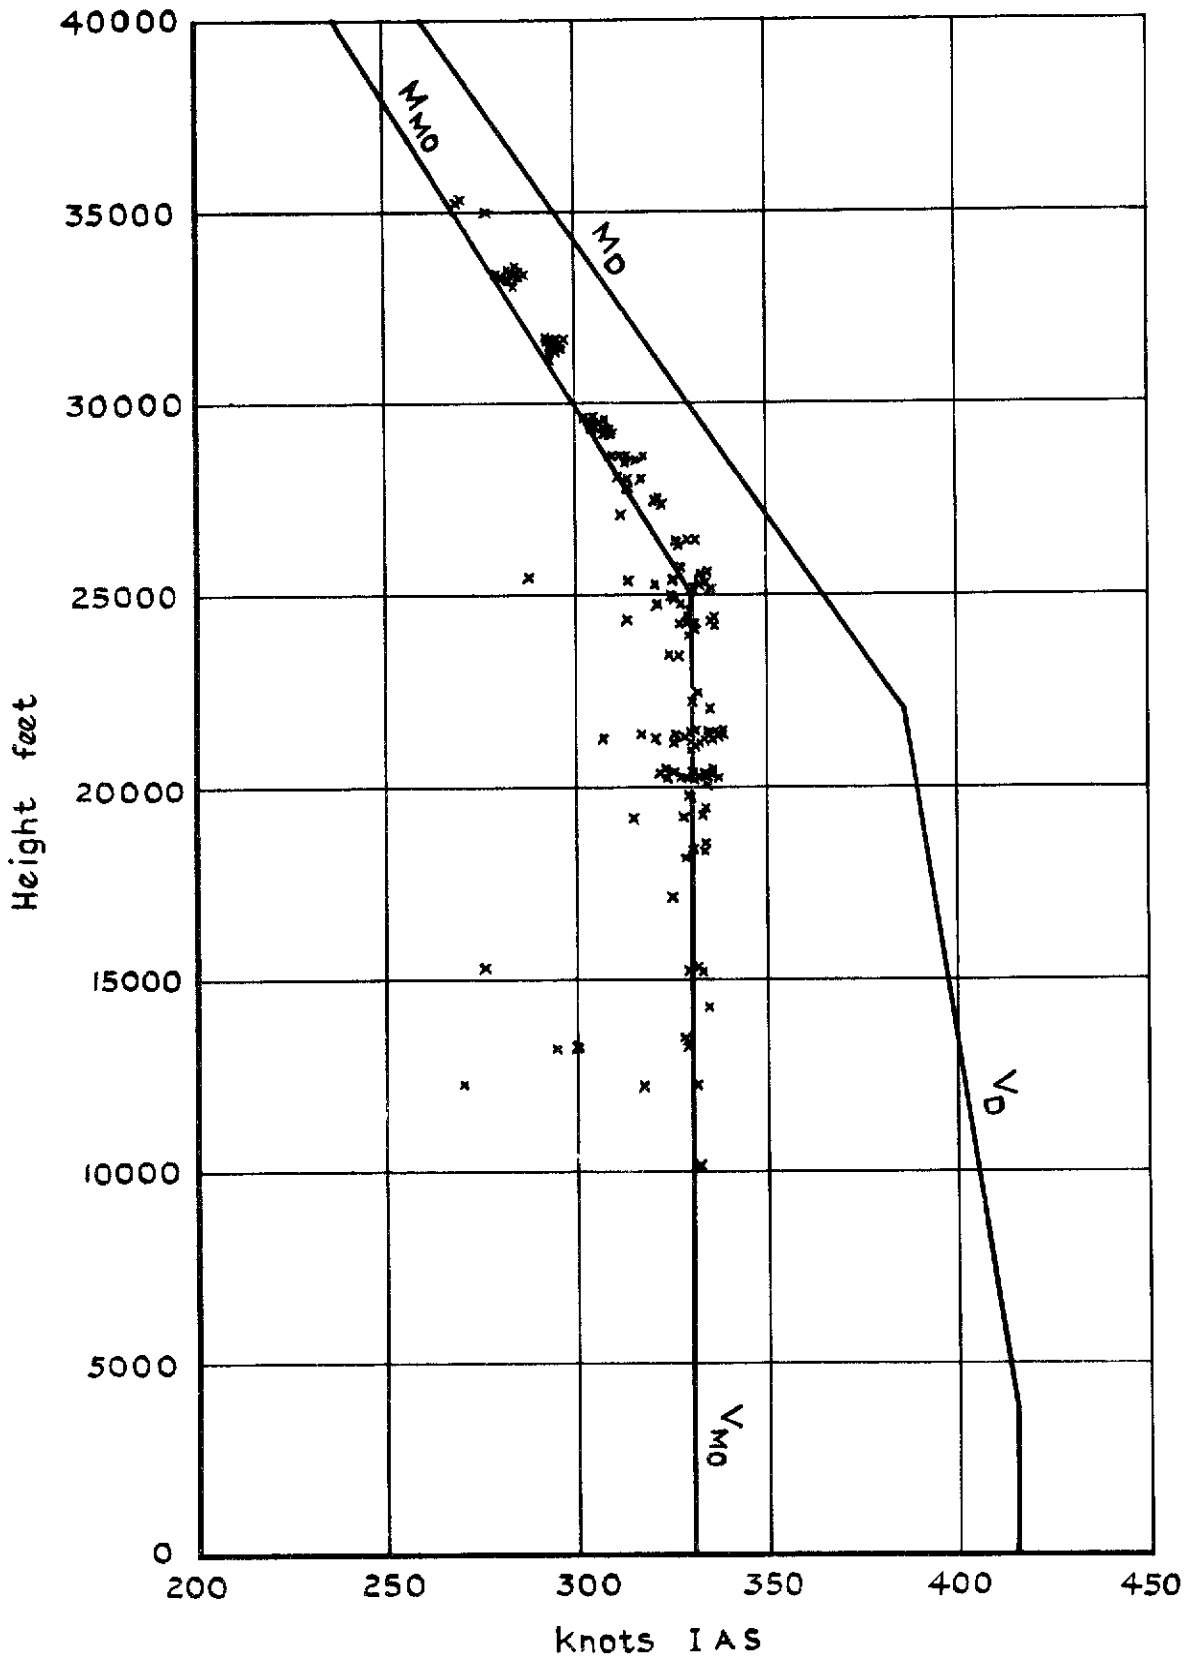
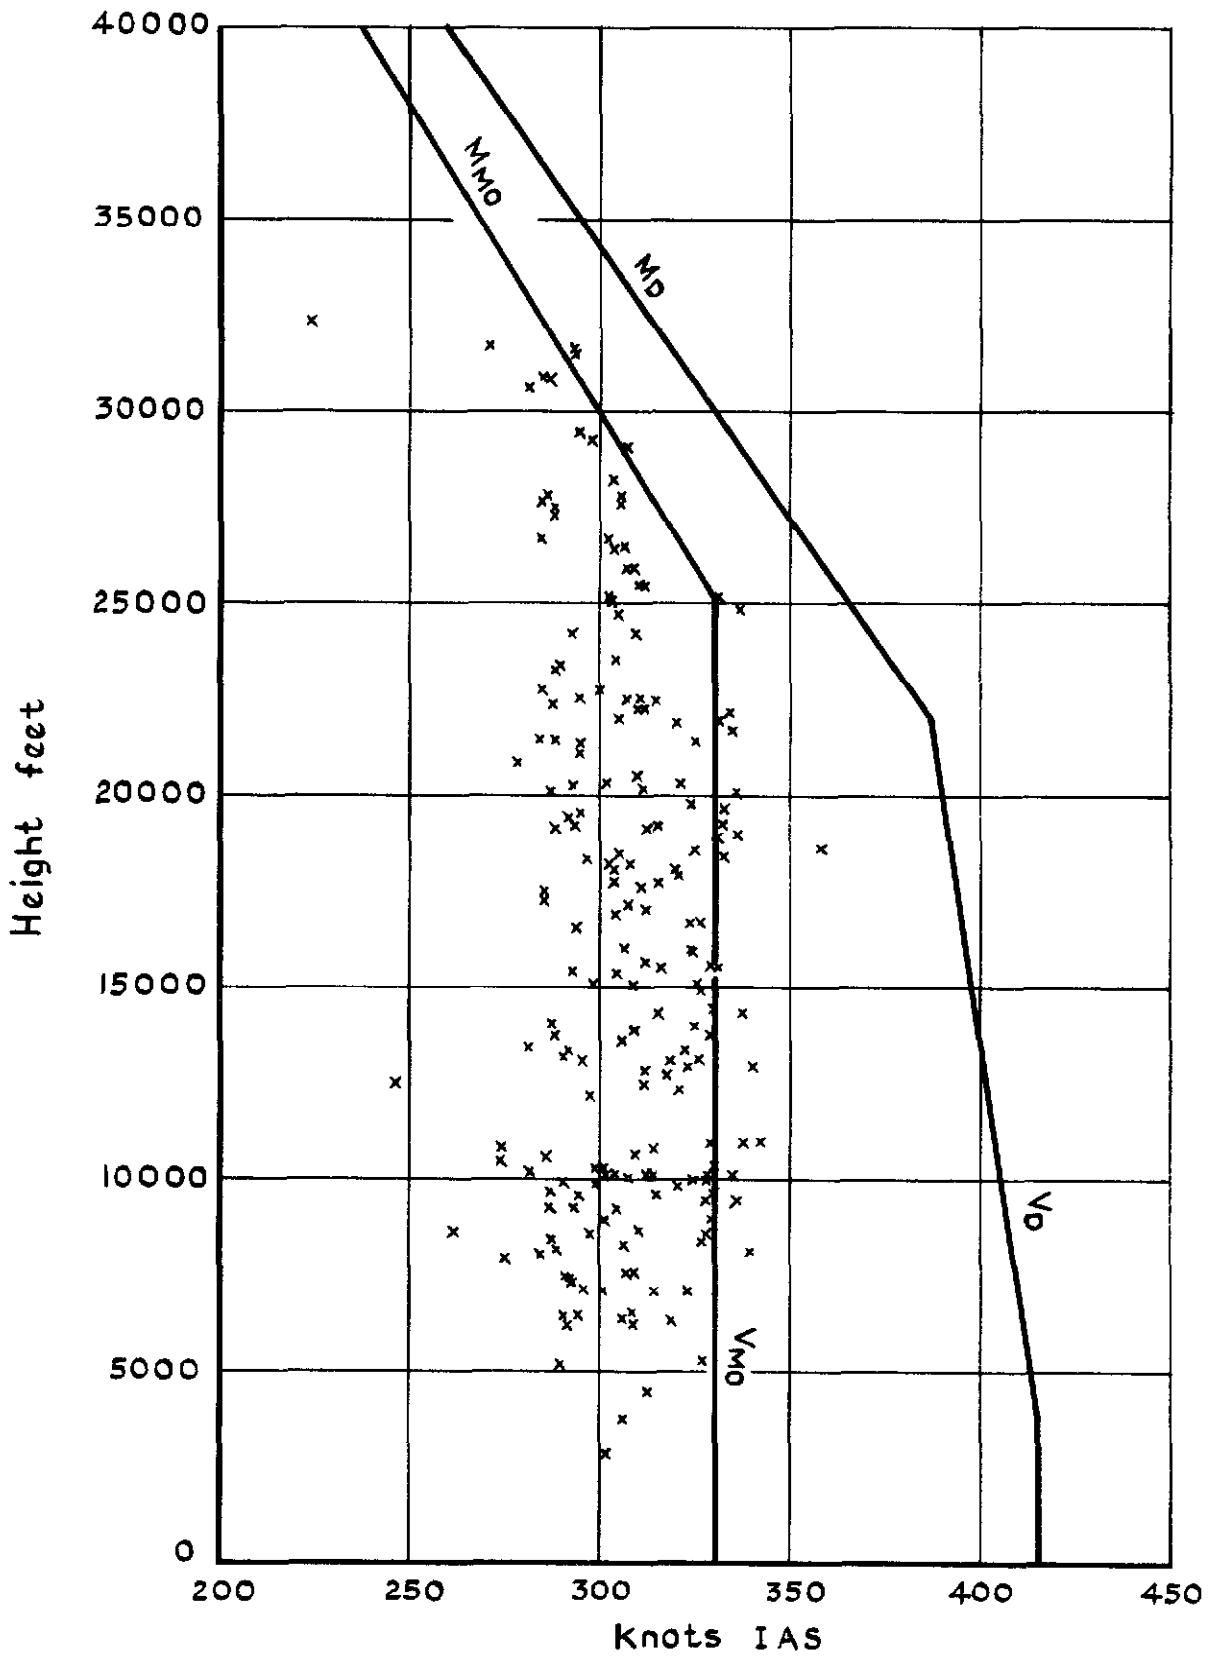
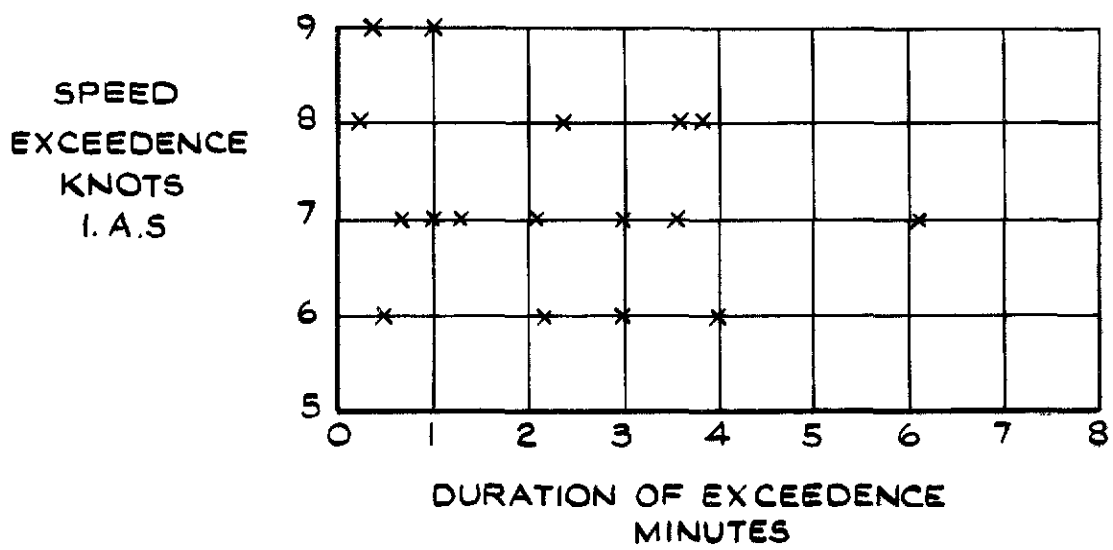
All phases of flight are commonly conducted at the maximum operating boundary, and hence speeds in excess of the limitation were frequently recorded. (Figs.29, 30, 31). However, the speed exceedences were rarely large, although often sustained (Fig.32) for a significant period.
