Low Speed Wind Tunnel
Calibration of a
Mk.9A Pitot-Static Head

Technical Note No. Aero.2364

Low Speed Wind Tunnel Calibration of a Mark 9A Pitot-Static Head

This note describes the calibration of a Mark 9A pitot-static head in the No.2 $11\frac{1}{2}$ feet wind tunnel. The results show the variation of pitot and static pressure error coefficients with incidence, at constant tunnel speed.

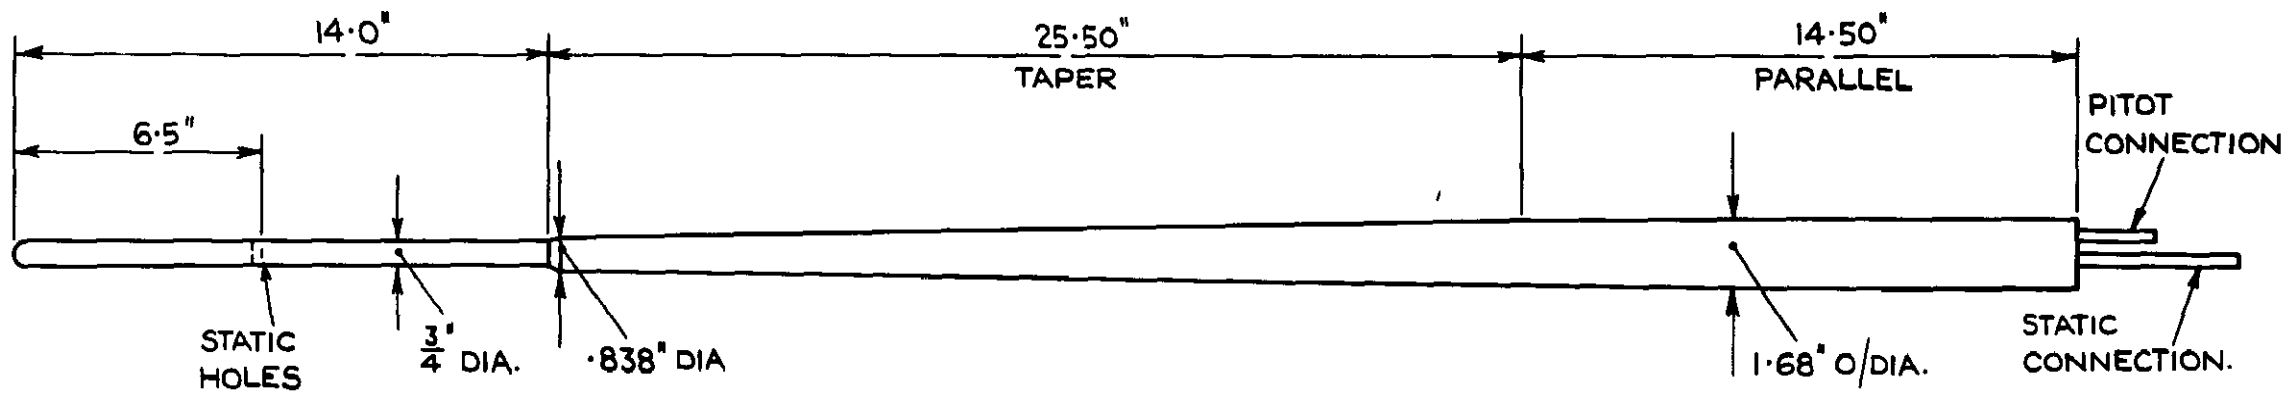
FIG. I. DETAIL OF MARK 9A PITOT - STATIC HEAD.

A sketch of a Mark 9A head is shown in Fig.1. It consists of the actual pressure head ¾" dia. and 14" long, with the static holes 6½" behind the nose, supported by a tapered tube terminating in a parallel portion 1.68" dia. There is a drain hole 1/32" dia. between the pitot and static lines.

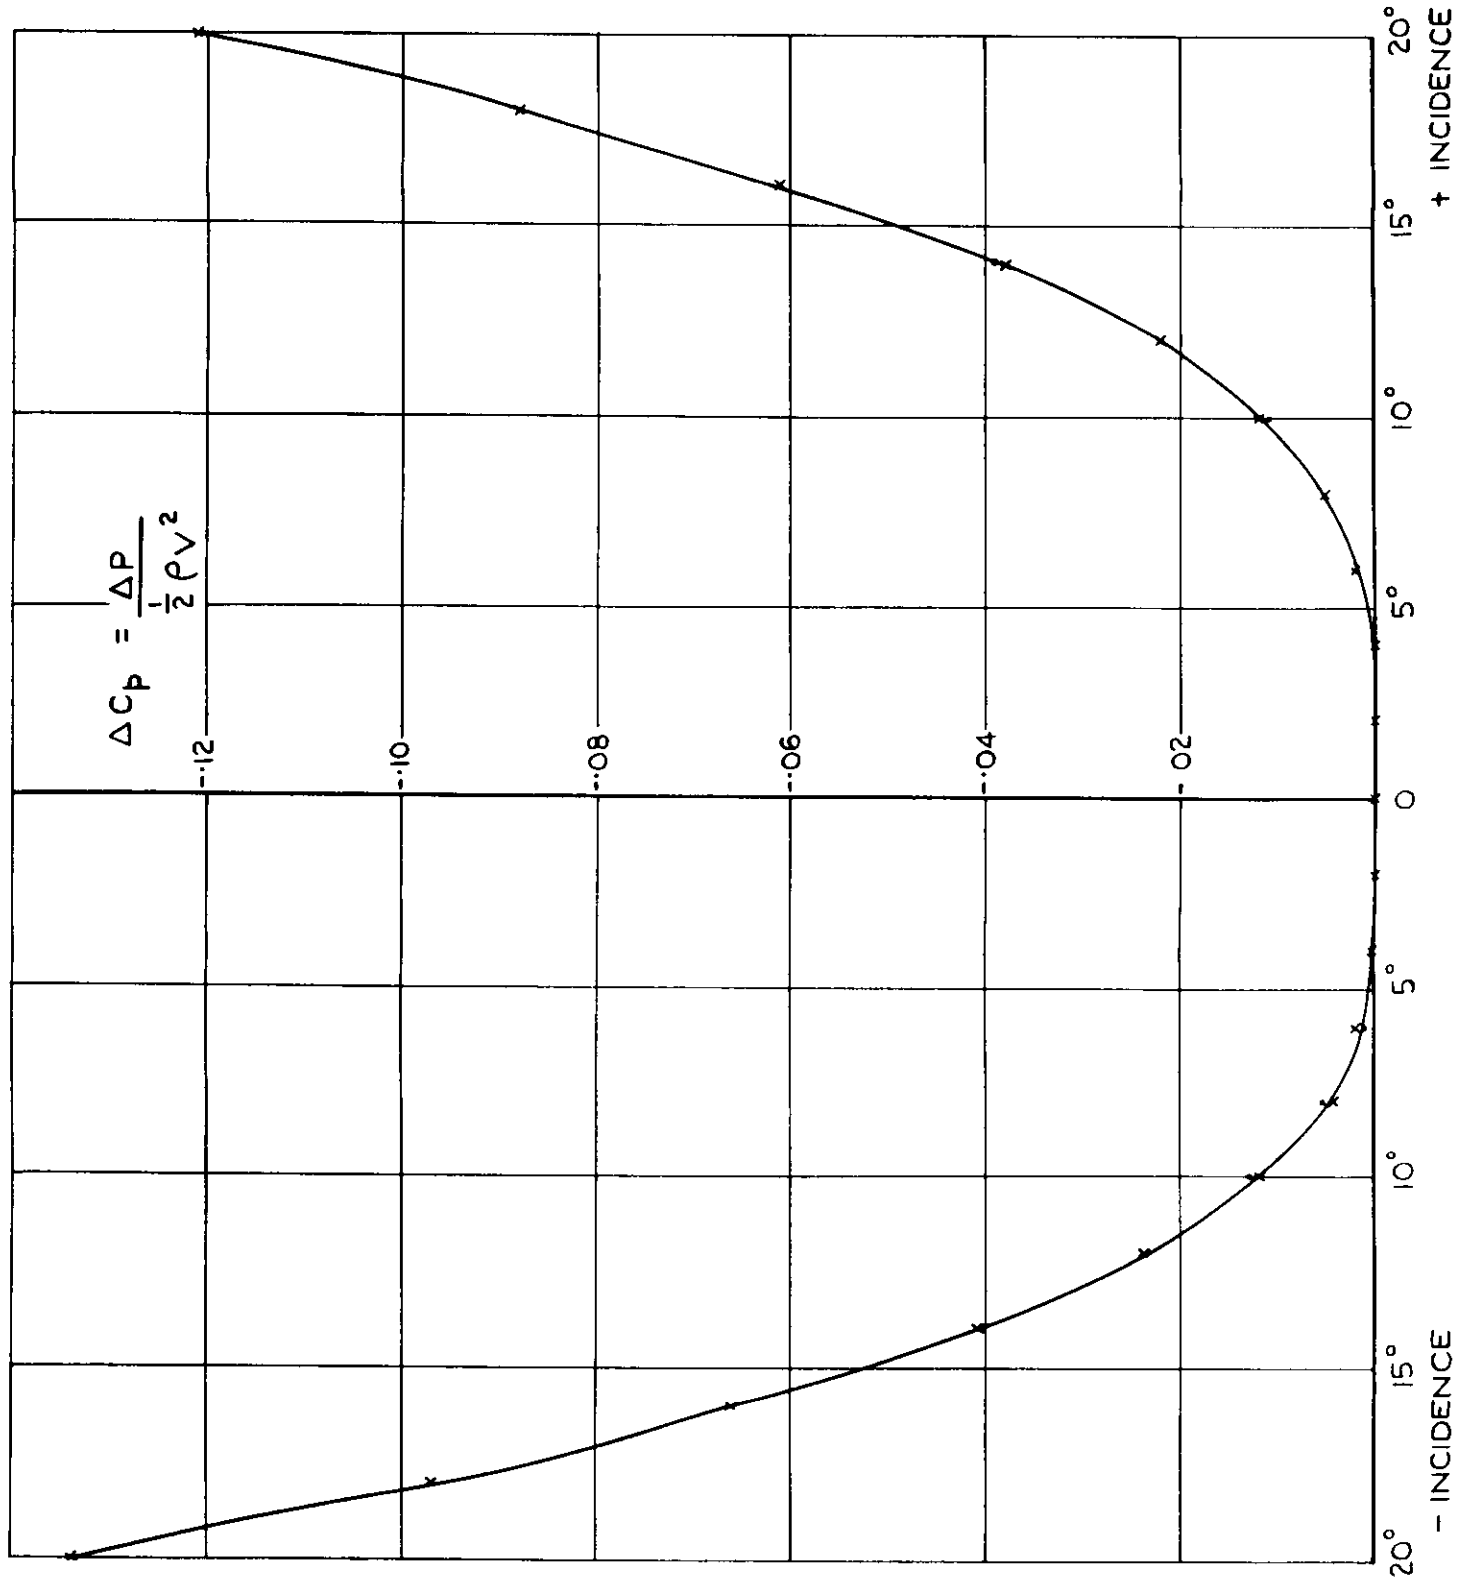
FIG. 2. MK. 9A HEAD - PITOT PRESSURE ERROR.

The results are presented in Table I and plotted in Figs.2 and 3 as pressure error against incidence.

Pitot error is negligible up to 5° and rises to about 1% of $\frac{1}{2}\rho V^2$ at 10°. Thereafter, the error increases rapidly and at 20° incidence is about 12% of $\frac{1}{2}\rho V^2$.

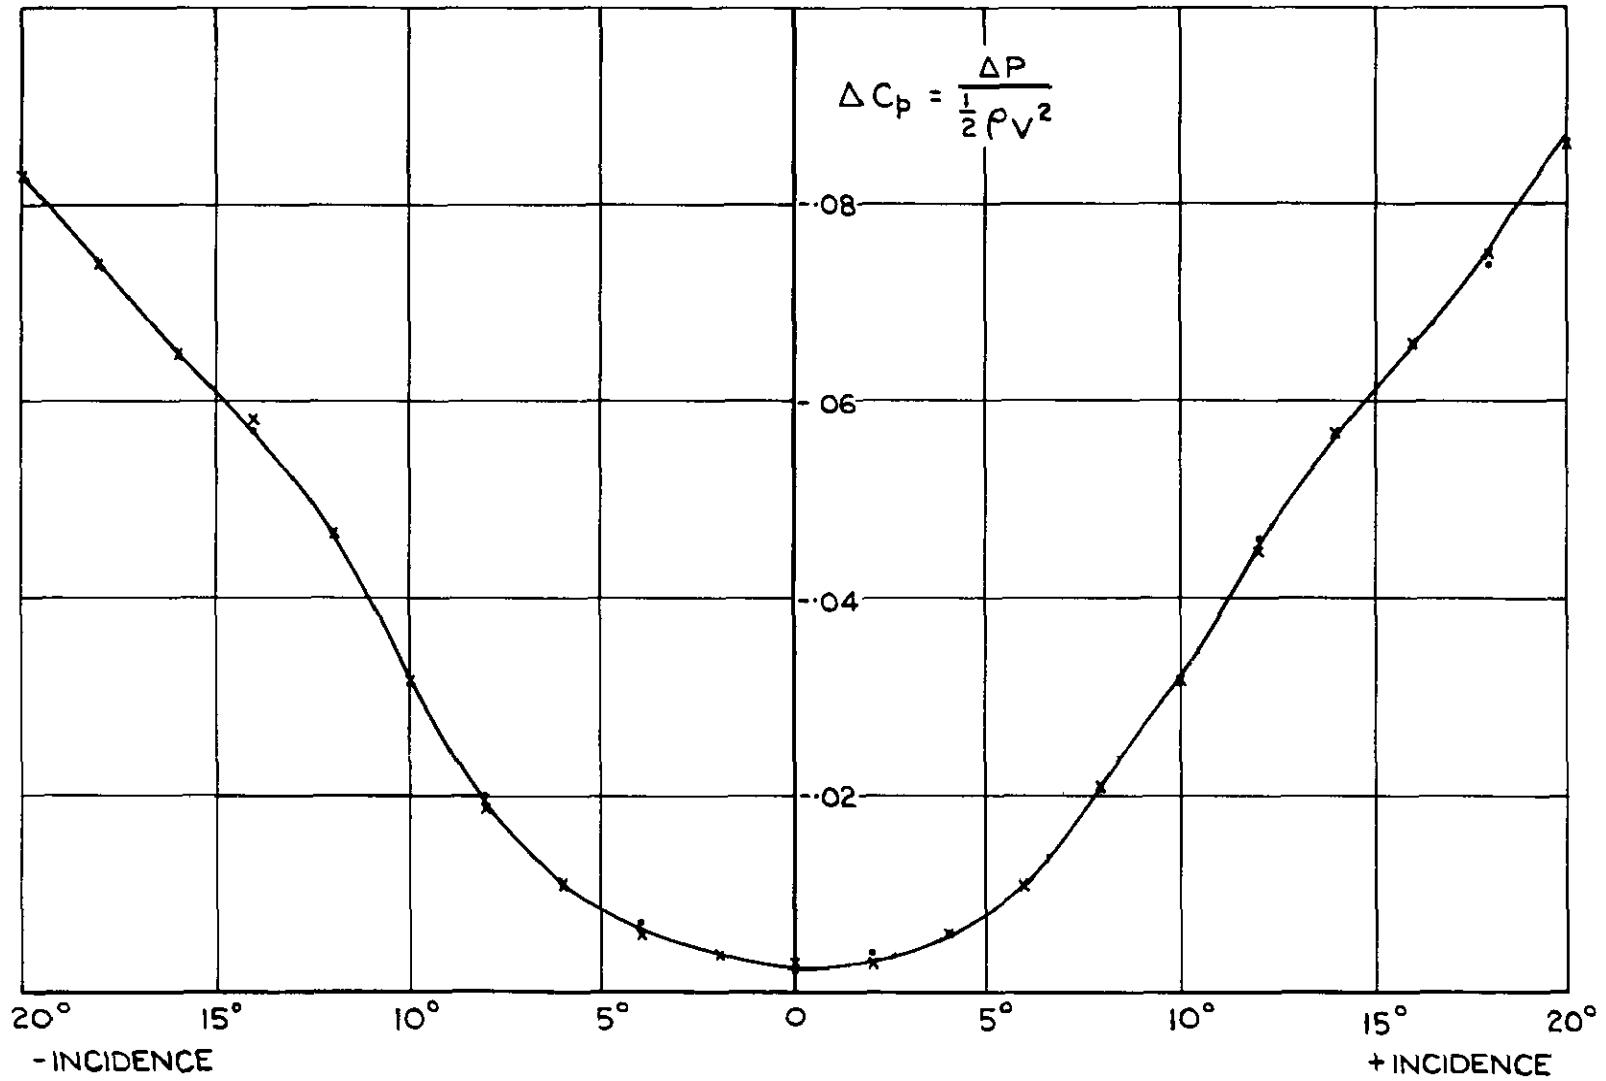
FIG. 3. MK. 9A HEAD - STATIC PRESSURE ERROR.

Static pressure error is 0.3% of $\frac{1}{2}\rho V^2$ at zero incidence, and is about 1% of $\frac{1}{2}\rho V^2$ at 6°. After 6°, the error increases considerably and is about 8.5% of $\frac{1}{2}\rho V^2$ at 20° incidence.
