Designing to Avoid Dangerous Behaviour of an Aircraft due to the Effects on Control Hinge Moments of Ice on the Leading Edge of the Fixed Surface

D. E. Morris, B.Sc.

ROYAL AIRCRAFT ESTABLISHMENT

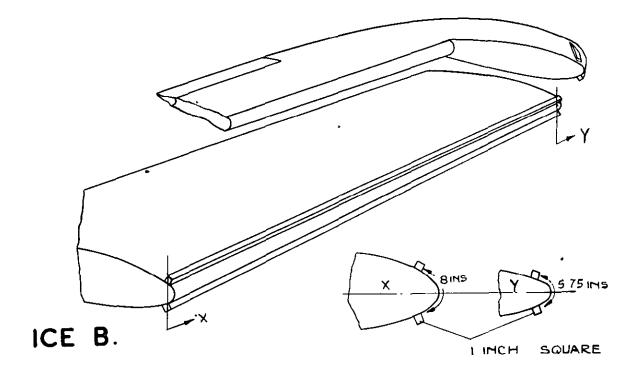
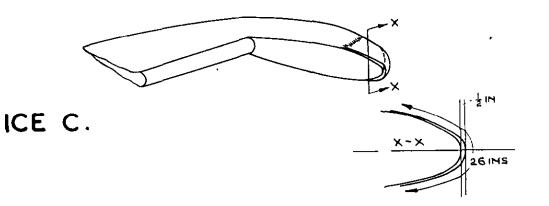
Sketches of the various types of ice formations simulated in the tunnel tests are given in Fig.1. Type A is intended to represent the ice formation observed on the viking.

During a flight to investigate the efficacy of the Viking de-icing equipment, fairly severe icing conditions were encountered. The de-icing fluid flow was not sufficient to prevent ice forming, but the porous metal strips themselves remained free of ice. An ice formation similar to Type A of Fig.1 was observed.

FIG. I.   ICE   FORMATIONS   TESTED
IN   WIND   TUNNEL.
