Vortex Breakdown—Some Observations in Flight on the *HP 115* Aircraft

By L. J. FENNELL

Aerodynamics Department, R.A.E., Farnborough, Hants.

*Reports and Memoranda No. 3805**
September, 1971

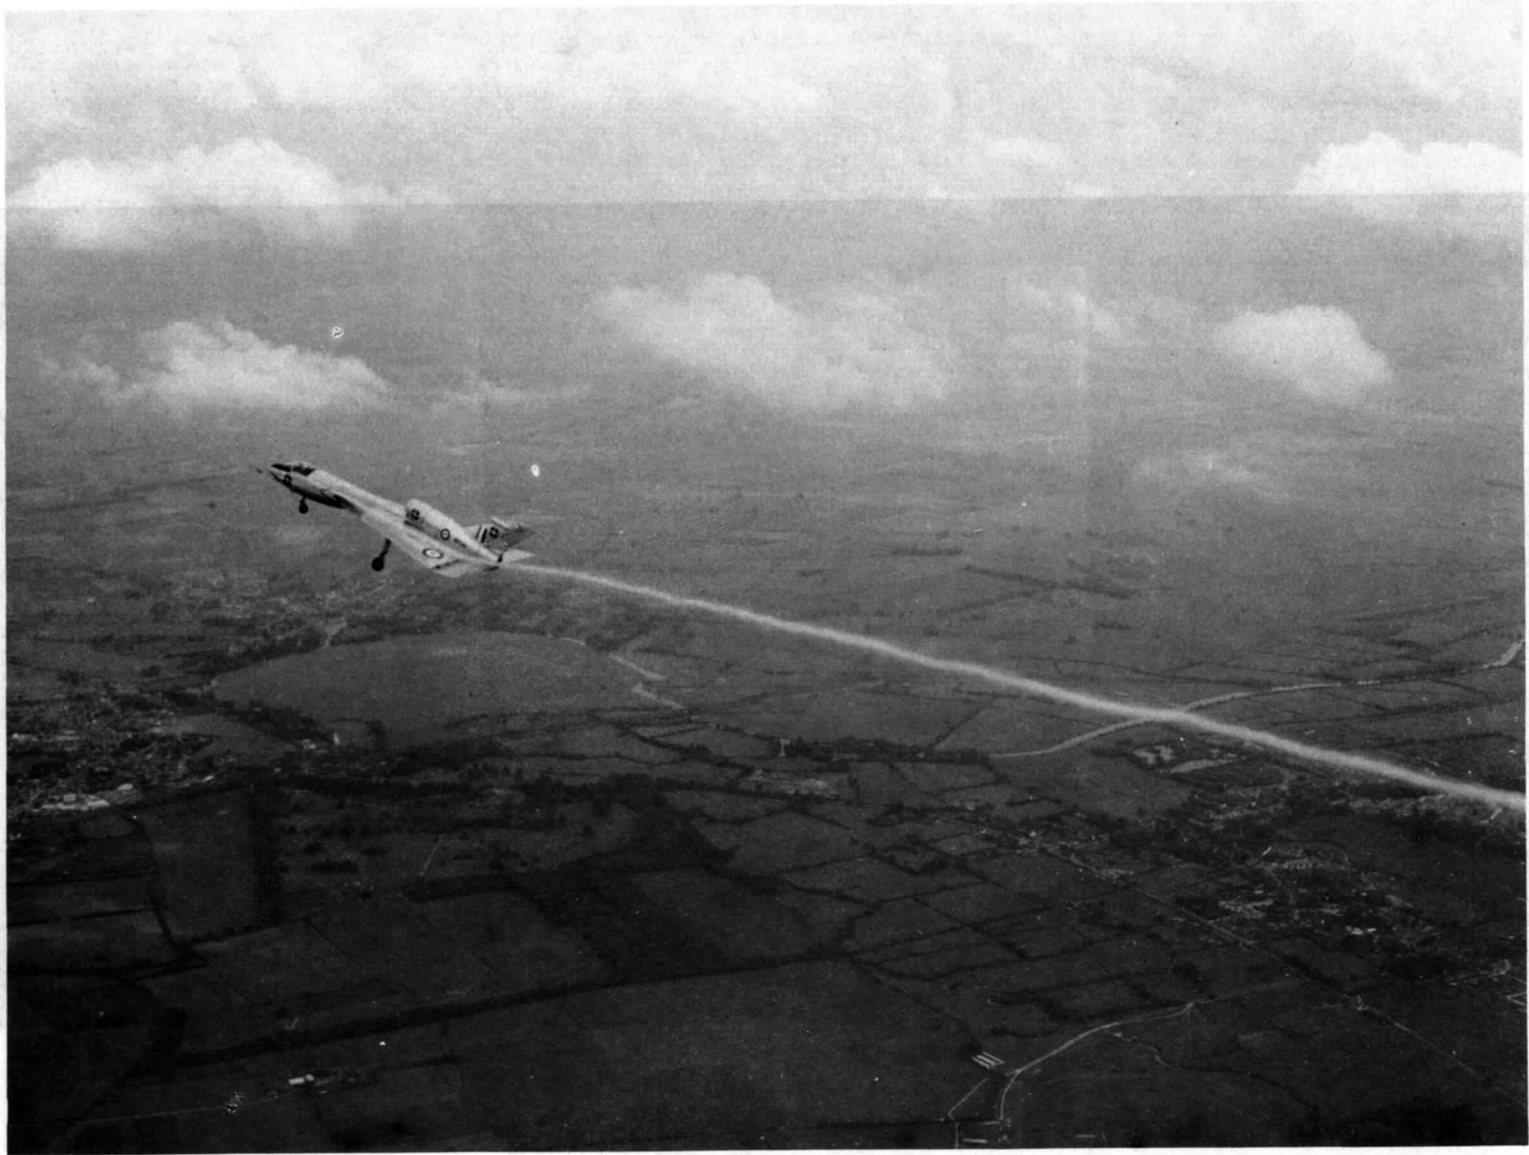
FIG. 4. Vortex core flow visualisation.

Some preliminary flights were necessary to establish the optimum position of the smoke ejection pipe (as evidenced by the slight kink in the pipe to be seen in Fig. 3) and once this had been obtained the vortex core was clearly defined by the injected smoke, as shown in Fig. 4. Prior to breakdown, the smoke was confined to a compact cylindrical zone of almost constant diameter for several aircraft lengths downstream of the trailing edge. Vortex breakdown was observed to occur at up to three or four aircraft lengths downstream of the trailing edge, moving upstream as incidence was increased. Fig. 5 shows a typical extract from the cine film record, the incidence in this case being 28 degrees and the burst position 0.6 C_0 (C_0 = wing centre line chord) downstream of the trailing edge. The form of the breakdown was similar to that described by other authors¹, namely an increase in the core diameter and an apparent reduction in axial velocity. The concentrated smoke in the vortex core appeared to separate into a number of filaments at breakdown, each of which followed a spiral path, as may be seen in Figs. 5 and 6 (the latter shows a sideslip condition). On some flights it was not possible to detect these filaments until a considerable distance downstream of the onset of breakdown; on these occasions the burst vortex had an appearance consistent with an envelope of the separate filaments. An example of this may be seen in the starboard smoke trail in Fig. 7. Fig. 8 is of particular interest. In this case the aircraft was sideslipping to port, and the breakdown position is consequently nearer to the trailing edge of the port wing than to that of the starboard wing. The starboard smoke trail however, is showing a spiralling motion of the whole core prior to breakdown, as observed by Lambourne and Bryer (Fig. 4 of ref. 1).

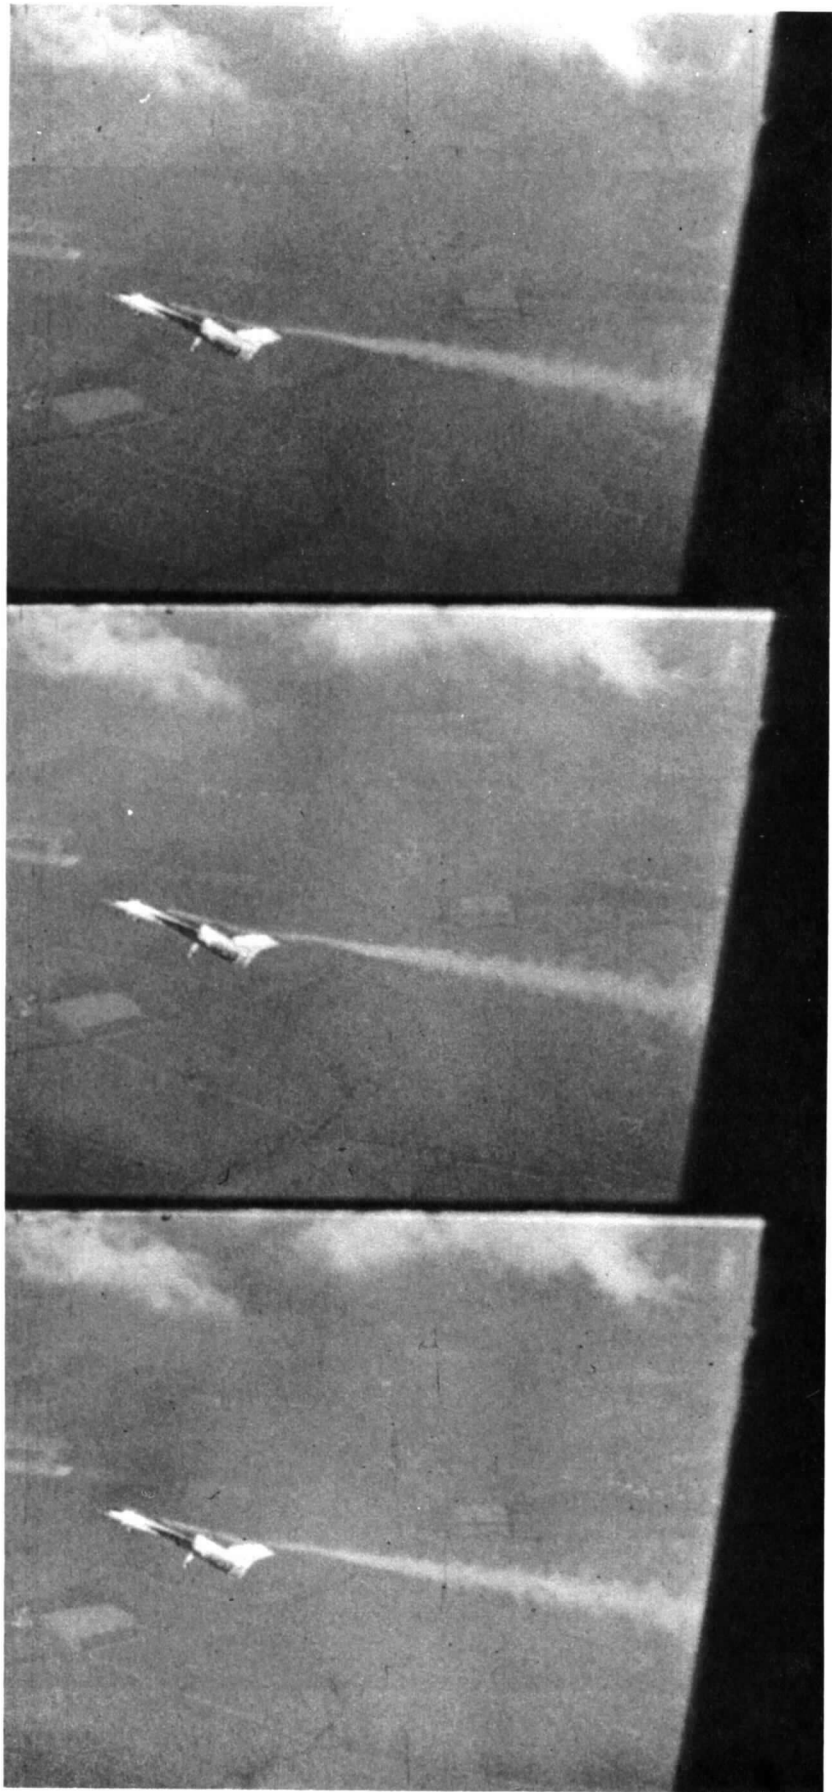
FIG. 5. Vortex breakdown at 28° incidence (extract from cine film).

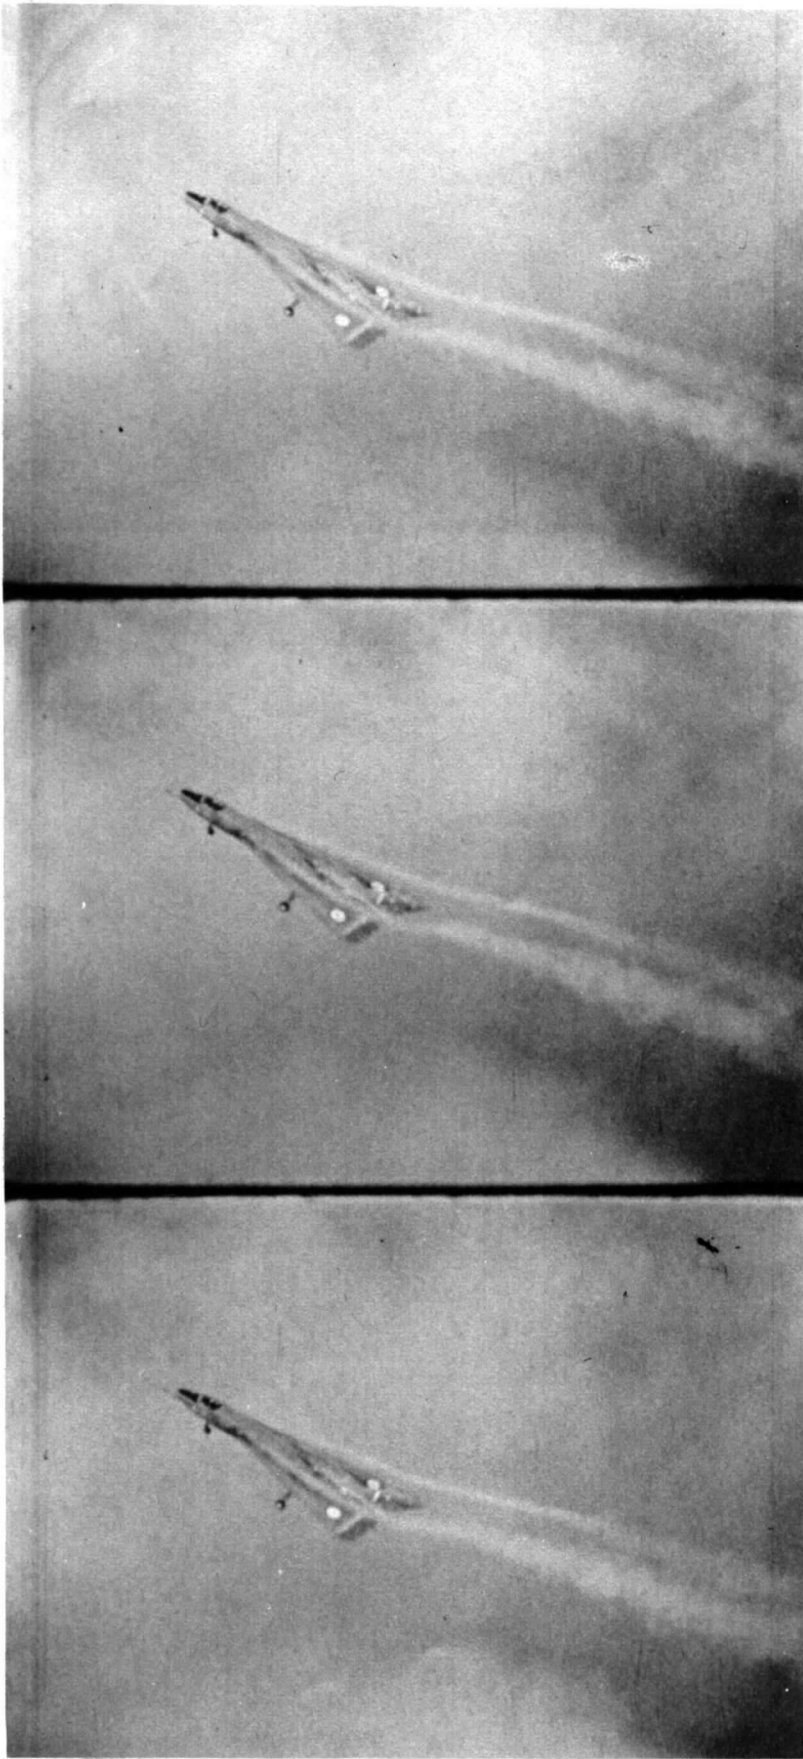
FIG. 6. Vortex breakdown at 30° incidence while sideslipping to port (extract from cine film).

When the aircraft was sideslipped, the breakdown positions moved rapidly, stabilizing closer to the trailing edge of the advancing wing, and further downstream of the opposite wing⁴. This is shown in Figs. 6 to 8.

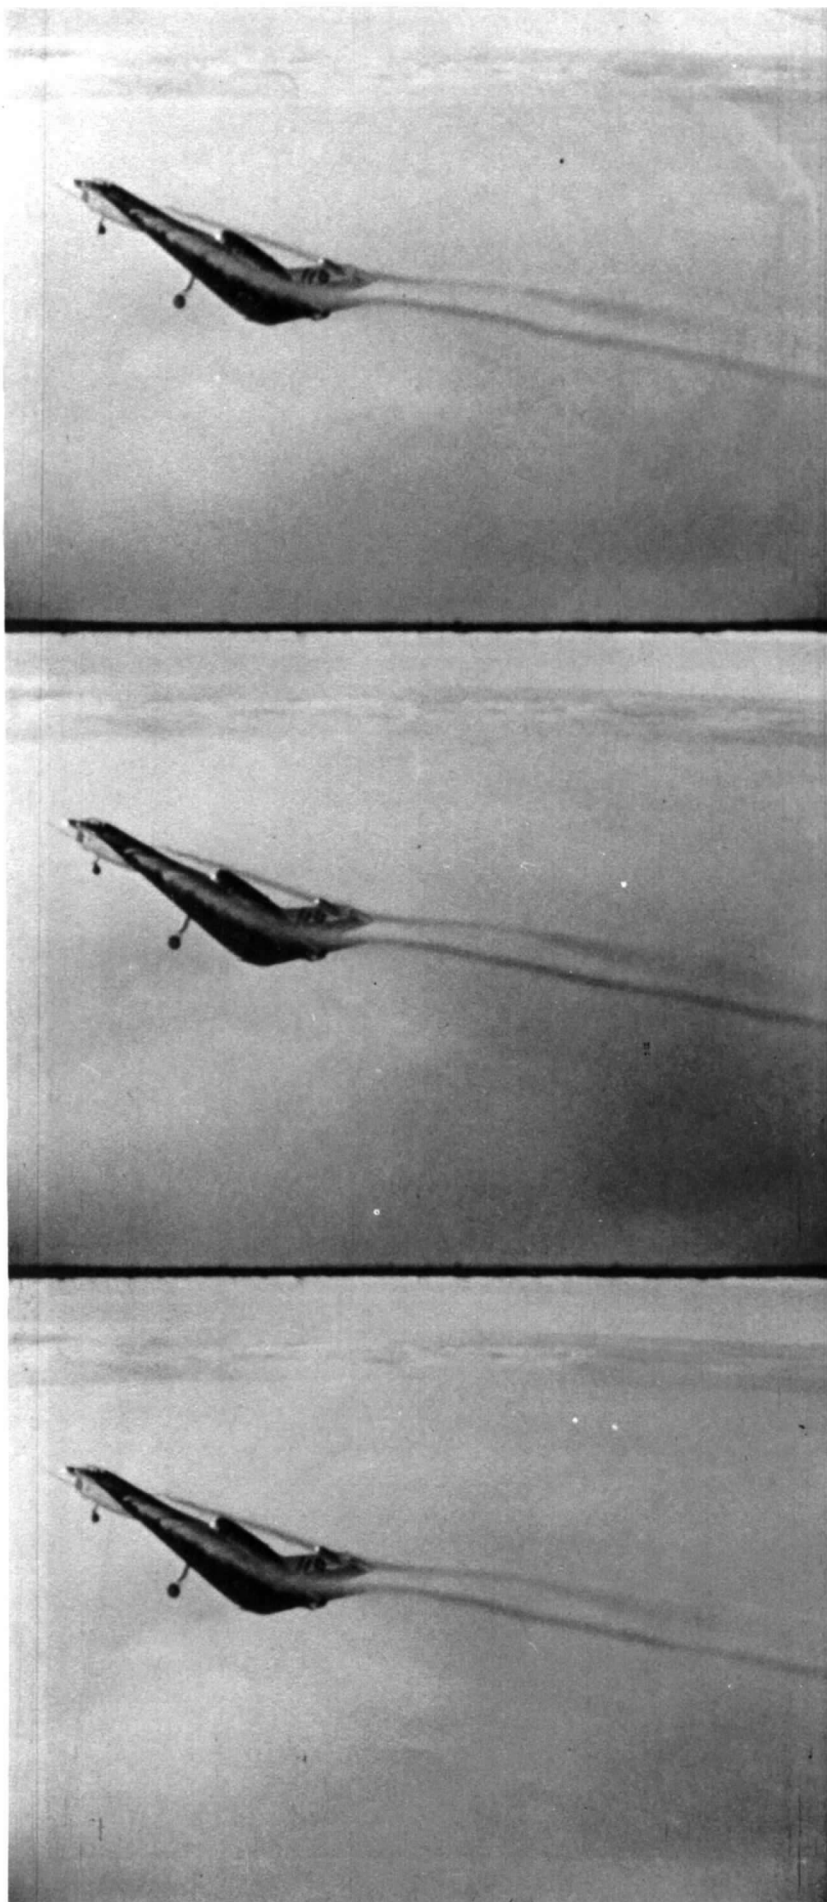
FIG. 7. Vortex breakdown at 28° incidence while sideslipping to starboard.

On all flights, a vertical change in direction was observed as the core passed over the trailing edge, when the core direction returned approximately to that of the free stream. Fig. 7 shows this occurring in flight, while Figs. 9 and 10, taken in the course of the work described in Ref. 5, show this on a model of the *HP 115* in the R.A.E. 13 ft × 9 ft wind tunnel.

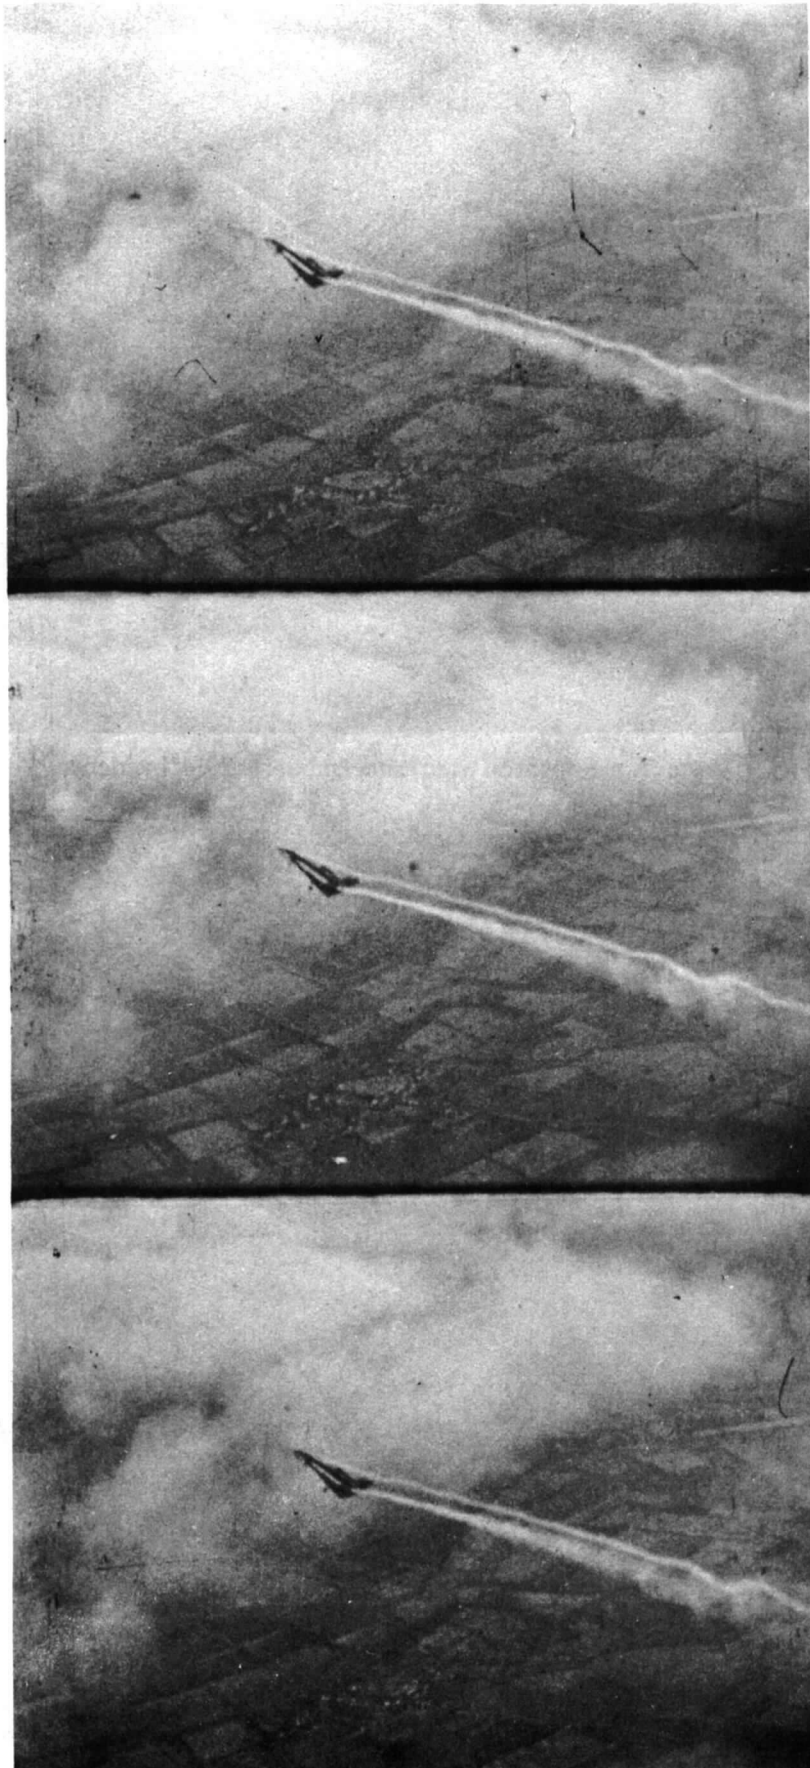
FIG 8. Vortex breakdown at 26° incidence while sideslipping to port.
