MINISTRY OF AVIATION
AERONAUTICAL RESEARCH COUNCIL
CURRENT PAPERS

Measurements of "Aquaplaning Height" on a Meteor Aircraft, and Photos of Flow Pattern under a Model Tyre

By
W.E. Gray, D.F.C.

November, 1962

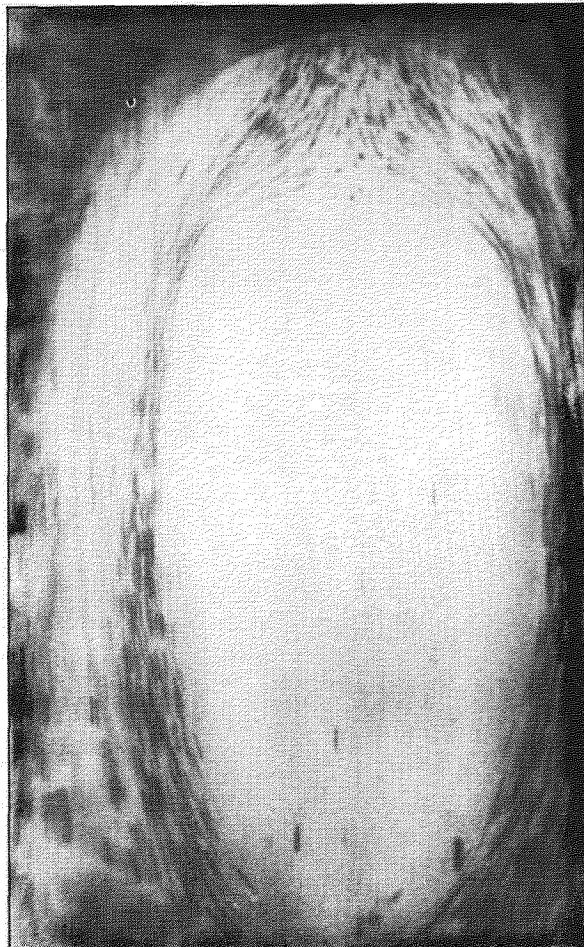
FIG.7. FULL ROLLING 30 ft/sec., 1/16th in.

FIG.8. LOCKED 30 ft/sec., 1/16th in.

The flow patterns at 30 ft/sec, before "penetration" has begun, are shown in Figs.7 and 8 for the fully rolling and locked cases. In rolling the stagnation region at the nose can be seen, also trapped particles moving at full speed (particle streaks are shorter at 30 ft/sec than at 50 ft/sec); in the locked case, the trapped particles (about $1/200$ " dia.) are stationary.
